10.0 Lowman, Idaho, Disposal Site

10.1 Compliance Summary

The Lowman, Idaho, Uranium Mill Tailings Radiation Control Act (UMTRCA) Title I Disposal Site was inspected on June 7, 2022. No changes were observed on the disposal cell or in the associated drainage features. Inspectors identified no maintenance needs and found no cause for a follow-up inspection. Groundwater monitoring is not required and was discontinued in 2004.

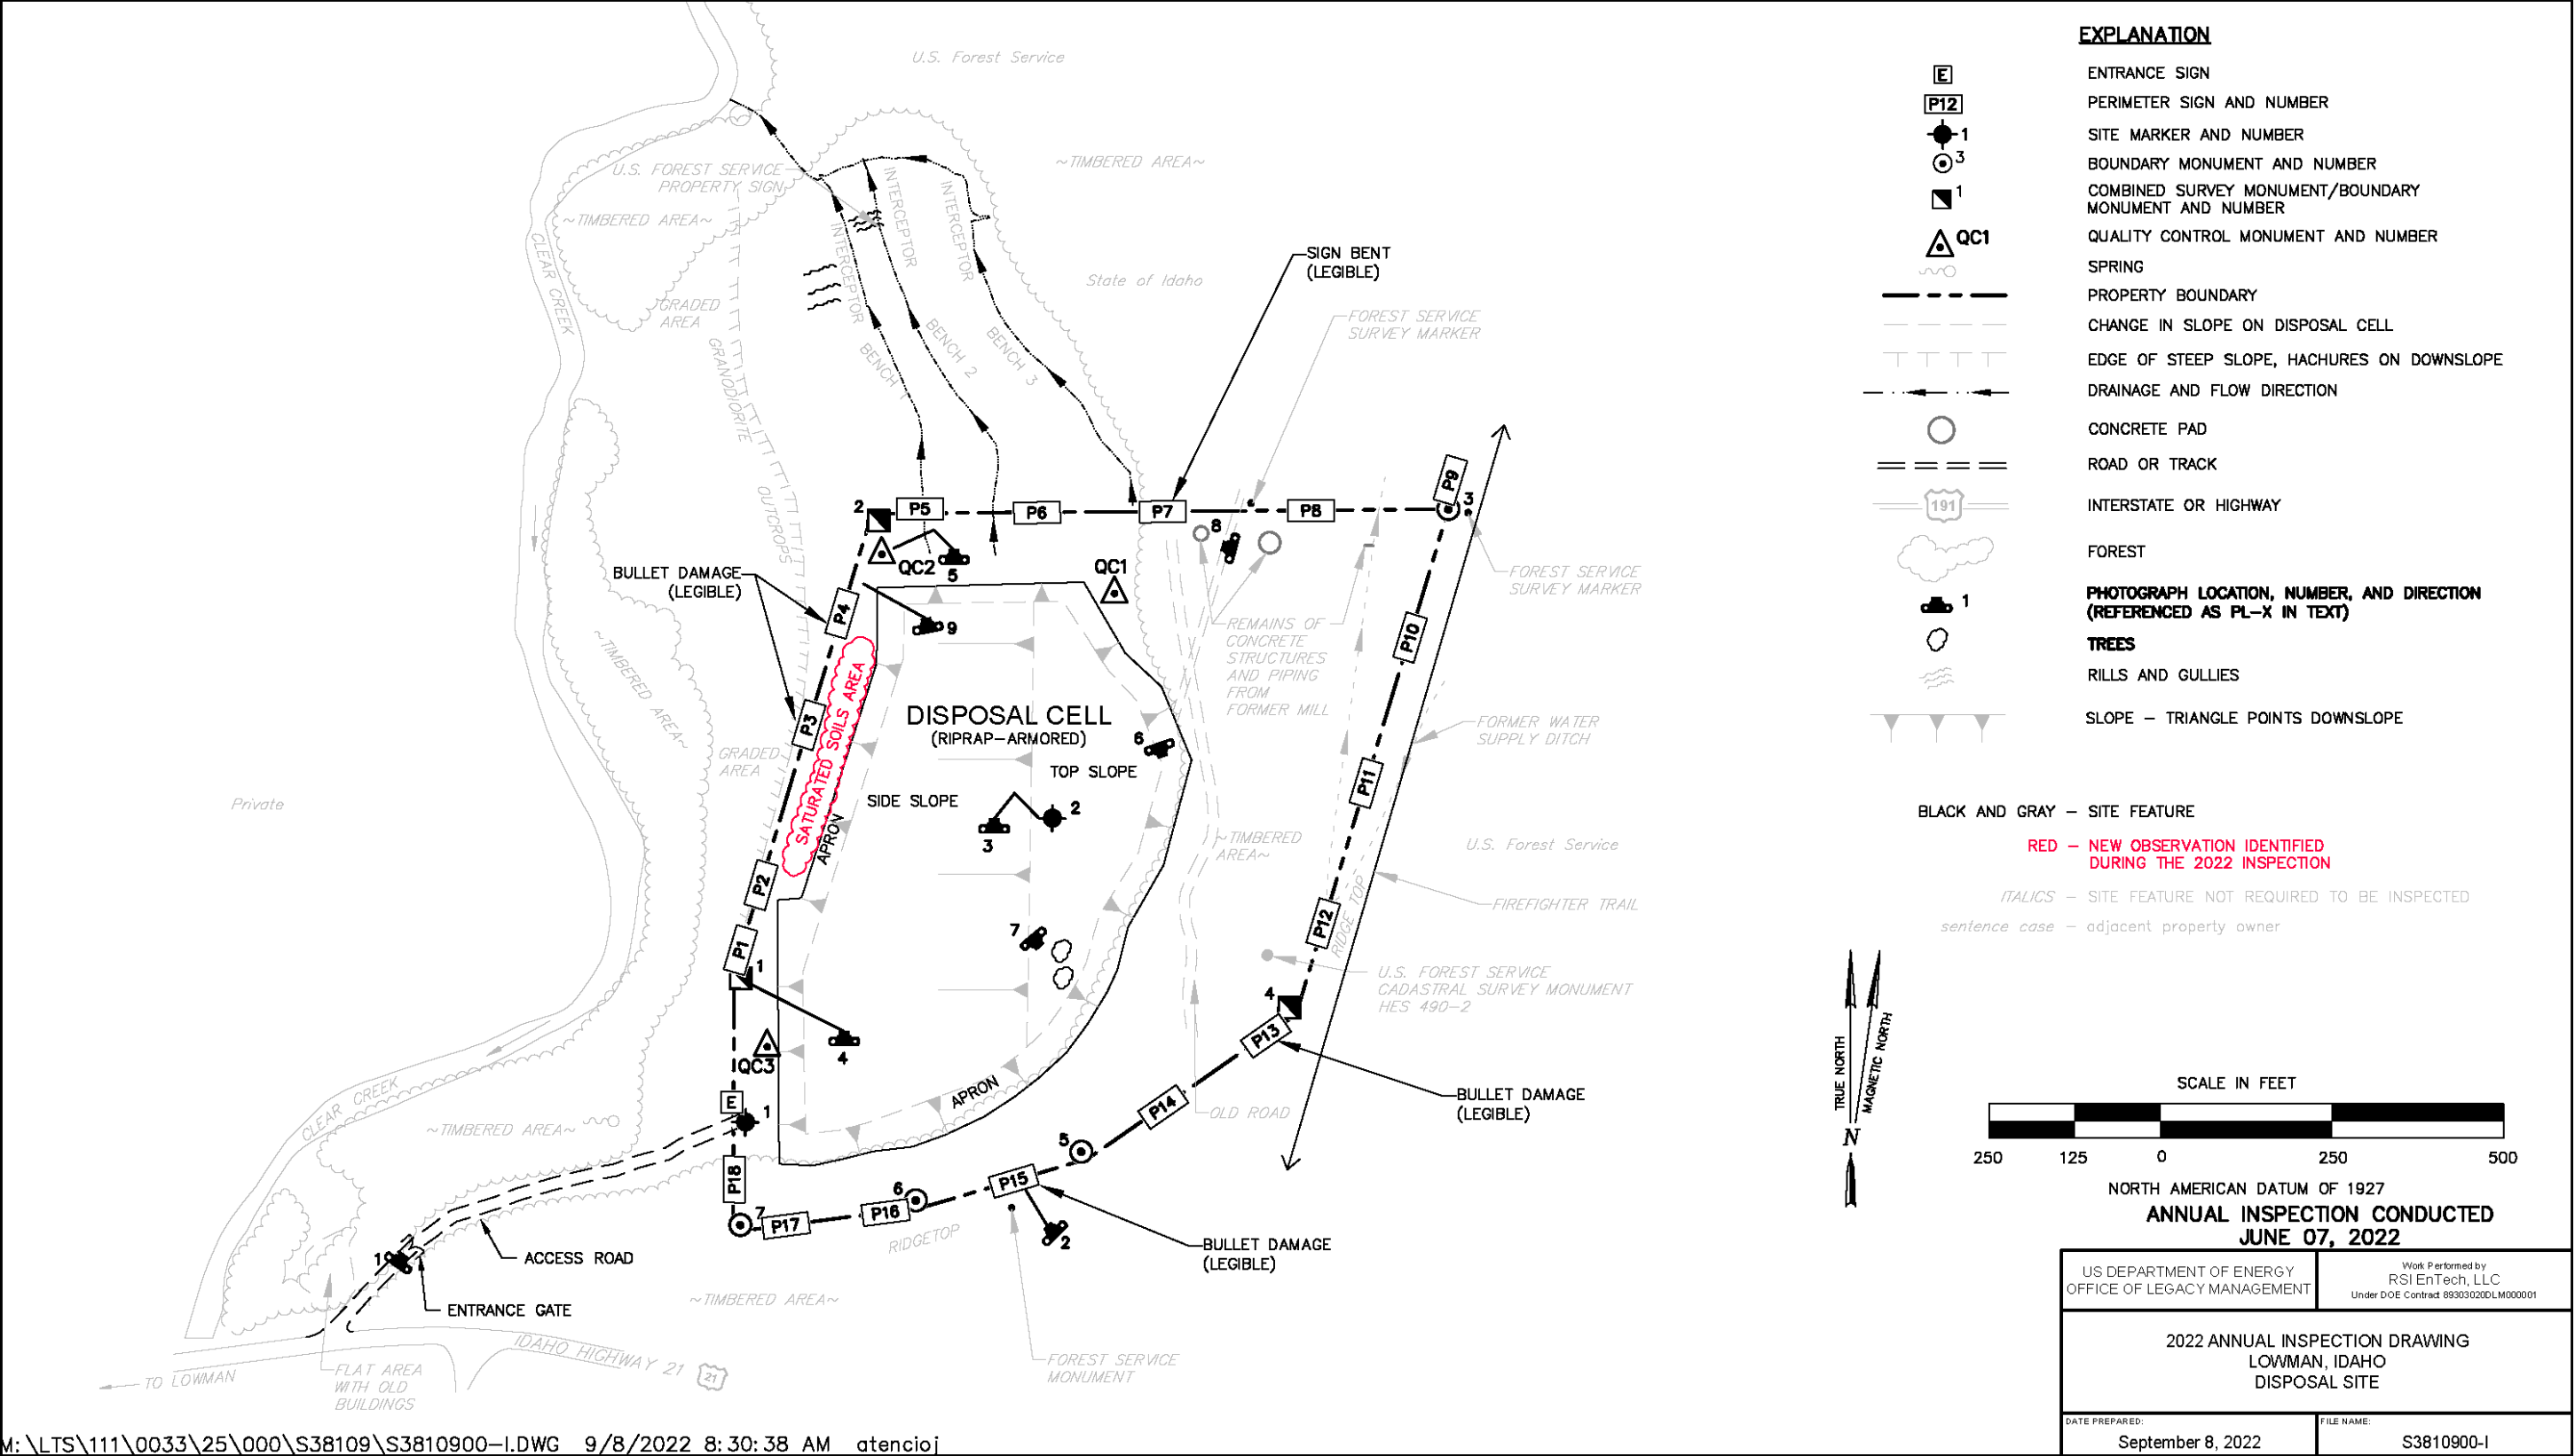
Figure 10-1. 2022 Annual Inspection Drawing for the Lowman, Idaho, Disposal Site

Figure 10-1 shows the locations of site features, including site surveillance features and inspection areas, in black and gray font. Some site features that are present but not required to be inspected are shown in italic font and new observations identified during the 2022 annual inspection are shown in red. Inspection results and recommended maintenance activities associated with site surveillance features are described in the following subsections. Photographs to support specific observations are noted in the text and in Figure 10-1 by photograph location (PL) numbers. The photographs and photograph log are presented in Section 10.10.
