10.0 Lowman, Idaho, Disposal Site

10.1 Compliance Summary

Figure 10-1. 2023 Annual Inspection Drawing for the Lowman, Idaho, Disposal Site

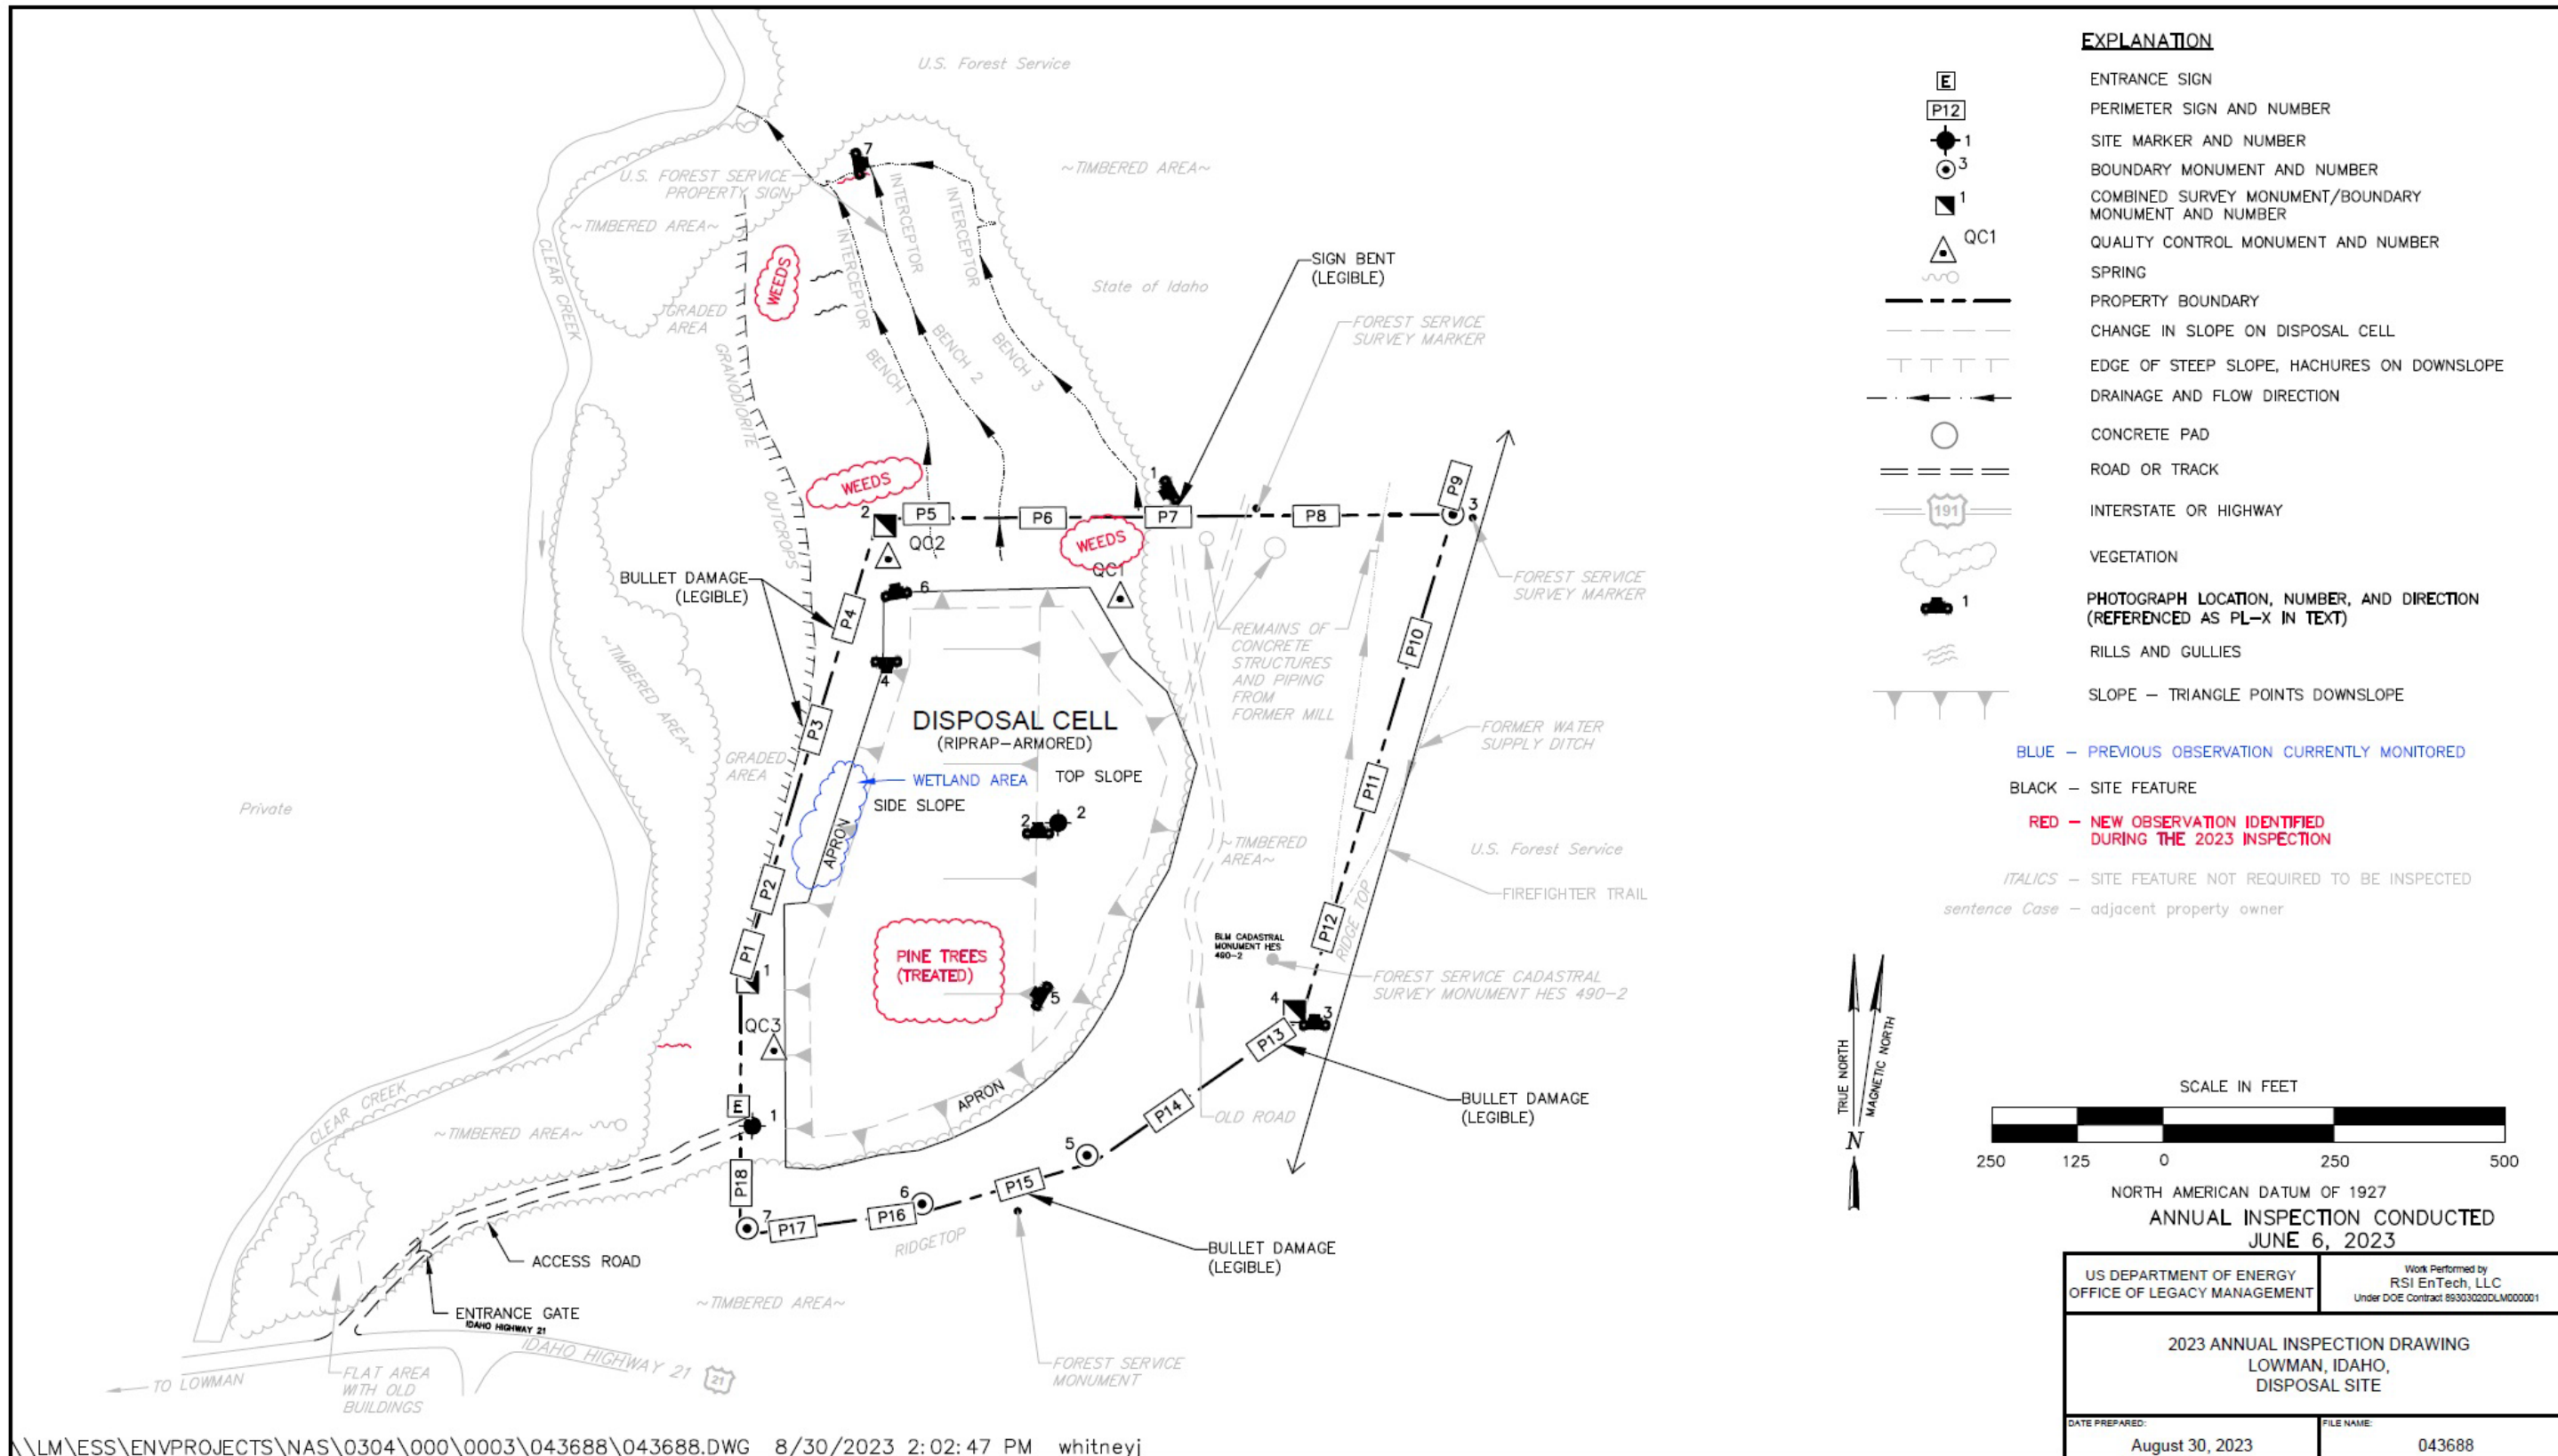
Figure 10-1 shows the locations of site features, including site surveillance features and inspection areas, in black and gray font. Some site features that are present but not required to be inspected are shown in italic font. Observations from previous inspections that are currently monitored are shown in blue, and new observations identified during the 2023 annual inspection are shown in red. Inspection results and recommended maintenance activities associated with site surveillance features are described in the following subsections. Photographs to support specific observations are noted in the text and in Figure 10-1 by photograph location (PL) numbers. The photographs and photograph log are presented in Section 10.10.
