## 10.0 Lowman, Idaho, Disposal Site

### 10.1 Compliance Summary

The Lowman, Idaho, Uranium Mill Tailings Radiation Control Act (UMTRCA) Title I Disposal Site was inspected on May 14, 2024. No significant changes were observed on the disposal cell or in the associated drainage features. Inspectors identified minor maintenance needs that were completed following the inspection but found no cause for a follow-up inspection. Groundwater monitoring is not required and was discontinued in 2004.

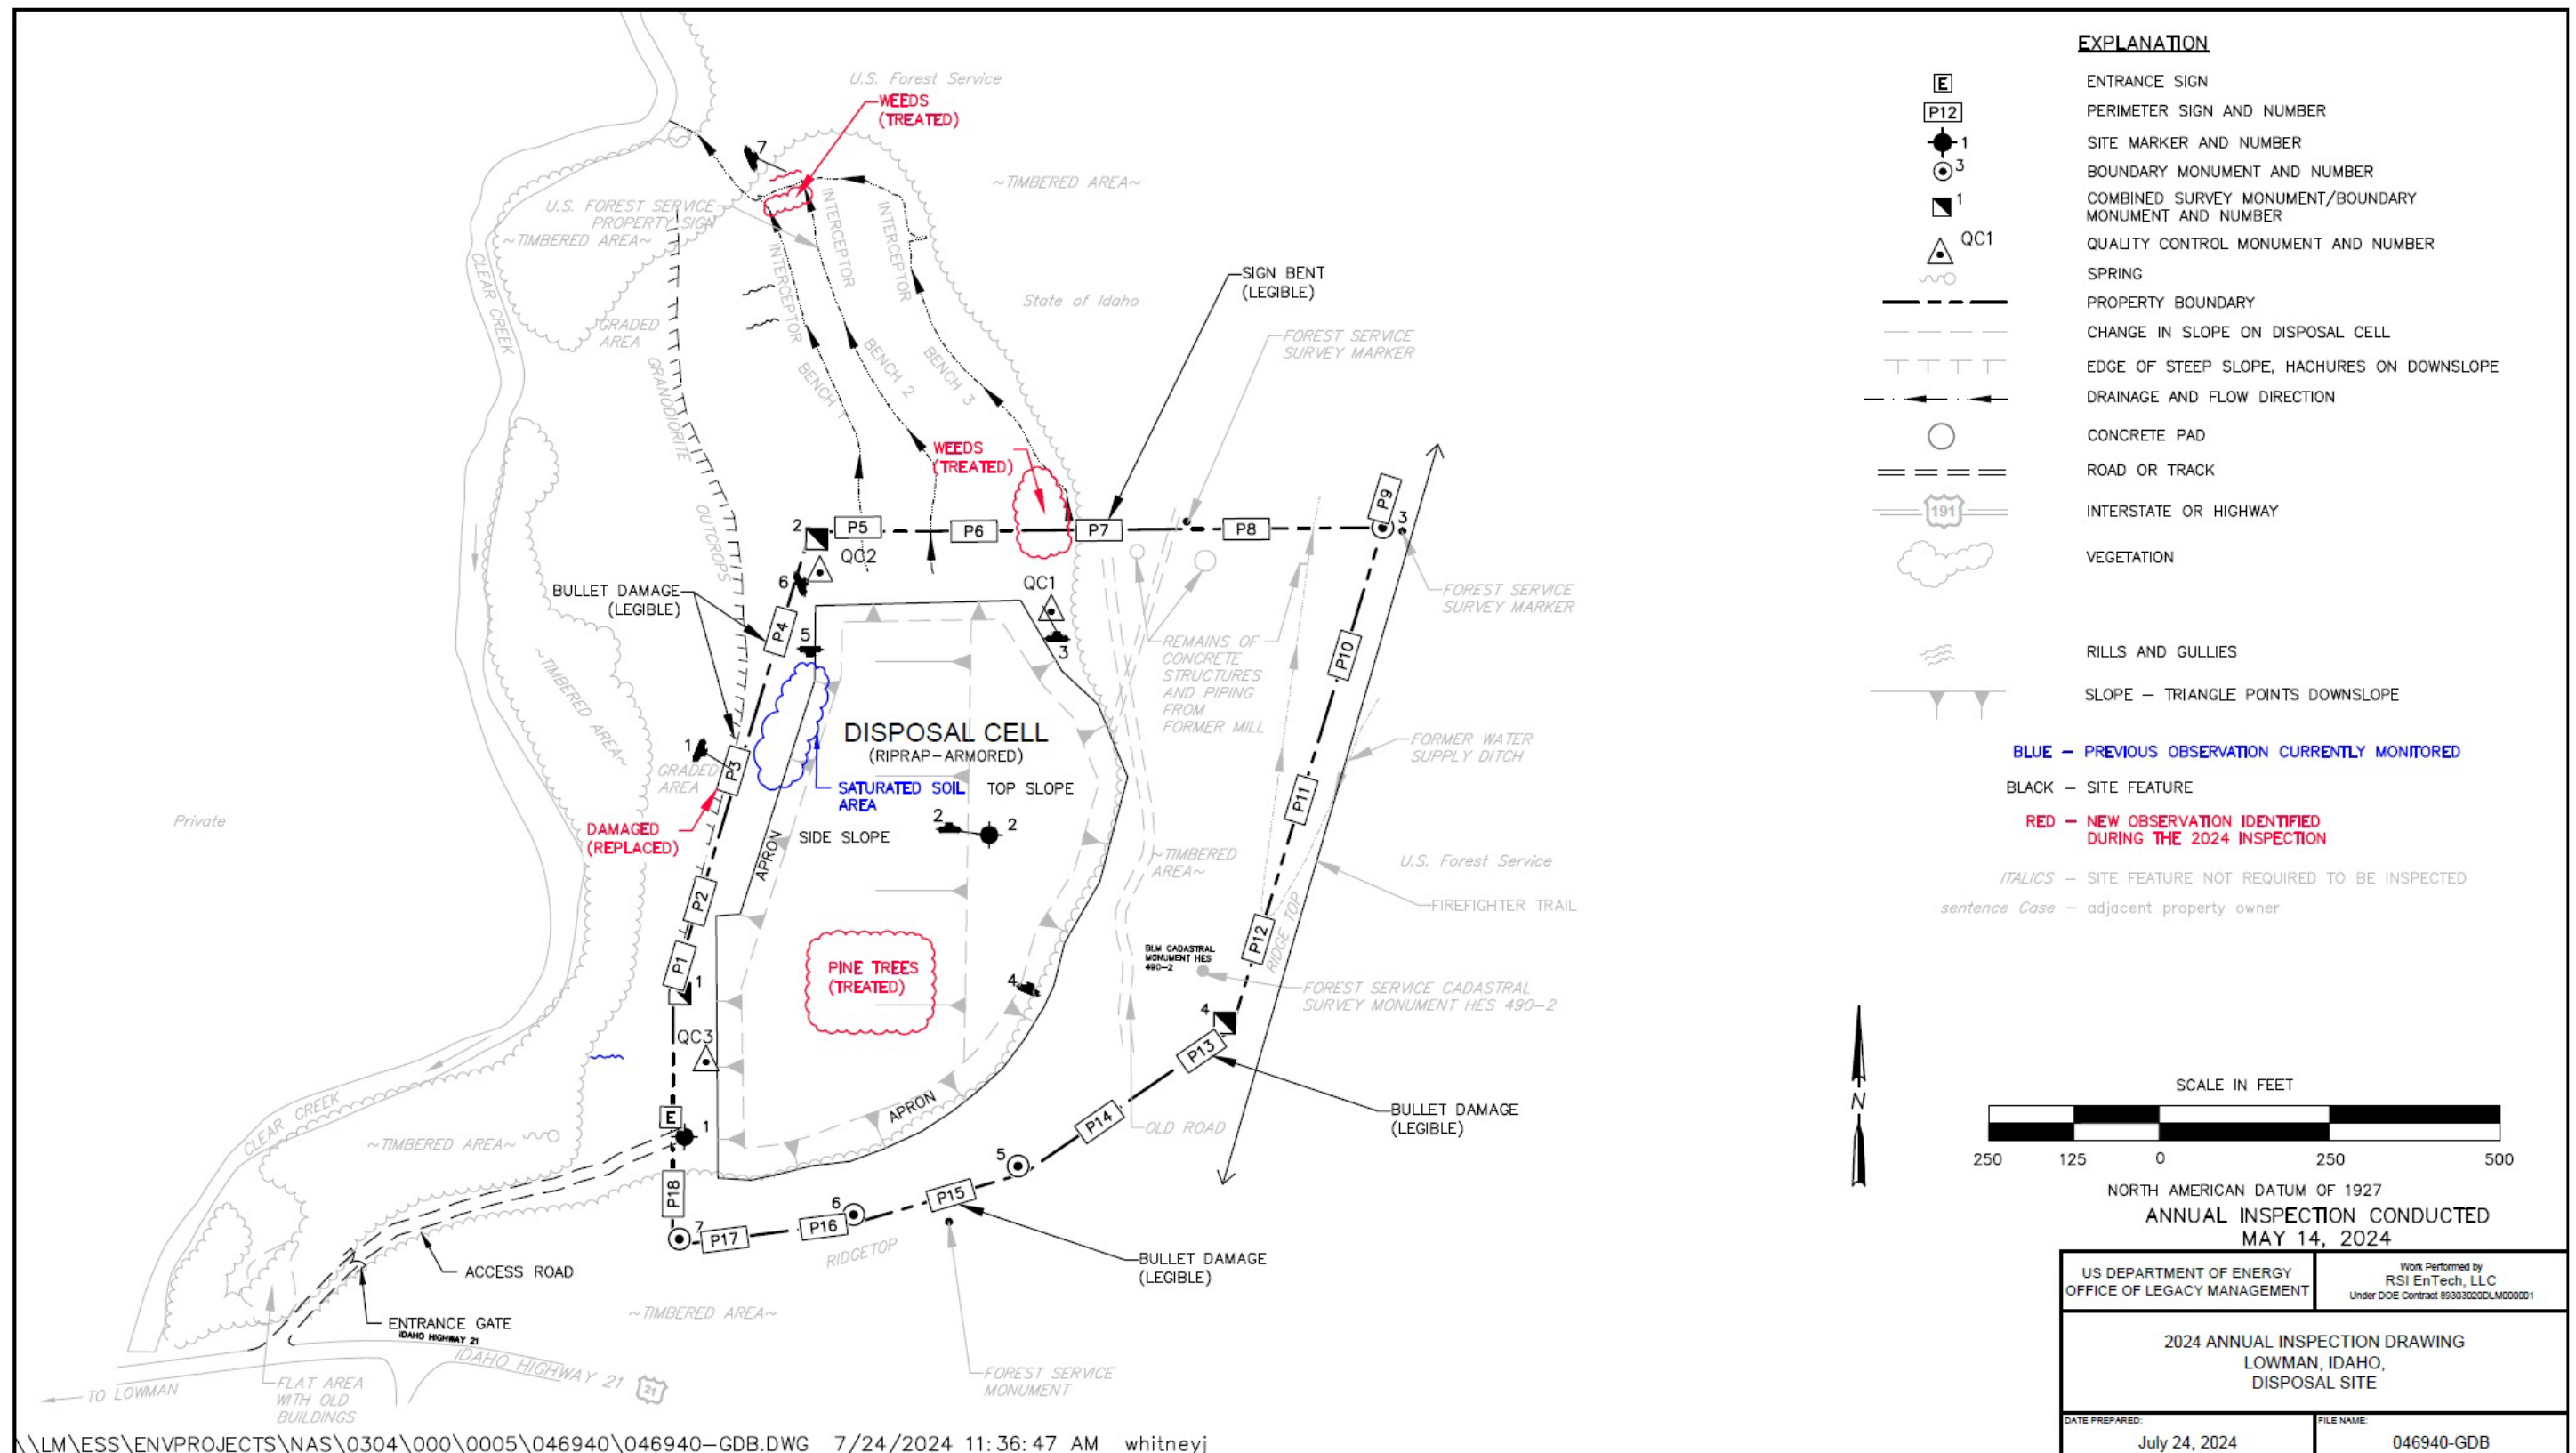
Figure 10-1. 2024 Annual Inspection Drawing for the Lowman, Idaho, Disposal Site

Figure 10-1 shows the locations of site features, including site surveillance features and inspection areas, in black and gray font. Some site features that are present but not required to be inspected are shown in italic font. Observations from previous inspections that are currently monitored are shown in blue, and new observations identified during the 2024 annual inspection are shown in red. Inspection results and recommended maintenance activities associated with site surveillance features are described in the following subsections. Photographs to support specific observations are noted in the text and in Figure 10-1 by photograph location (PL) numbers. The photographs and photograph log are presented in Section 10.10.
