4.0 Durango, Colorado, Disposal Site

4.1 Compliance Summary

4.3.1 Annual Inspection and Report

The site, located southwest of Durango, Colorado, was inspected on May 28, 2008. Results of the inspection are described below. Features and photograph locations (PLs) discussed in this

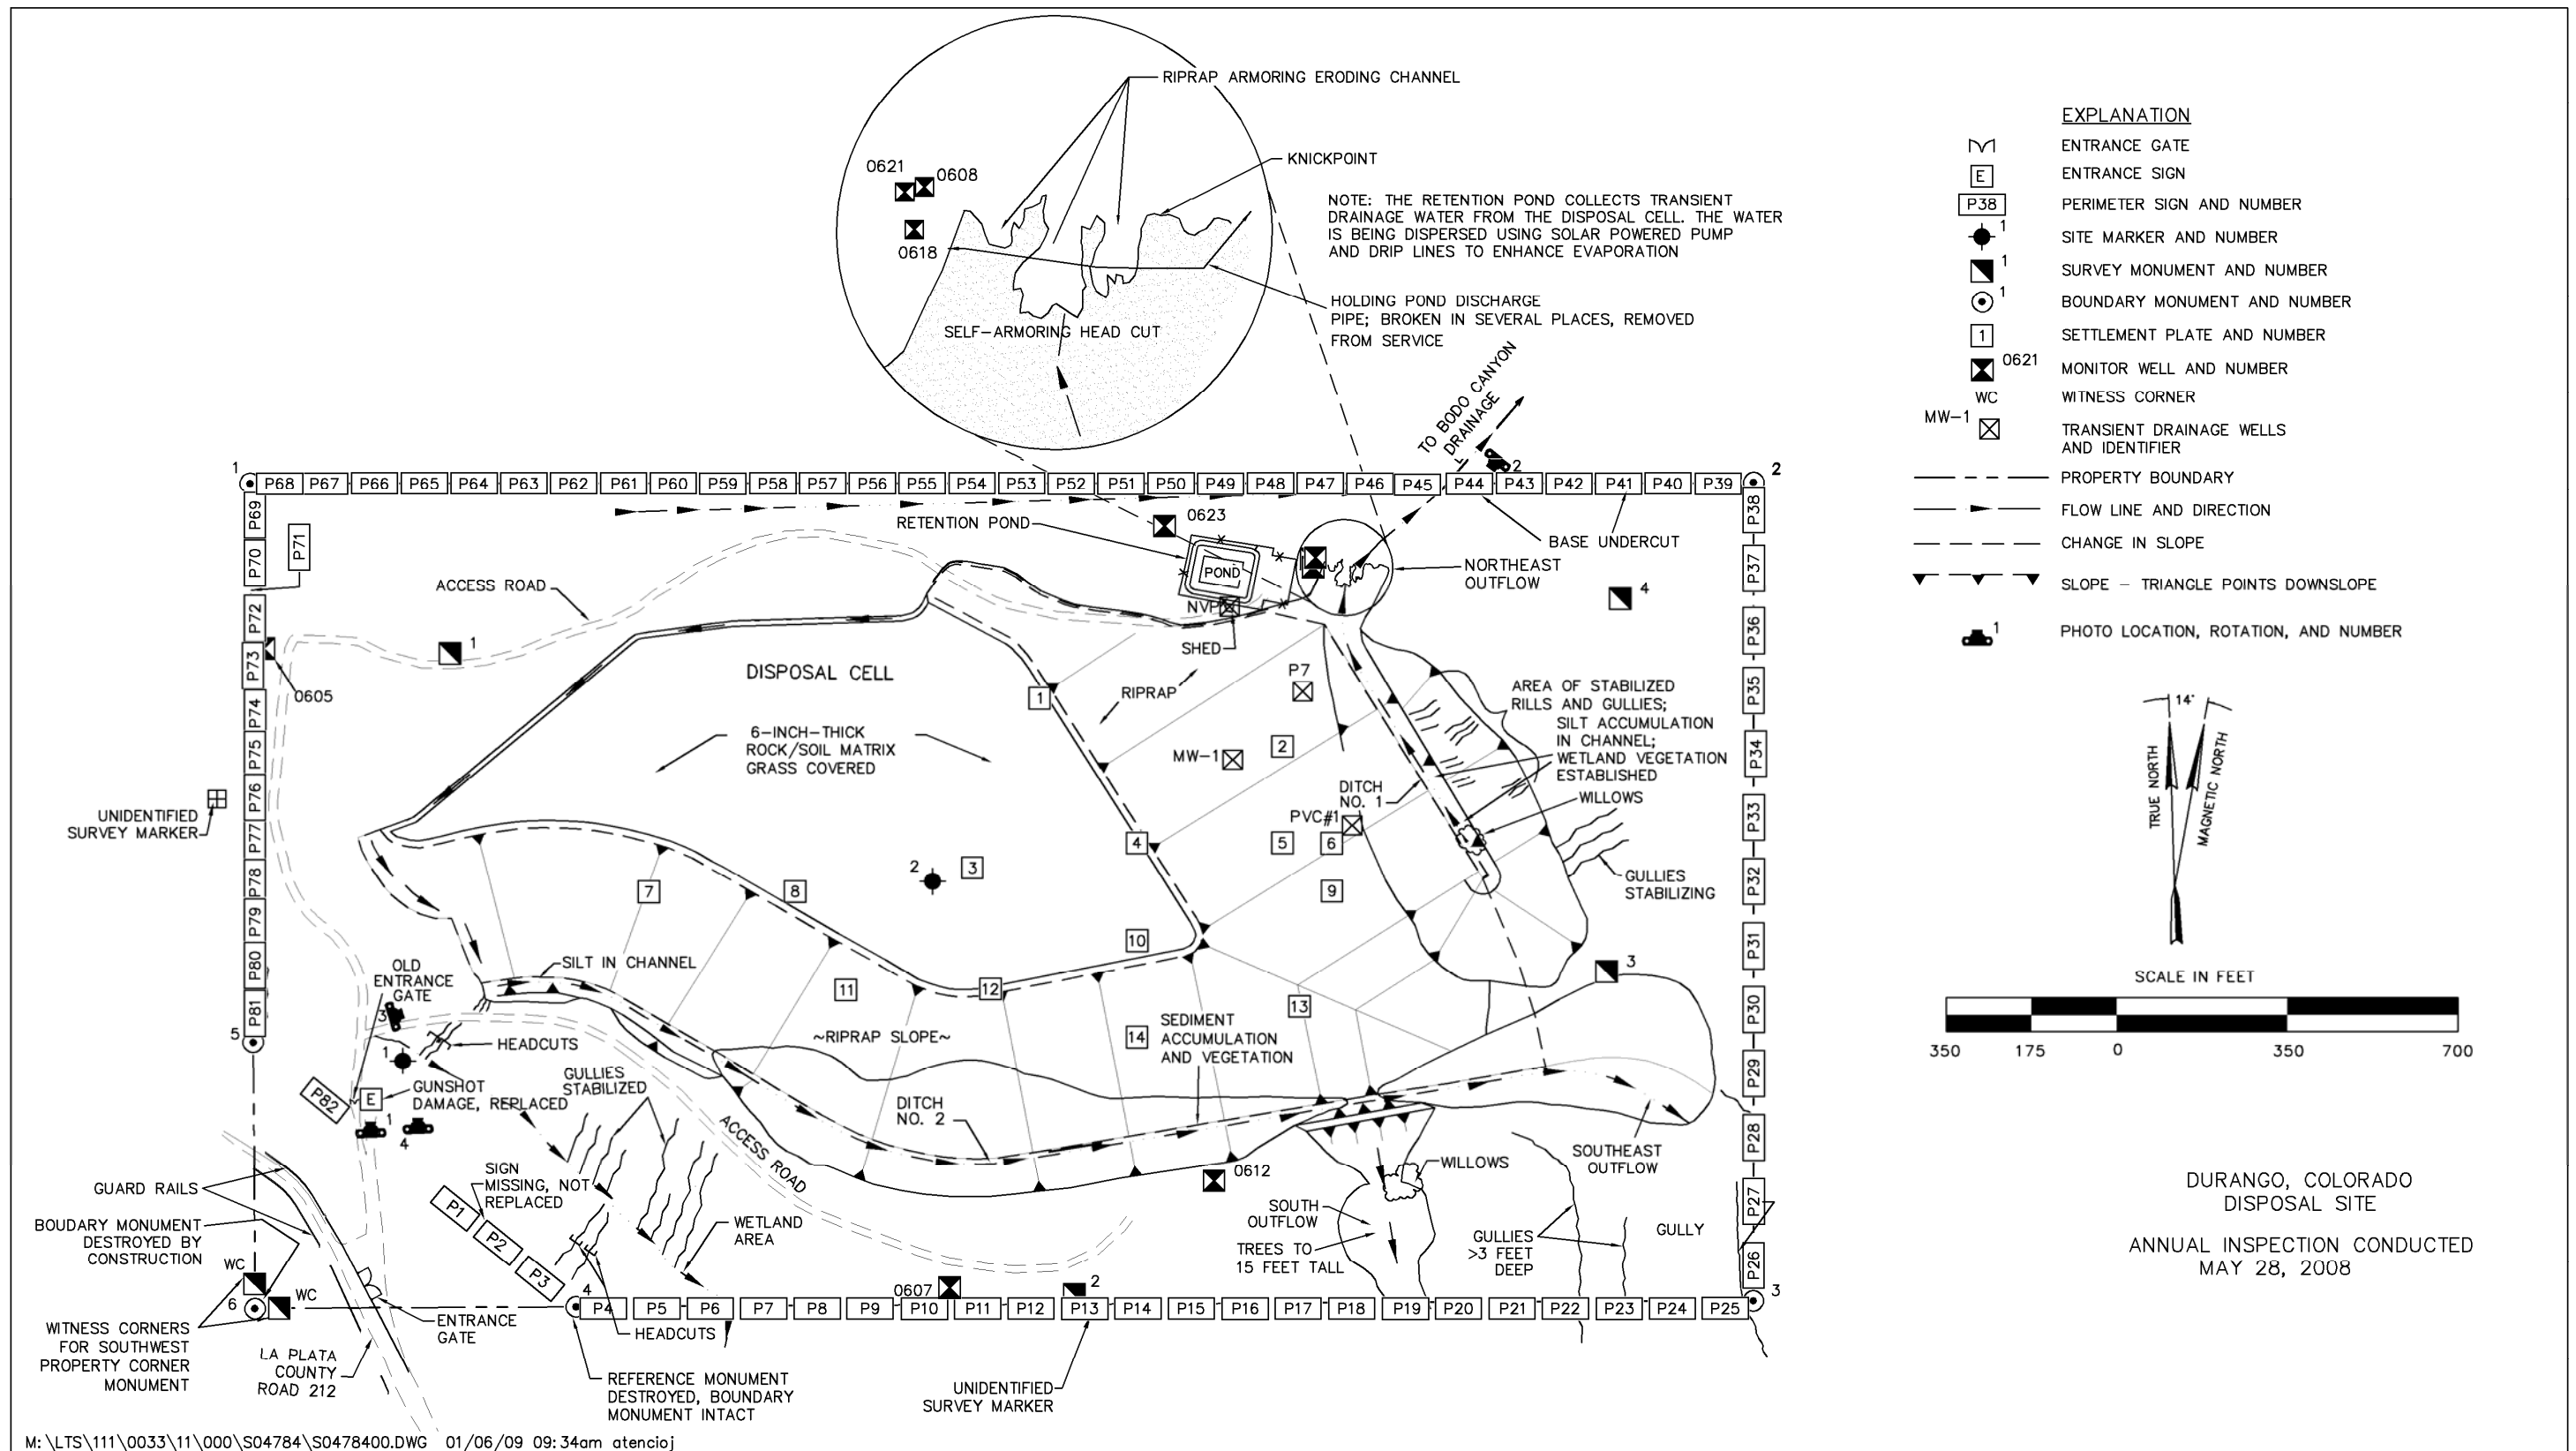
Figure 4-1. 2008 Annual Compliance Drawing for the Durango Disposal Site

Monitor Wells and Other Wells—Monitor wells were locked and in good condition. The cap on one of the disposal cell’s transient drainage collection system vent wells, PVC #1, is cracked but remains functional.

Top of Disposal Cell—The top of the disposal cell is vegetated and in excellent condition. No evidence of settling, slumping, or erosion was observed.

In the past, small rodents have dug burrows in the top of the disposal cell near site marker SMK-2. Inspectors noted that the burrows appeared to be abandoned in 2008. Burrow holes will continue to be monitored but do not appear to degrade isolation or disposal cell integrity.

Side Slopes of Disposal Cell—The riprap-covered side slopes of the disposal cell are in good condition. There was no evidence of subsidence, rock deterioration, and slope failure.

Drainage Ditches—Rock-armored drainage ditches beneath the toe of the side slope on the northwest, south, and east sides of the disposal cell direct runoff into natural drainages that carry storm water away from the disposal site. Past erosion and sloughing in Ditch No. 1 have allowed wetland vegetation, including willows, to take root in areas where moist sediments have accumulated. In other places, trees as tall as 15 feet grow in the drainage ditches. The sediment deposits and vegetation currently will not compromise the drainage ditches’ performance in the event of a large storm. Should colluvial deposits or excessive vegetation dam a drainage ditch so as to impound water, the deposits or vegetation will be removed.

Site Boundary—The site is not fenced. Missing and damaged perimeter signs indicate continued trespassing and vandalism. However, before the guardrail and gate along County Road 212 were installed in 2000, the public used the area between the county road and the original entrance gate quite heavily. Since the installation of the guardrail, use of this area has been minimal except for the destruction and theft of perimeter signs.

In 2008, the entrance sign and perimeter signs P1 and P82 were replaced. Noxious weeds were treated with herbicide.
