Verification Monitoring Report for the Durango, Colorado, Processing Site

September 2009

U.S. DEPARTMENT OF
ENERGY

Legacy
Management

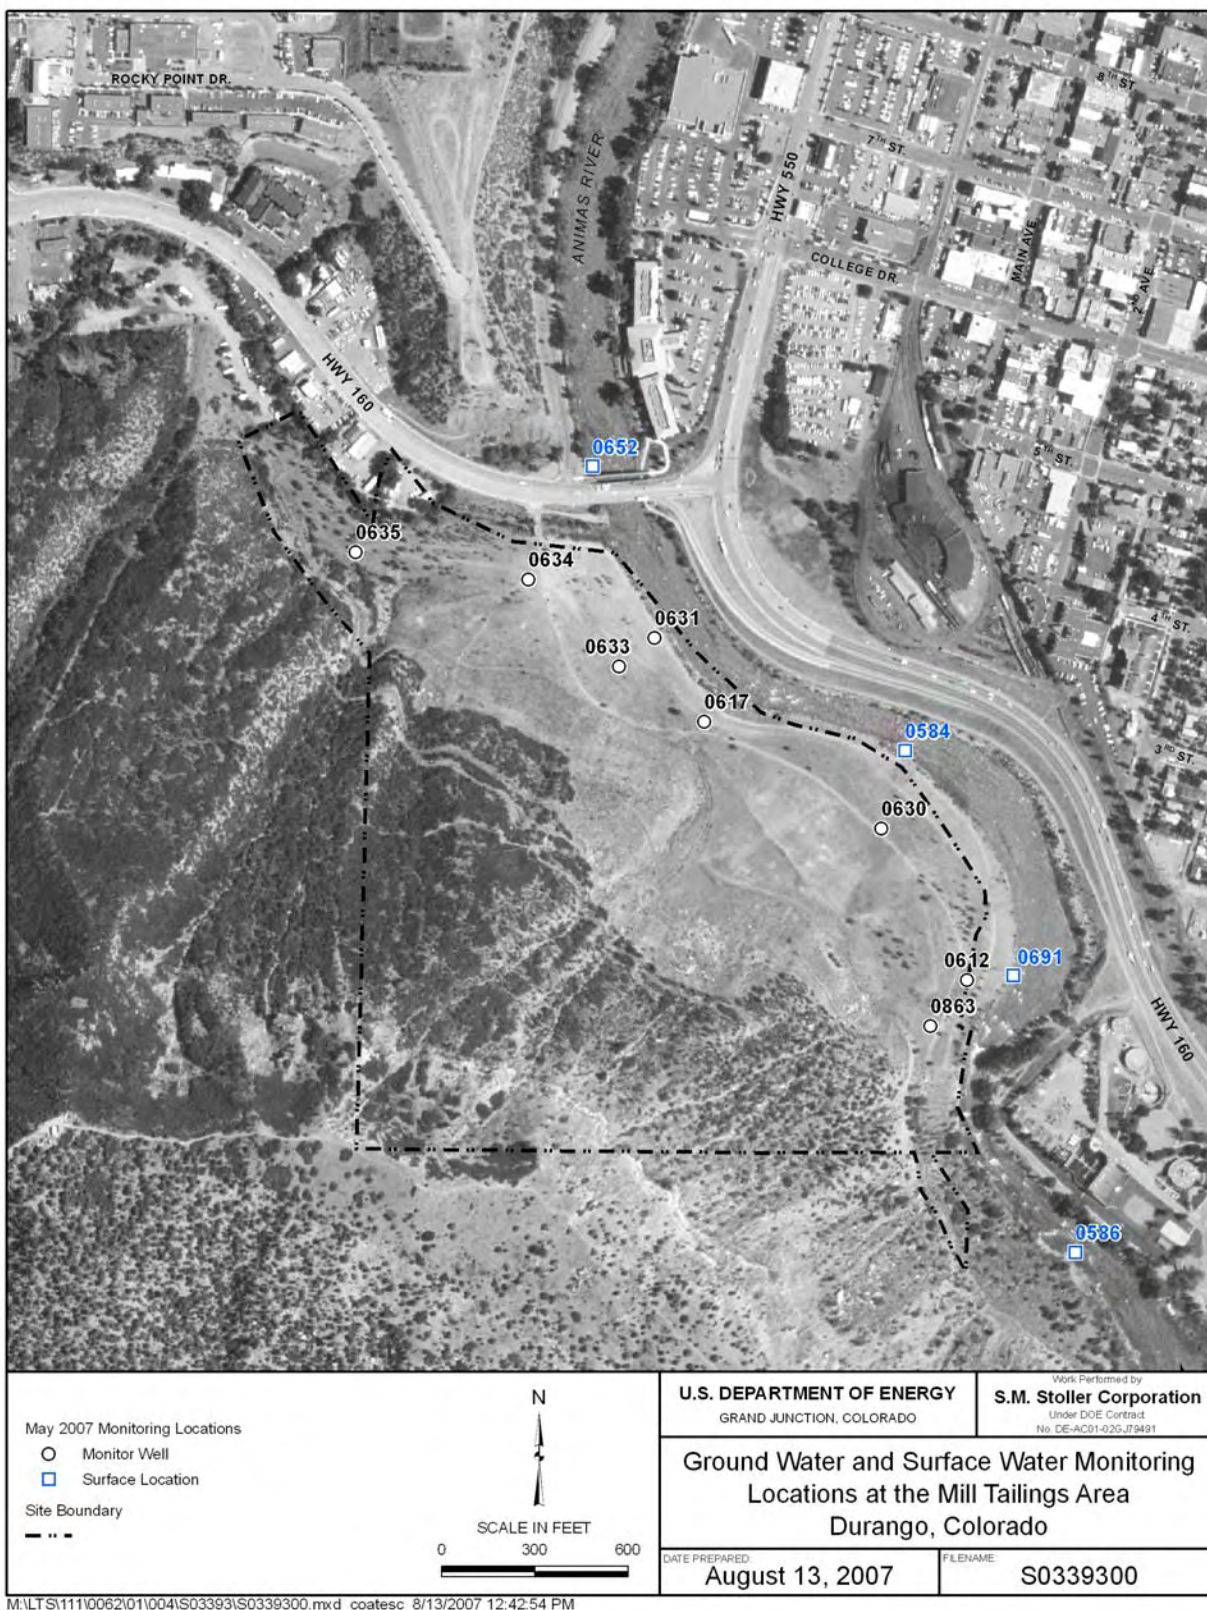
Figure 2. Monitoring Network in the Mill Tailings Area at the Durango Site

At the mill tailings area, monitor wells 0612, 0617, 0630, 0631, 0633, 0634, 0635, and 0863 have been established as point-of-compliance (POC) wells that will be used to monitor the progress of natural flushing in groundwater in the alluvial aquifer (Figure 2). In accordance with provisions of the GCAP (DOE 2003), natural flushing for a given analyte is complete when its concentration no longer exceeds the compliance goal at the POC wells for three consecutive annual sampling events. Monitoring for that constituent may then be discontinued.

Groundwater was sampled from the eight POC locations (Figure 2) and analyzed for constituents shown in Table 2. Sampling results for 2009 are provided in Appendix A and are discussed below by constituent.

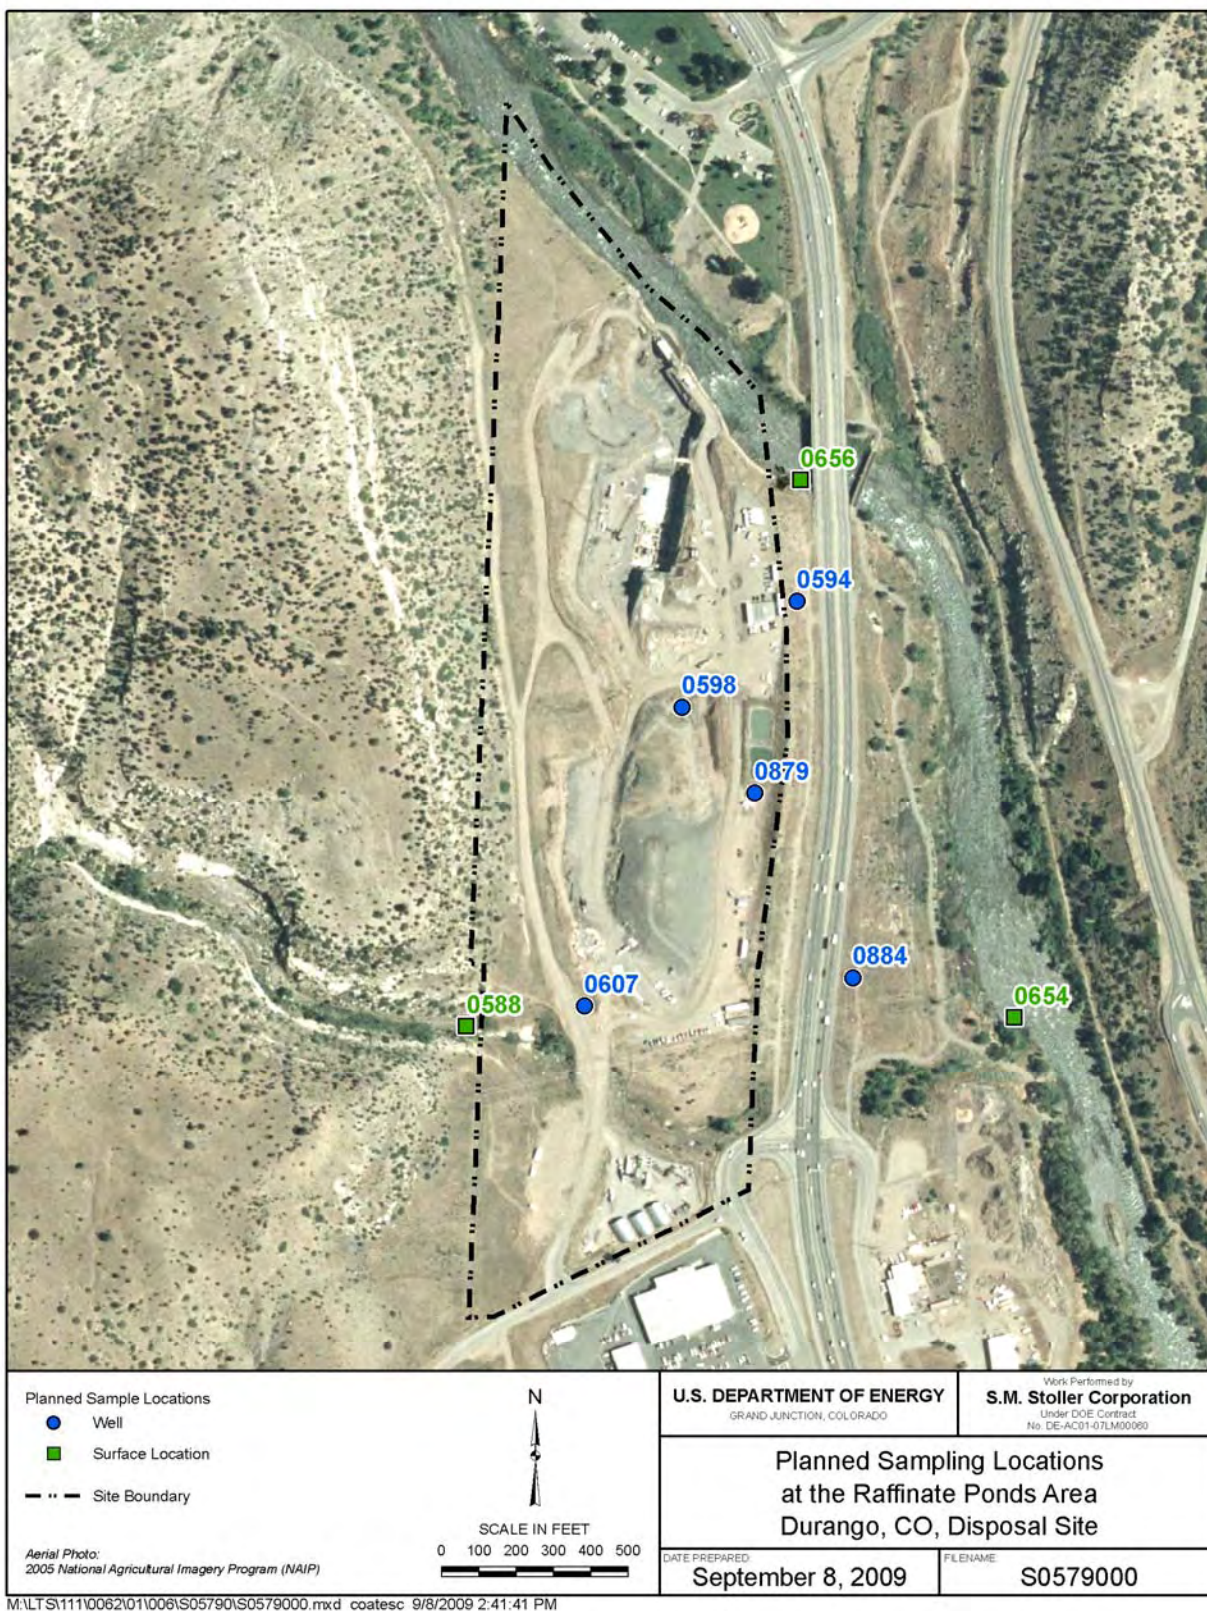
Figure 3. Monitoring Locations for the Raffinate Ponds Area

Groundwater was sampled from four of the five well locations in the monitoring network (Figure 3) in 2009 and analyzed for uranium and selenium. Well 0879 could not be sampled because it was covered with two feet of water from heavy rains during the June 2009 sampling event. Sampling results for 2009 are provided in Appendix A and are discussed below by constituent.

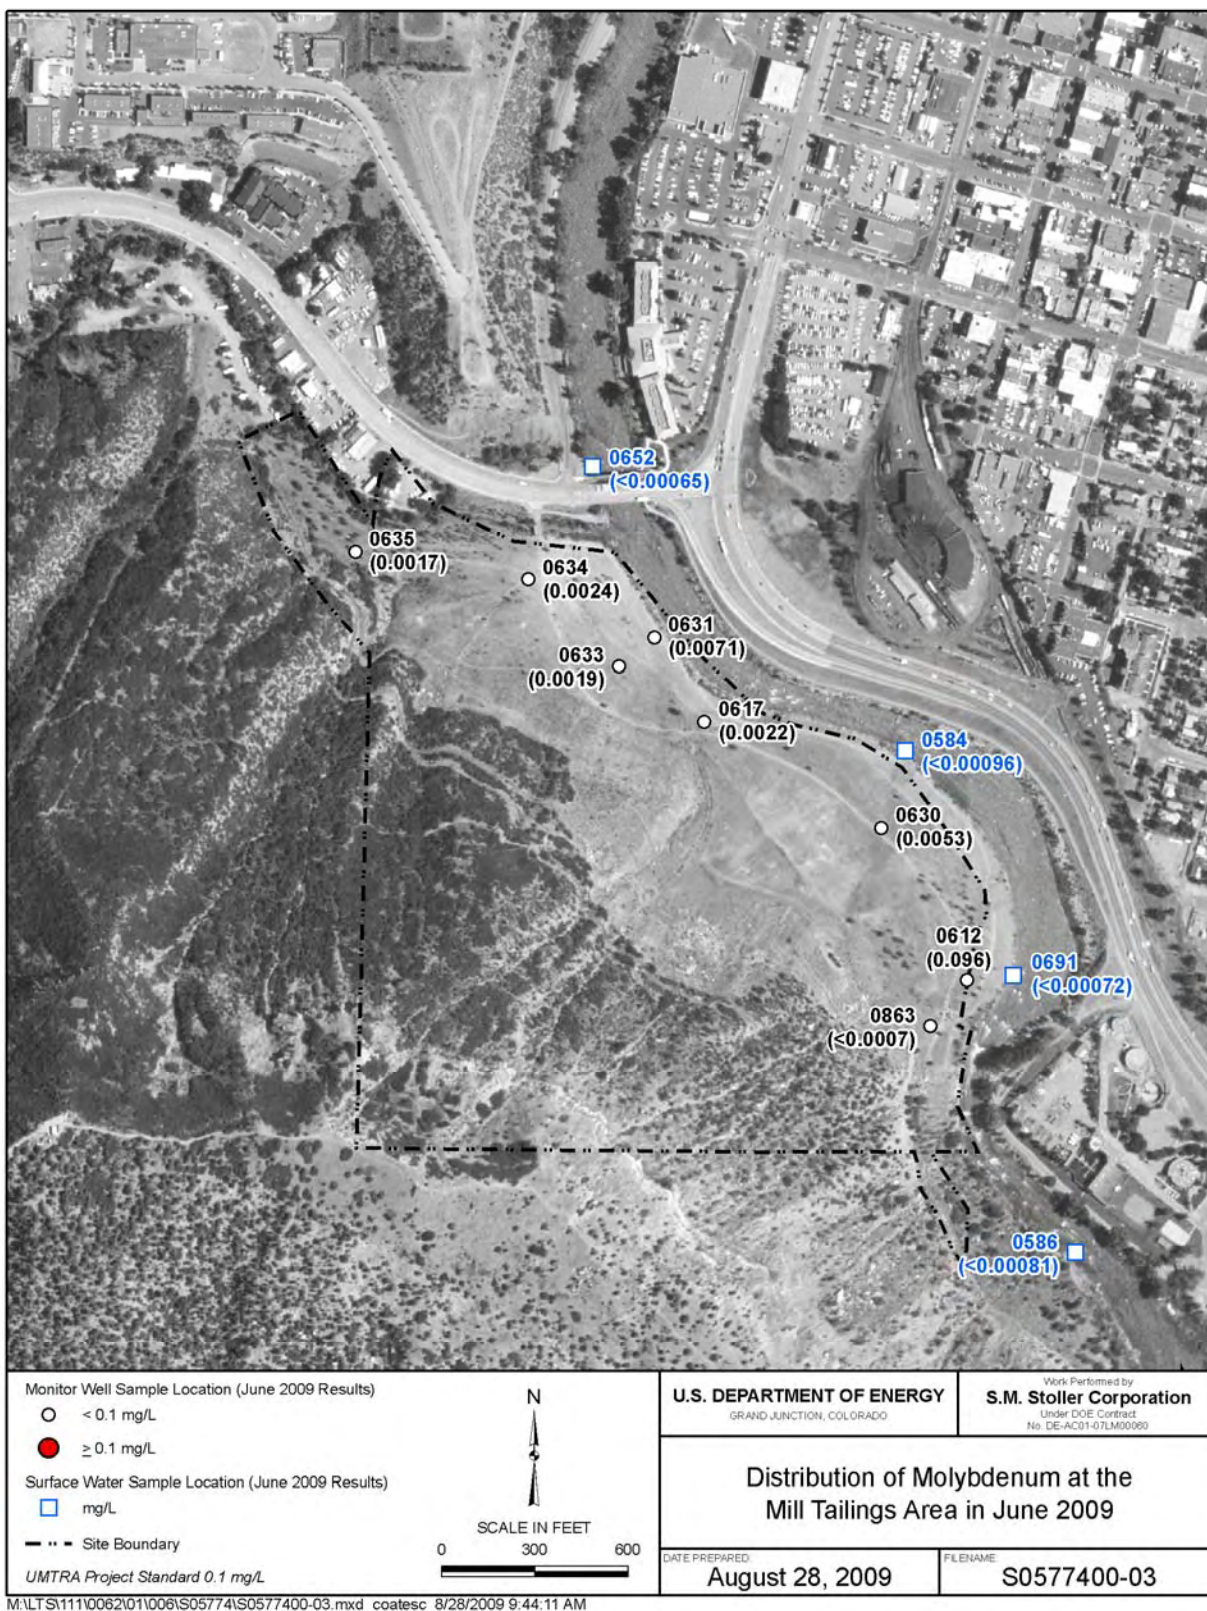
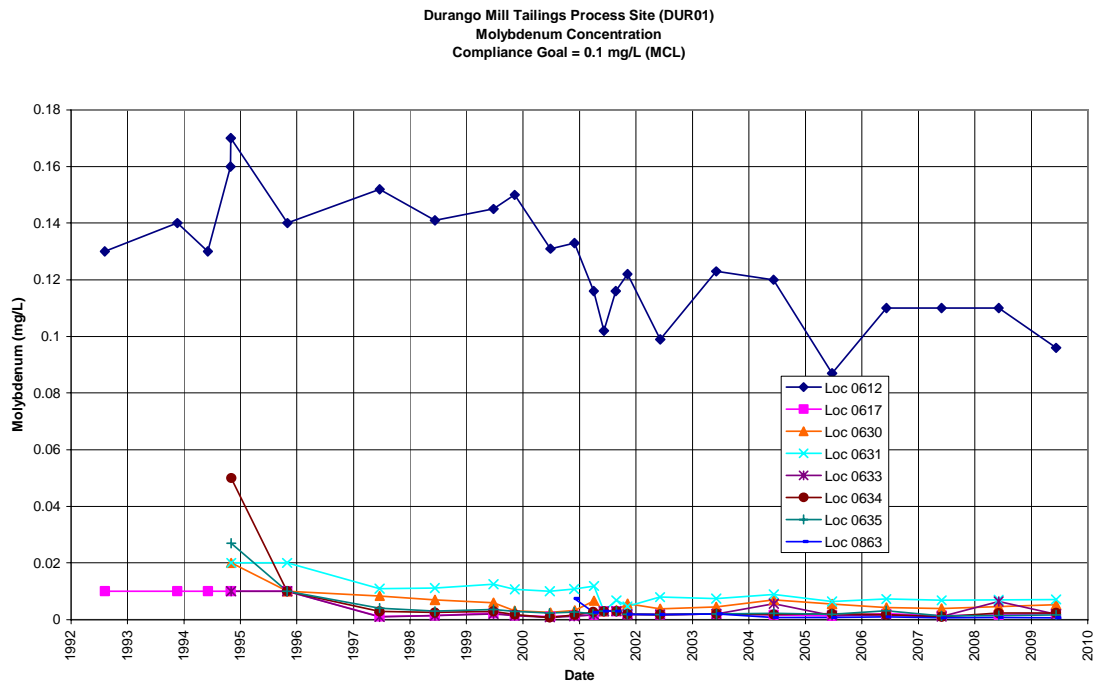
Figure 10. Distribution of Molybdenum at the Mill Tailings Area

Molybdenum concentrations in June 2009 were less than the compliance goal of 0.1 mg/L at all locations. Concentrations at well 0612, which remained slightly above the compliance goal in 2008, declined slightly to 0.096 mg/L in 2009 (Figures 10 and 11). If all wells remain below the standard for two more sampling rounds, compliance will be achieved and monitoring for molybdenum can be discontinued. The linear trend of observed concentrations at well 0612 forecasts molybdenum flushing to be complete in 2009 (Figure 12); observations bear out this prediction.

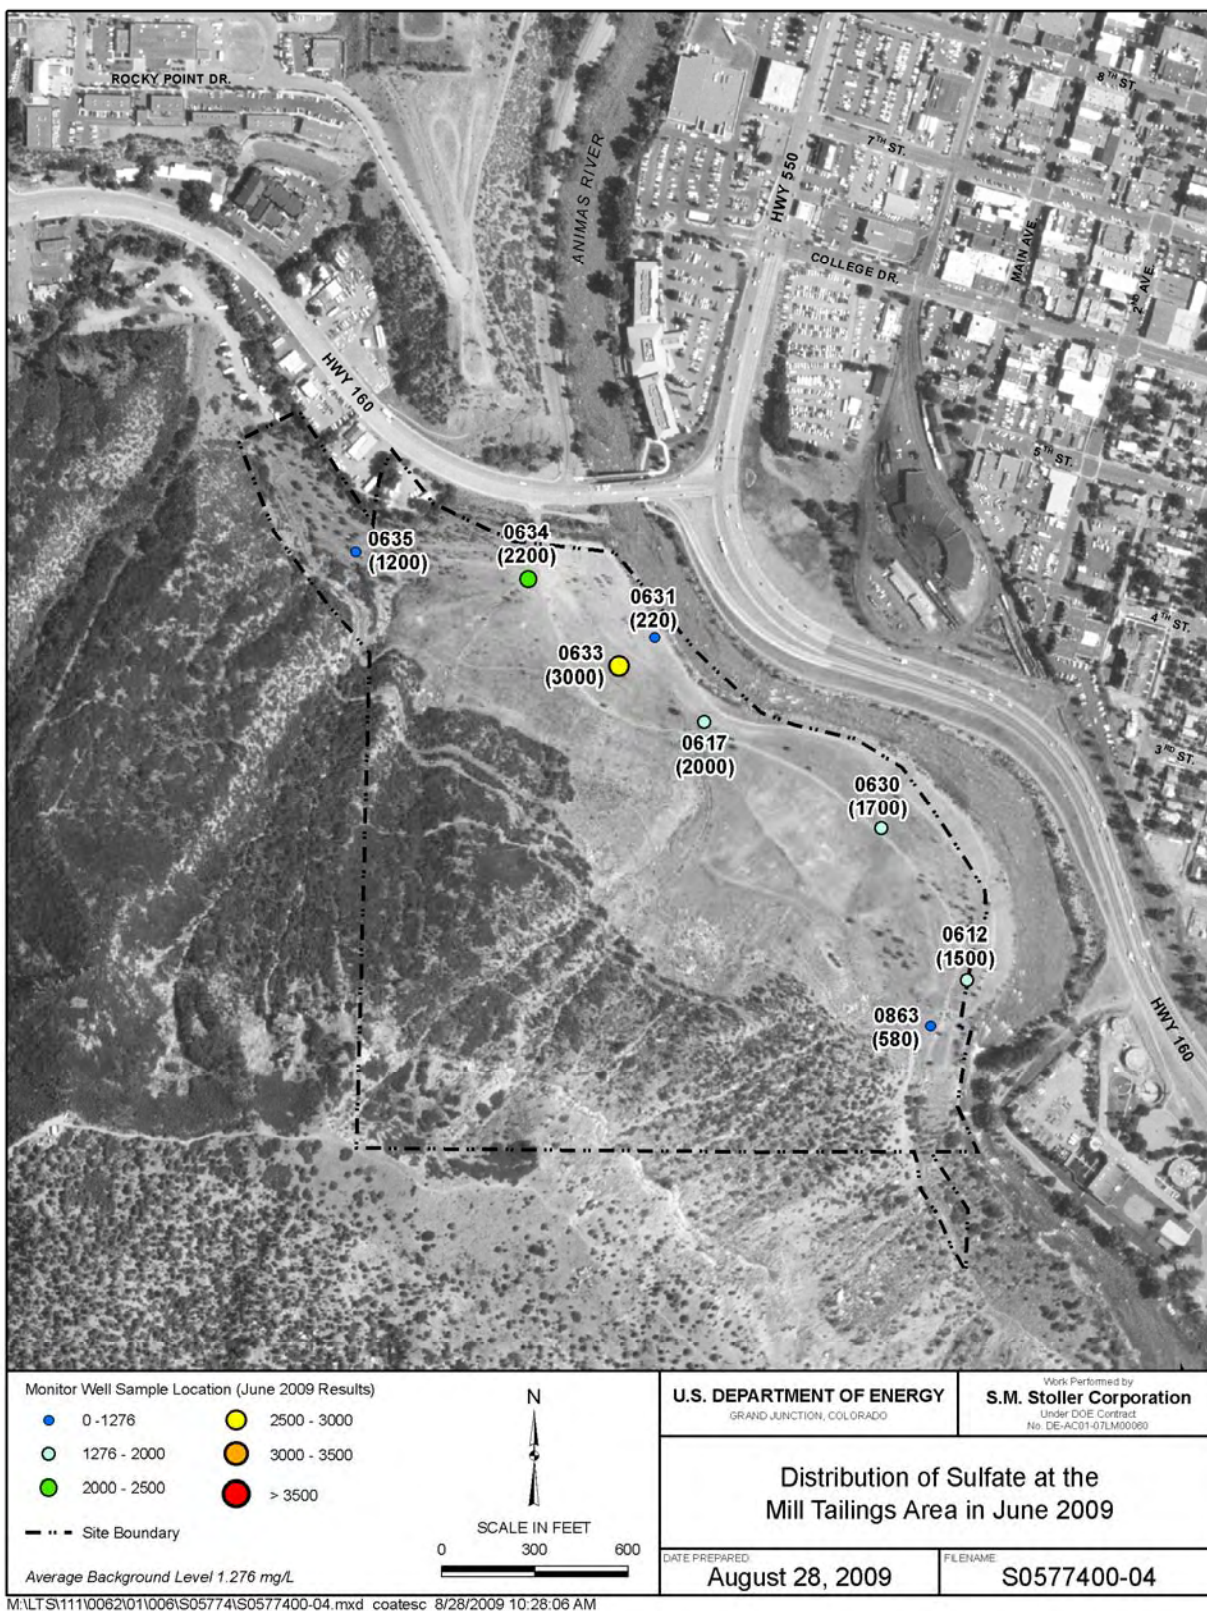
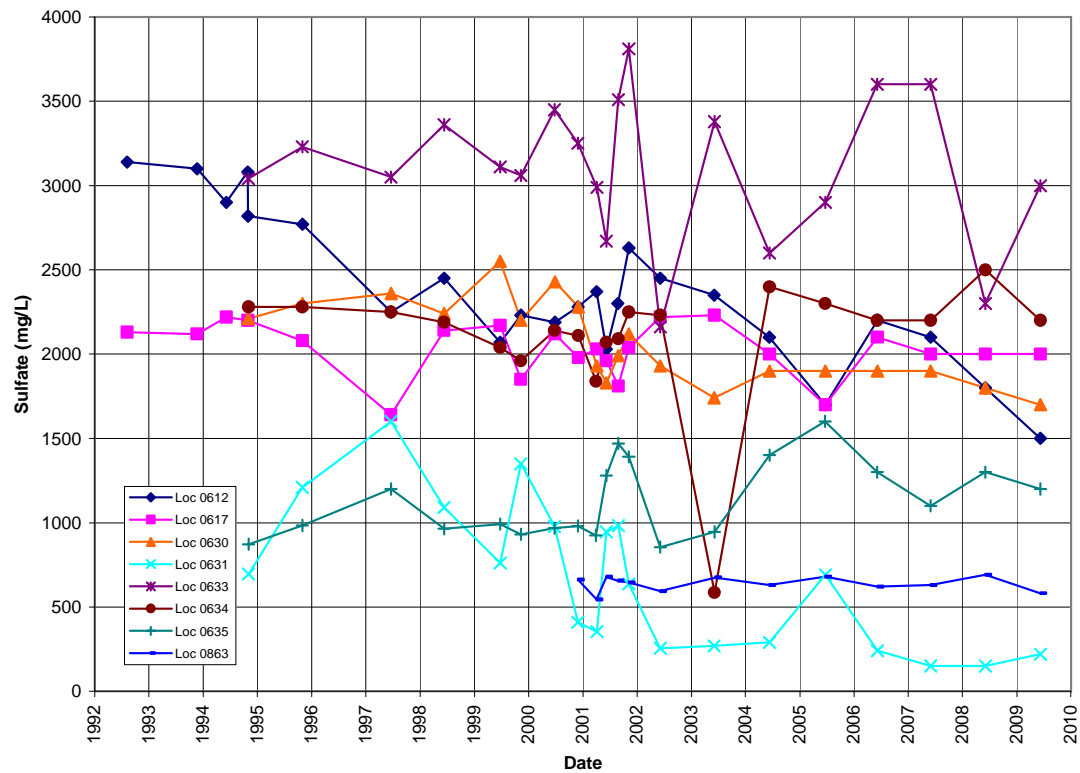
Figure 16. Distribution of Sulfate at the Mill Tailings Area

Sulfate concentrations that exceed background levels are related to the former use of sulfuric acid in the milling process. In June 2009, sulfate exceeded the average background concentration at each compliance well except wells 0631, 0863, and 0635 (Figures 16 and 17). Most wells showed a decline compared to 2008; however well 0633 increased to 3,000 mg/L after decreasing sharply the year before. Observed concentrations since 1992 fluctuate considerably at a given well and generally do not show any obvious trending. However, projecting best-fit lines to the data reveals that sulfate flushing will be complete at most locations by about 2092 (Figure 18). Linear trend projection of data from well 0612 shows that concentrations for that well should be below the compliance goal by about 2015. Sulfate concentrations predicted by the model decrease linearly throughout the flushing period.

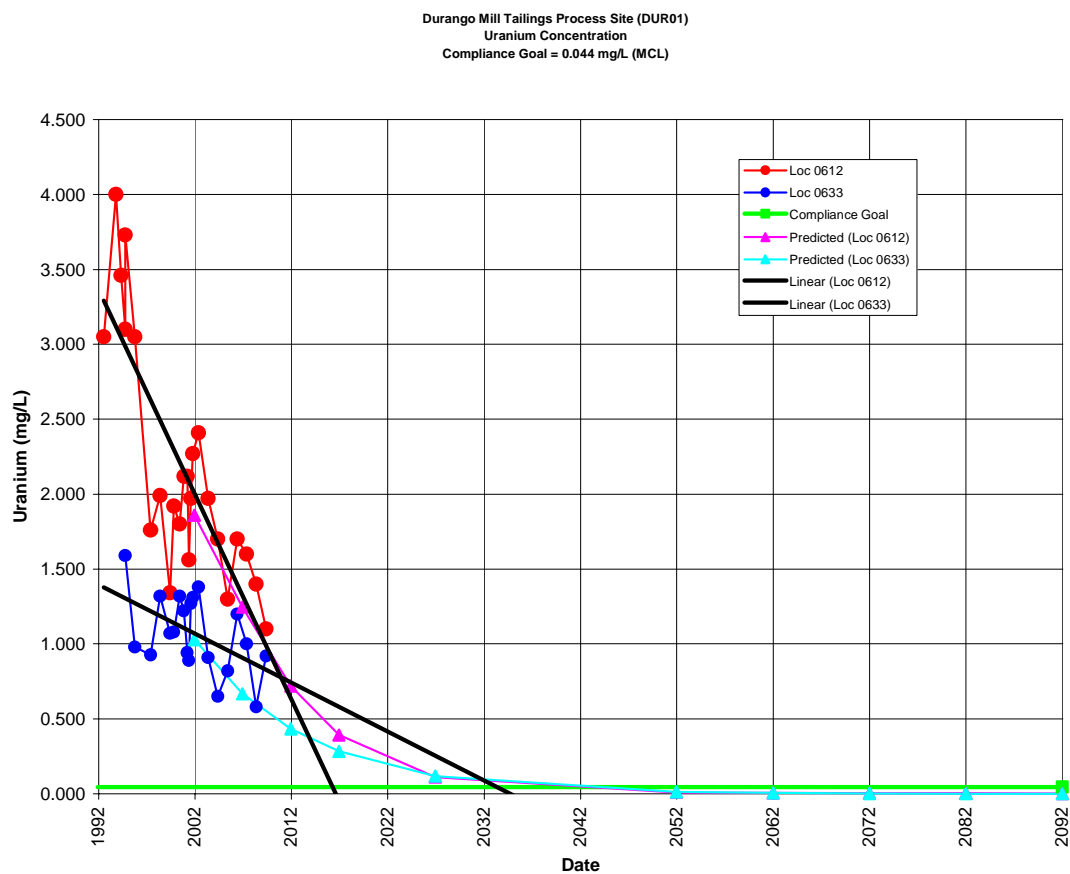
Figure 21. Predicted and Measured Uranium Concentrations at the Mill Tailings Area

The uranium compliance goal was exceeded at all locations except wells 0635 and 0863 in June 2009 (Figures 19 and 20). This is consistent with previous monitoring results. The four wells with the most elevated uranium concentrations (0612, 0617, 0631, and 0633) have shown a generally decreasing concentration trend since source removal, though concentrations at well 0633 increased about 50 percent over 2008 concentrations. Groundwater model predictions indicate that sitewide uranium flushing will be complete by about 80 years after June 2002 (Figure 21). To date, observed concentrations at the two wells that have the highest uranium concentrations (wells 0612 and 0633) are in close agreement with the model results (Figure 21). These wells are widely separated in the aquifer. The predicted flushing period for these two wells differs from the predicted sitewide flushing time because the last area to flush is south of the downgradient-most monitor well (well 0612). Linear projection of the observed concentration trends implies sitewide uranium flushing by about 2031. The model predicts similar rates of flushing initially, followed by a period of much less rapid flushing and marginal levels of contamination (concentration tailing) until the goal is attained. Uranium concentrations may remain slightly above the compliance goal during the period of reduced flushing.
