4.0 Durango, Colorado, Disposal Site

4.1 Compliance Summary

4.4 Inspection Results

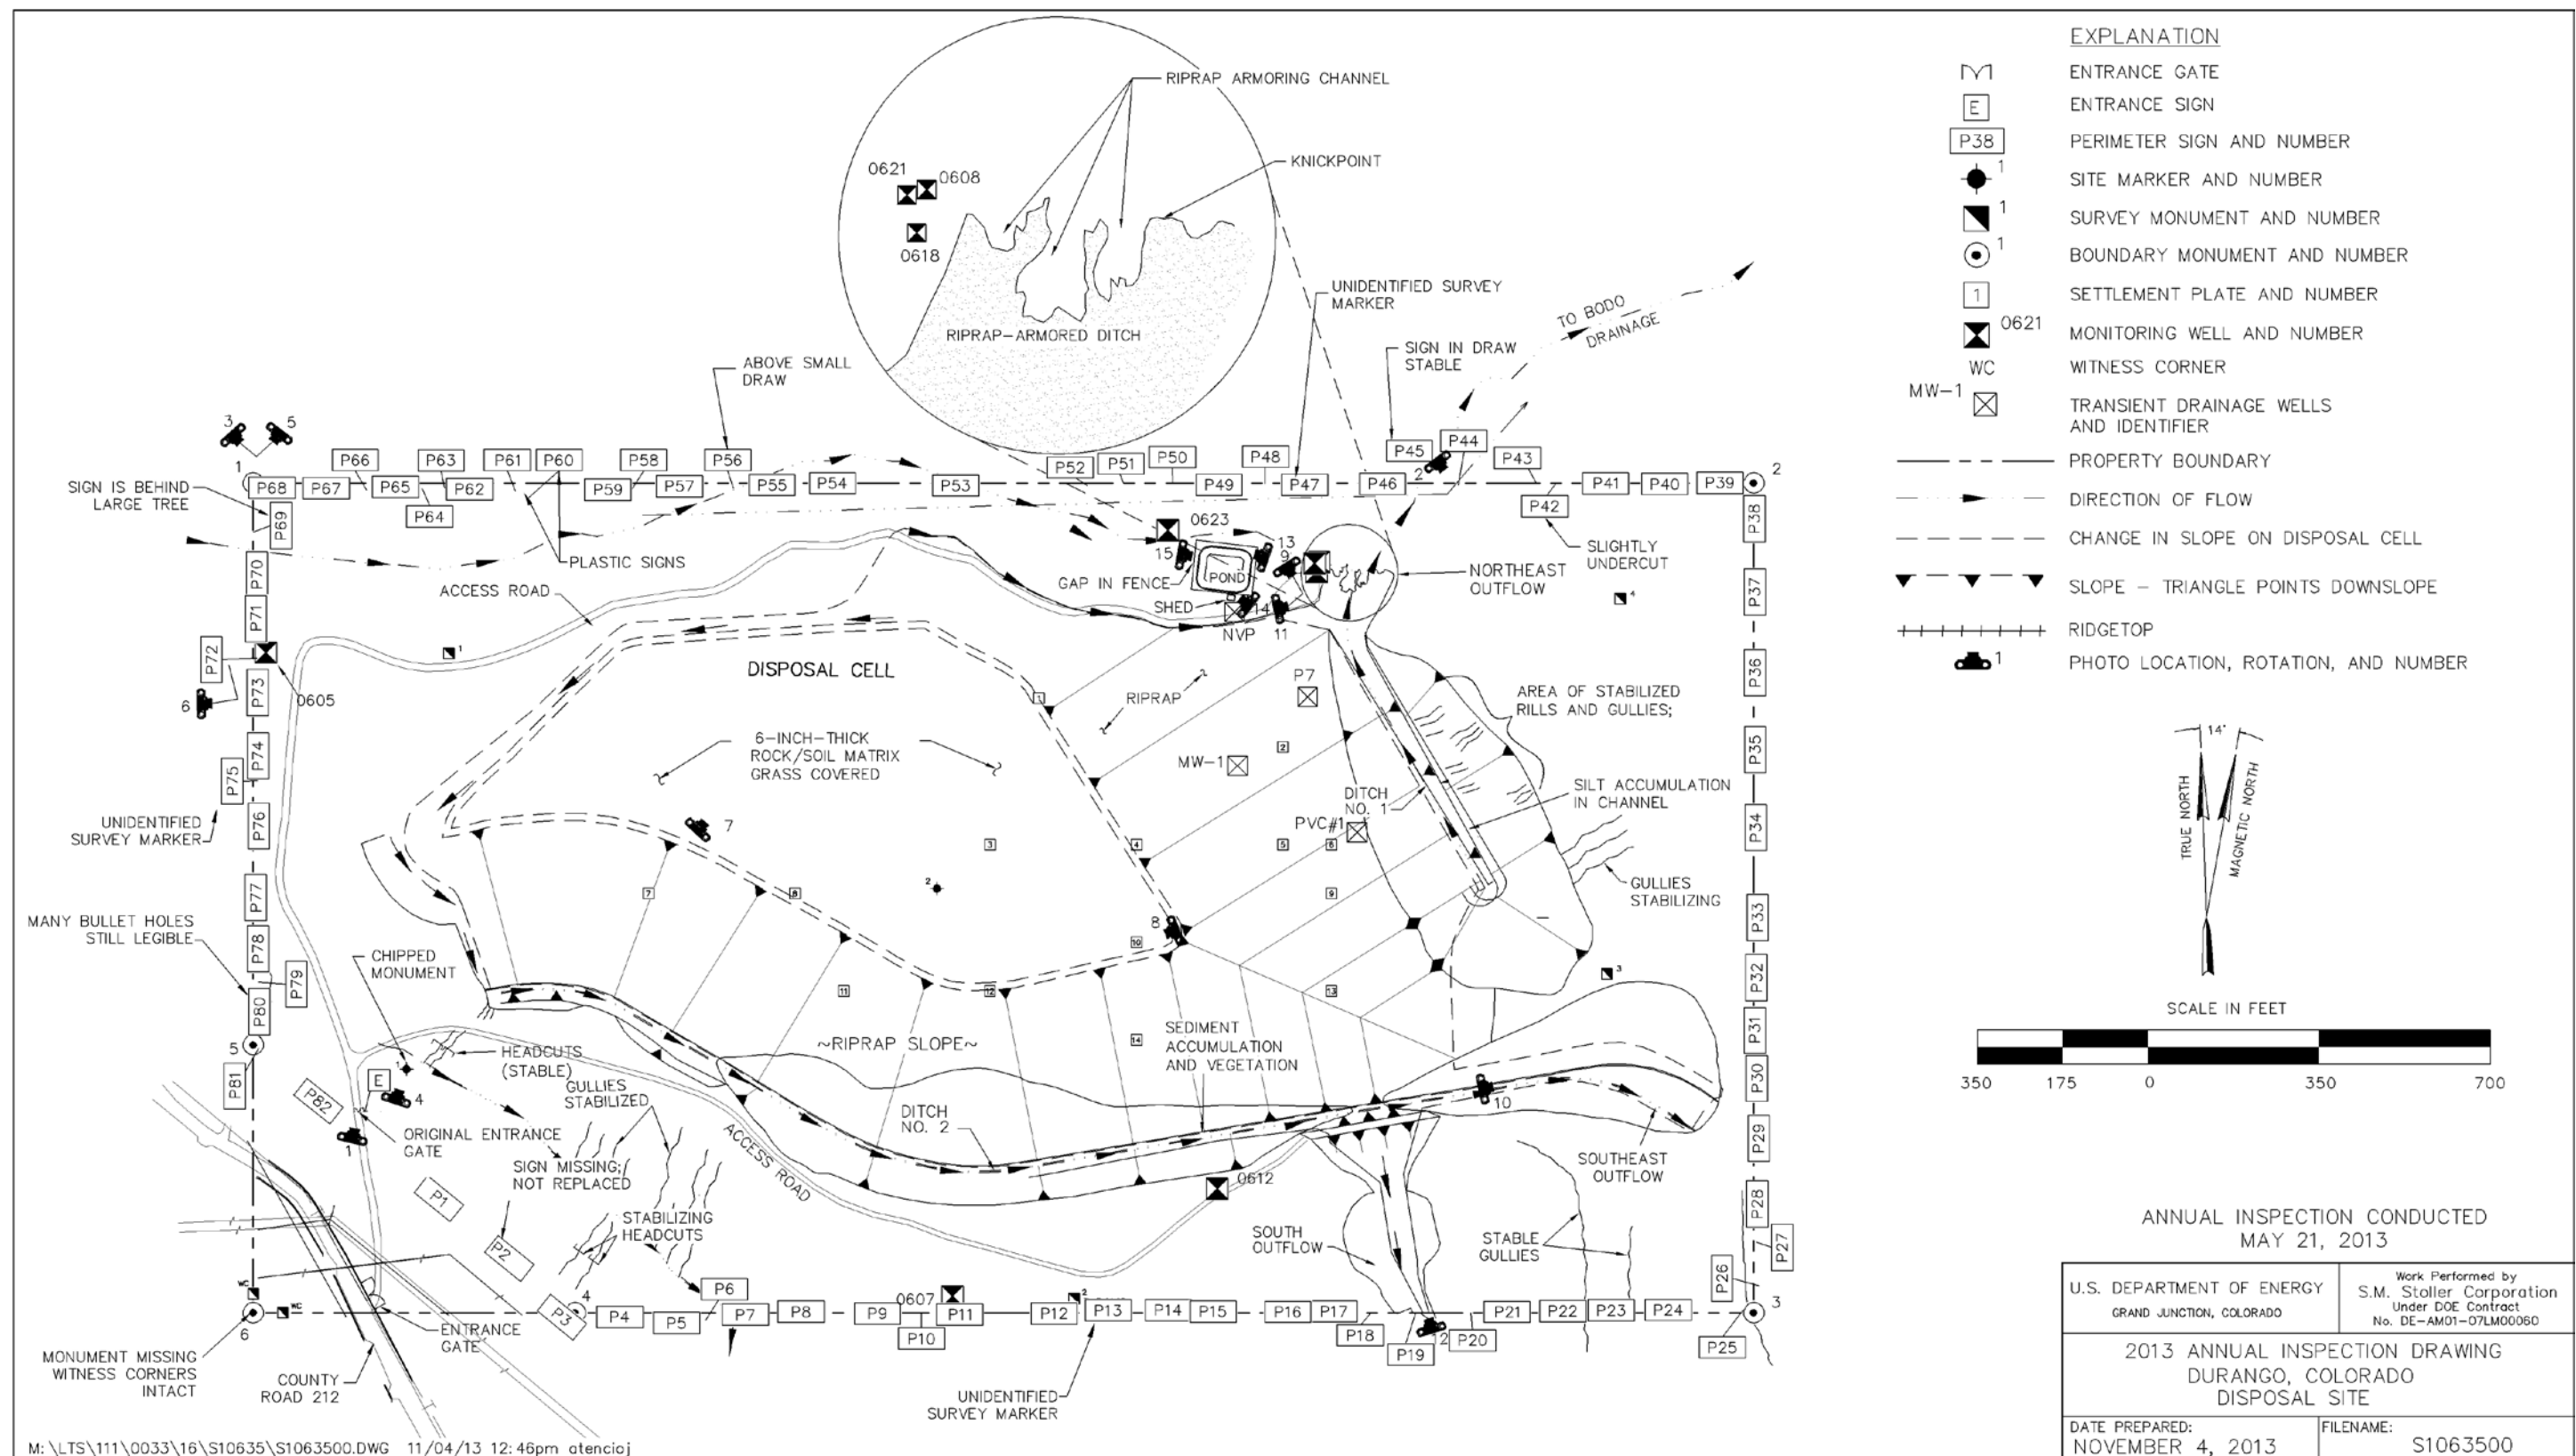
Site marker SMK-1 historically has been superficially pocked from gunfire but has remained legible. During the 2012 inspection inspectors discovered that an additional chip along the bottom edge of the marker had fallen off; however, the information on the face of the marker remains legible, and no new damage was observed (PL-4). SMK-2 remains in excellent condition.
