4.0 Durango, Colorado, Disposal Site

4.1 Compliance Summary

The Durango, Colorado, Disposal Site, inspected on August 14, 2007, is in good condition. In June 2006, the criteria for permanent closure of the transient drainage water collection and treatment system were met; however, an increased uranium concentration reported downgradient needs to be evaluated. In 2007, a solar-powered water management system was installed to distribute retention pond water to drip lines used to enhance evaporation. Infestations of noxious weeds continue to be monitored and controlled with herbicide. Vandalism, primarily theft and damage to signs, continues at the site. No other maintenance needs or cause for a follow-up or contingency inspection was identified.

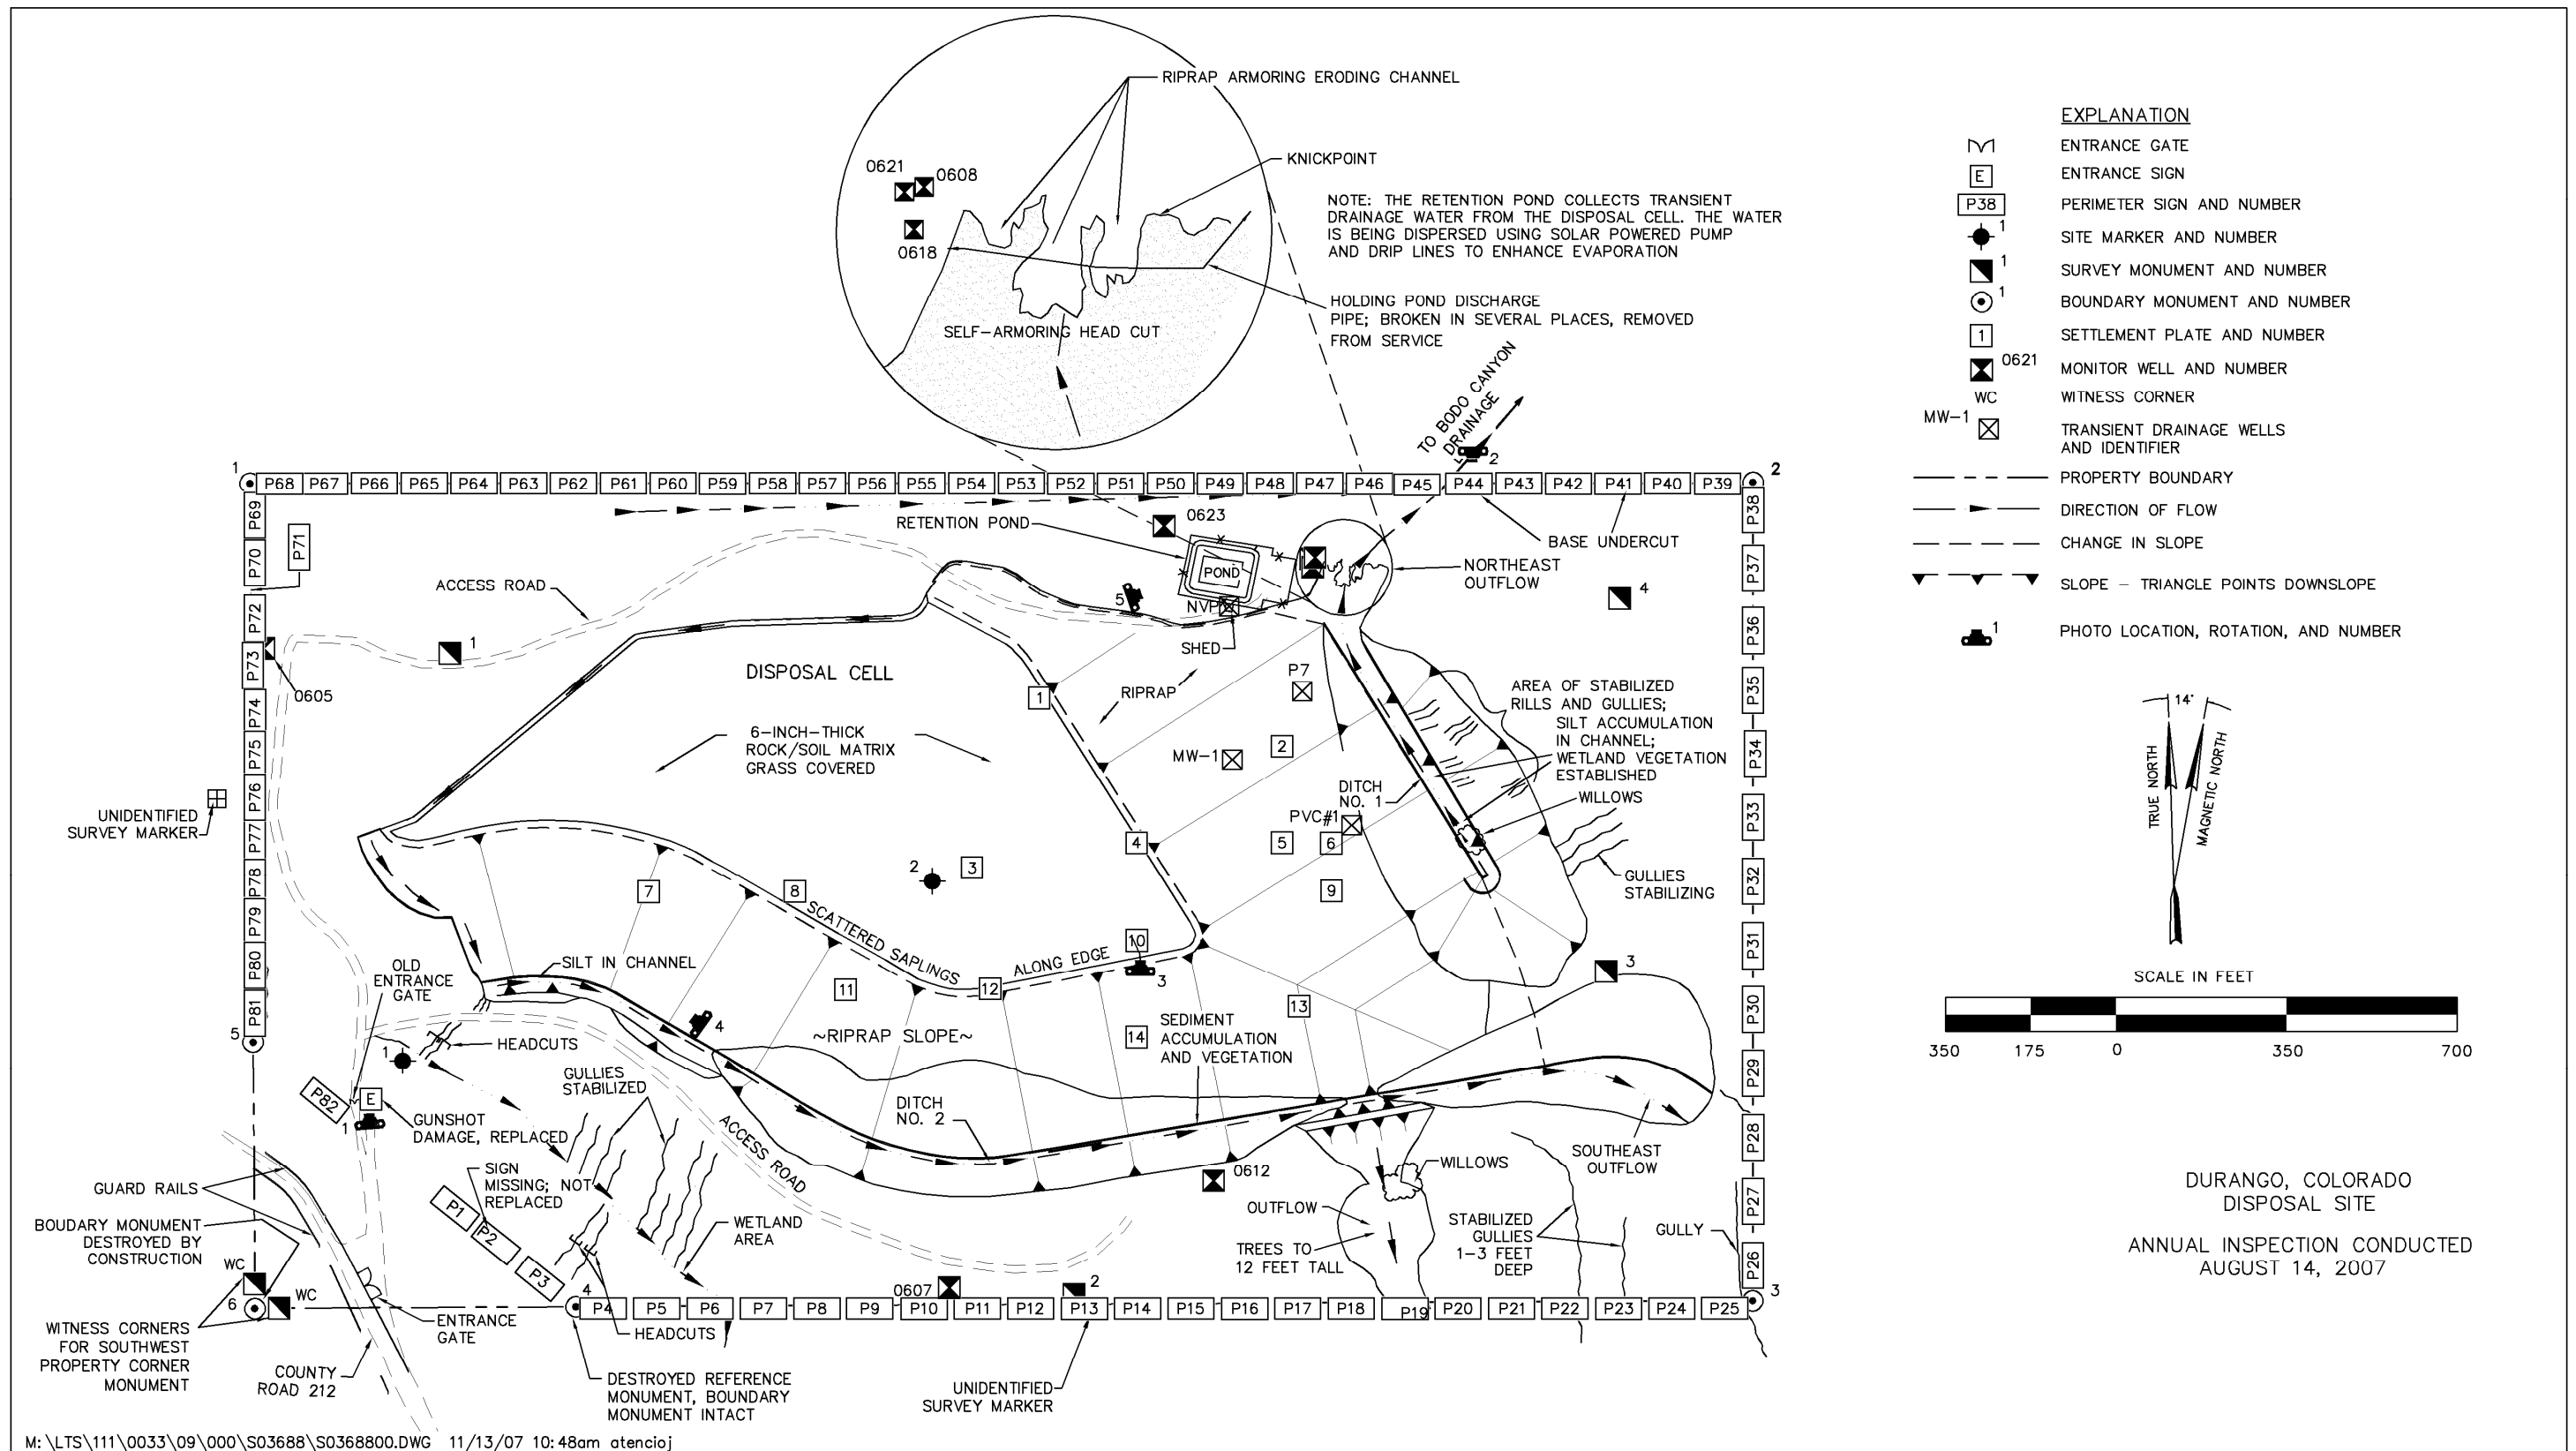
Figure 4-1. 2007 Annual Compliance Drawing for the Durango, Colorado, Disposal Site

Top of Disposal Cell—The top of the disposal cell is vegetated and in excellent condition. No evidence of settling, slumping, and erosion was observed.

Side Slopes of Disposal Cell—The riprap-covered side slopes of the disposal cell are in excellent condition and continue to prevent subsidence, rock deterioration, or slope failure.

Drainage Ditches—Rock-armored drainage ditches beneath the toe of the side slope on the northwest, south, and east sides of the disposal cell direct runoff into natural drainages that carry storm water away from the disposal site. Past erosion and sloughing in Ditch No. 1 has allowed wetland vegetation including willows to take root in areas of moist sediments. In other places, trees as tall as 10 and 15 feet grow in the drainage ditches. The sediment deposits and vegetation currently will not compromise the drainage ditches’ performance in the event of a large storm. Should colluvial deposits or excessive vegetation dam a drainage ditch so as to impound water, the deposits or vegetation will be removed.

Site Boundary—The site is not fenced. Missing and damaged perimeter signs indicate continued trespassing and vandalism. However, the guardrail and entrance gate off of the county road, installed in 2000, have effectively prevented vehicular trespass and the associated damage that had occurred prior to their installation.

Historical rill and gully erosion on the south-facing slope along the southern boundary of the site is stable. Establishment of vegetation and exposure of resistant bedrock in the gullies are effectively preventing further erosion in most of the gullies. Headcuts in two gullies in the southwest portion noted in 2006 were revisited in 2007. These are active, but do not pose a threat to cell integrity at this time and will be inspected again in 2008. Additionally, the two gullies on the north-facing slope, just north of perimeter sign P3 along the southern boundary of the site, were checked during the 2007 inspection. It appears that the headcutting is stable. No potential threat to the cell is posed by these headcuts.
