4.0 Durango, Colorado, Disposal Site

4.1 Compliance Summary

The Durango, Colorado, Uranium Mill Tailings Radiation Control Act (UMTRCA) Title I Disposal Site was inspected on June 15, 2010. The disposal cell and all associated surface water diversion and drainage structures were in good condition and functioning as designed. The water level in the disposal cell has dropped, which satisfies criteria for the permanent closure of the transient drainage water collection and treatment system. Vandalism, primarily theft and damage to signs, continues at the site. The bases of perimeter signs P41 and P44 have been undercut by erosion but remain stable. Infestations of noxious weeds and deep-rooted plants on the disposal cell continue to be monitored and controlled with herbicide. No other maintenance needs or cause for a follow-up or contingency inspection was identified.

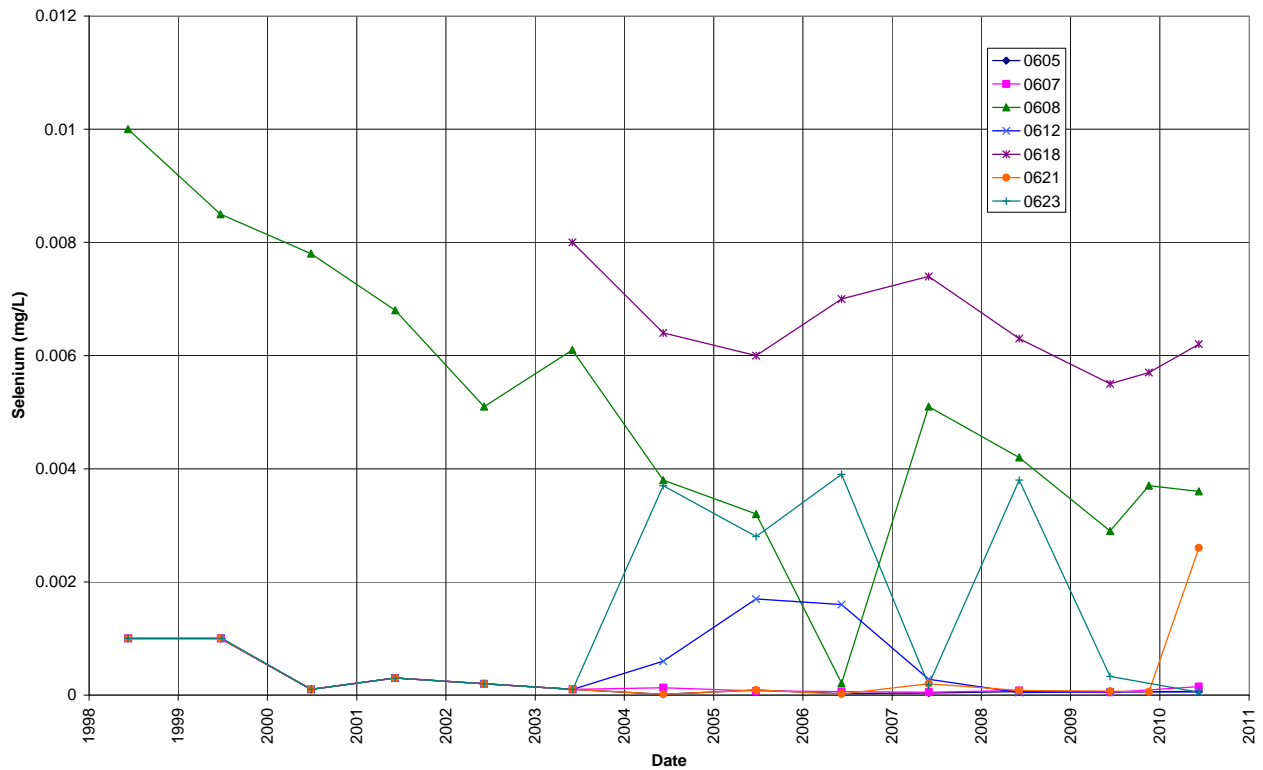
Figure 4-3. Time-Concentration Plot of Selenium in Groundwater at the Durango Disposal Site

Groundwater samples are collected annually and analyzed for three indicator parameters: molybdenum, selenium, and uranium. To monitor the increased uranium observed in well 0618, wells MW-0608, MW-0618, and MW-0621 have been increased to monthly sampling as weather permits. The site-specific standards used for the three indicator parameters are the respective maximum observed background concentrations reported in groundwater samples collected from wells completed in the bedrock aquifer as identified in Table 5-4 of the LTSP. These site-specific standards are provided below in Table 4-3. Time-concentration plots for uranium, selenium, and molybdenum monitoring results are included as Figures 4-2, 4-3, and 4-4, respectively.
