## 4.0 Durango, Colorado, Disposal Site

### 4.1 Compliance Summary

The site, southwest of Durango, Colorado, was inspected on June 10, 2011. The results of the inspection are described below. Figure 4–1 shows features and photograph locations (PLs) discussed in this report. Numbers in the left margin of this report refer to items summarized in the “Executive Summary” table.

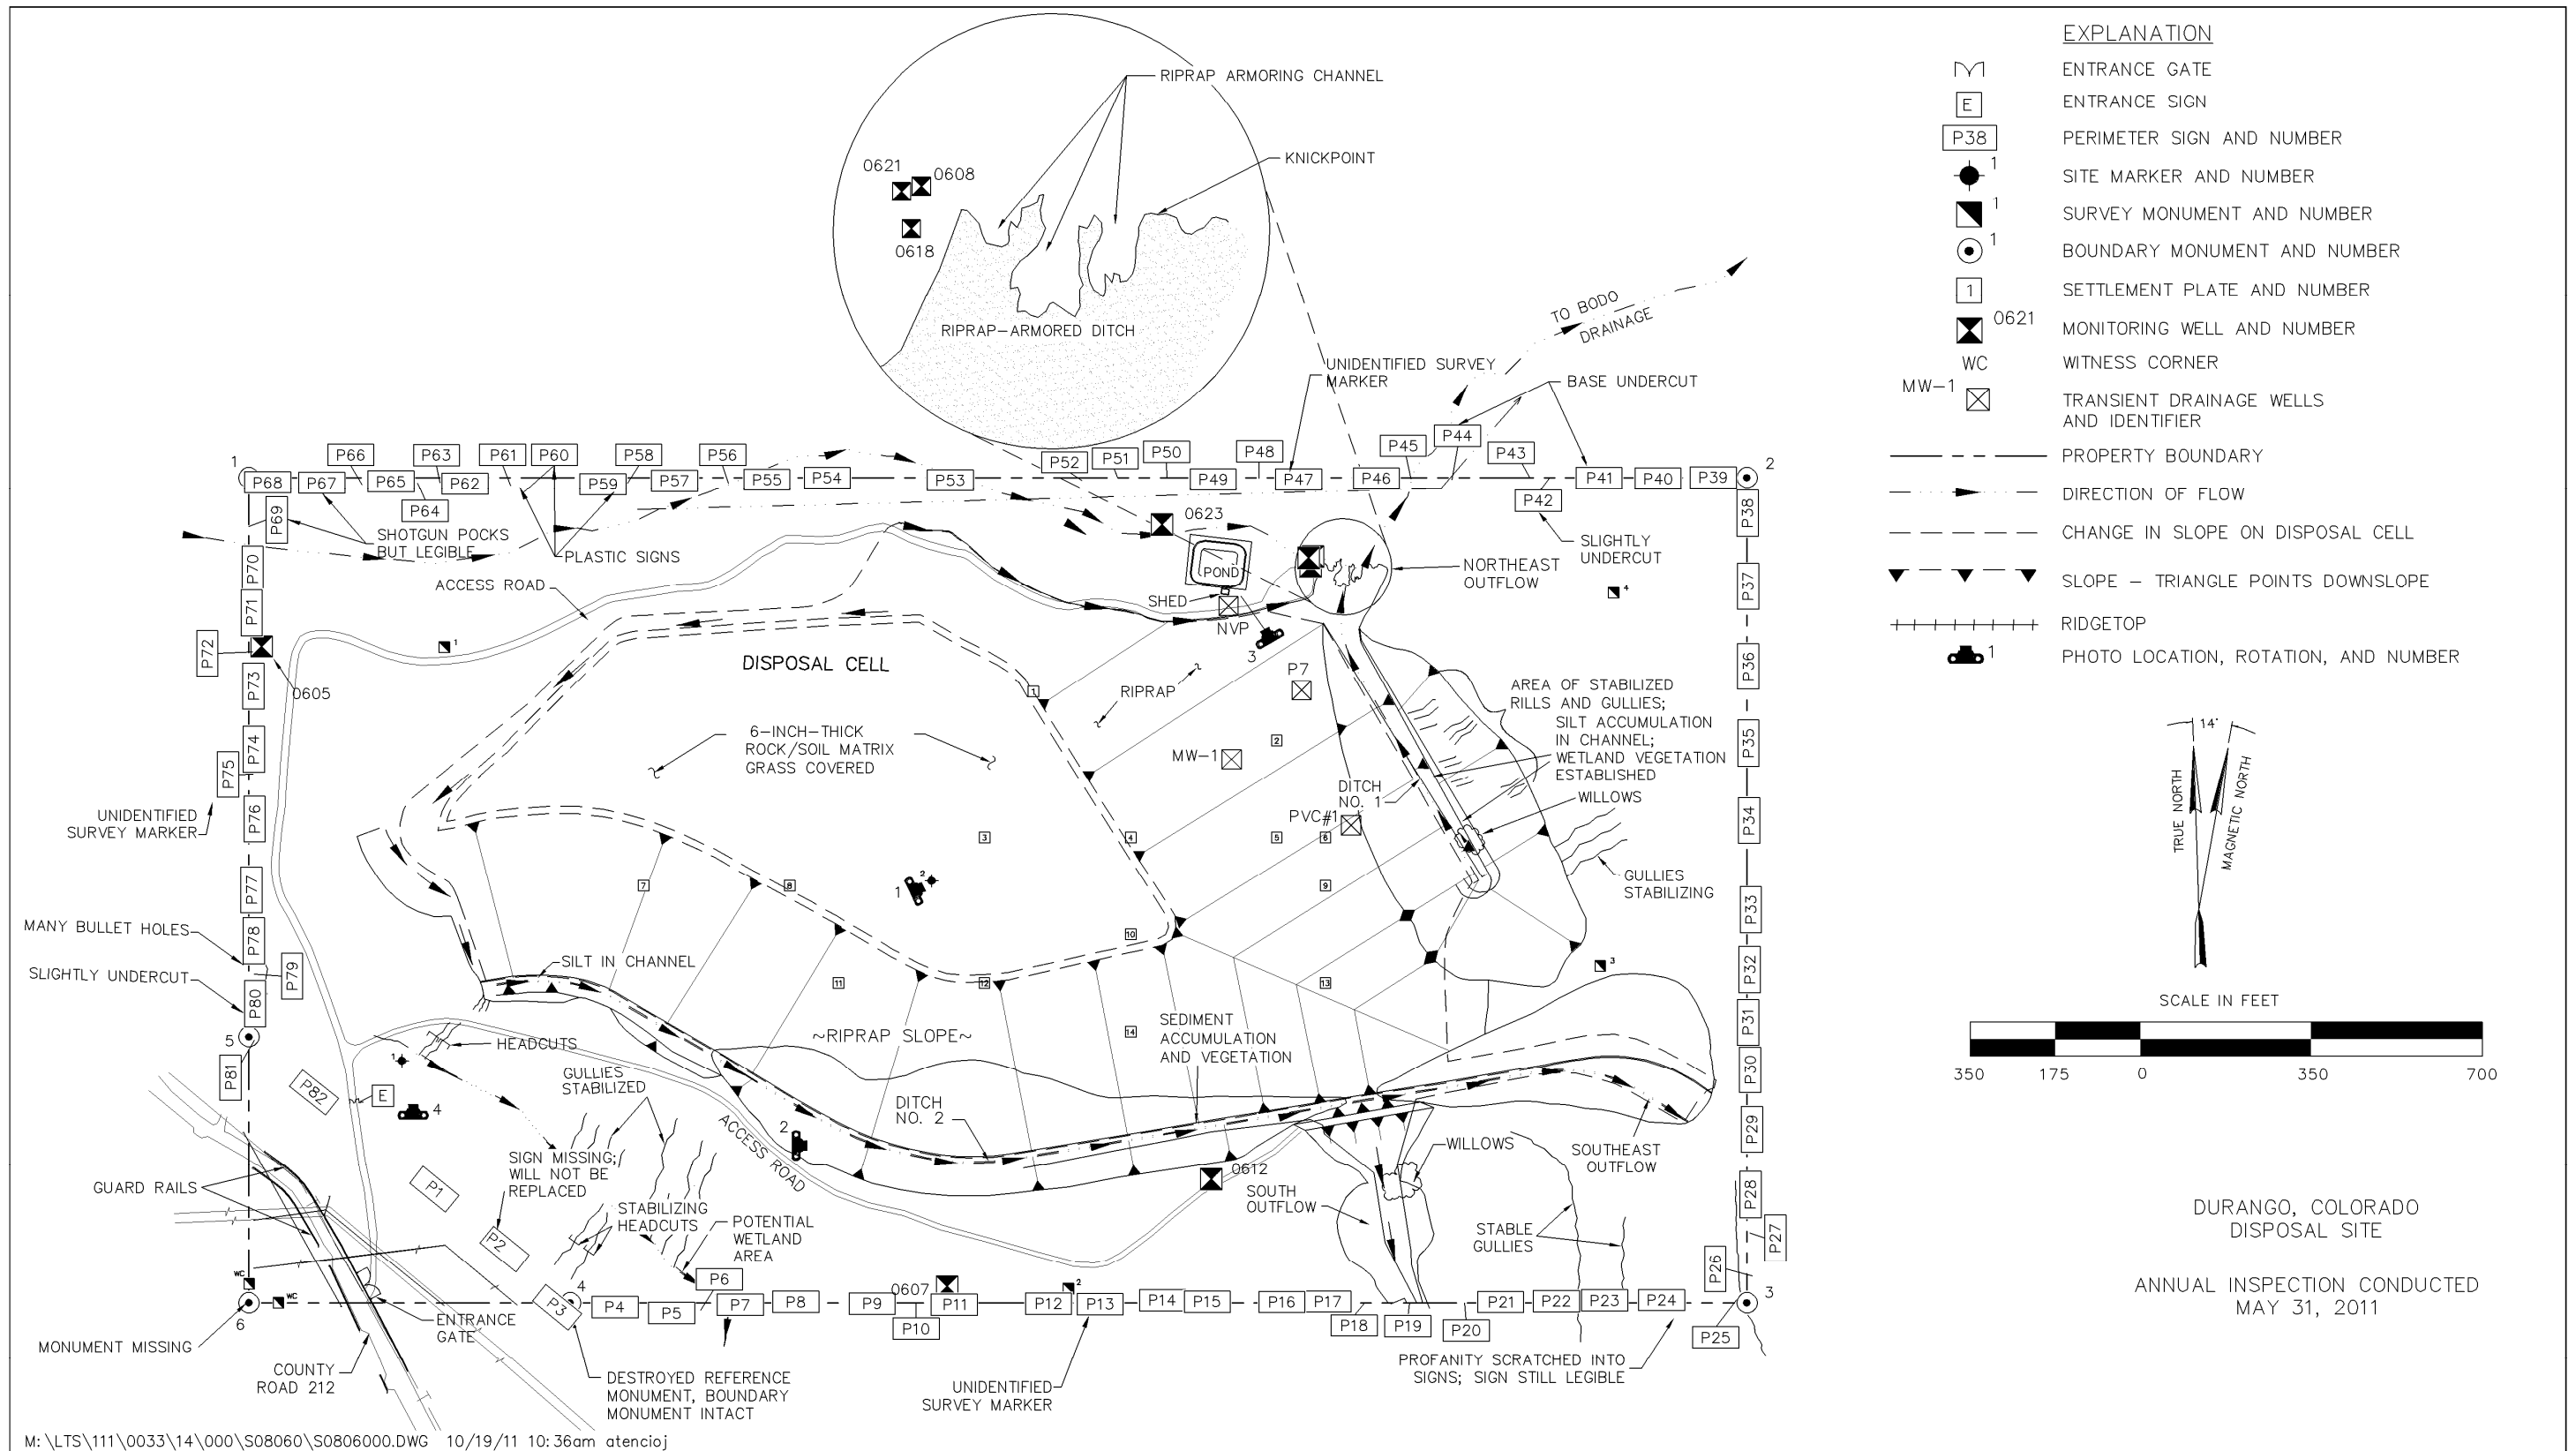
Figure 4-1. 2011 Annual Compliance Drawing for the Durango Disposal Site

**Top of the Disposal Cell**—The top of the disposal cell (PL-1) was in excellent condition. No evidence of settling, slumping, or erosion was observed.

**Side Slopes of the Disposal Cell**—The riprap-covered side slopes of the disposal cell were in good condition. There was no evidence of subsidence, rock deterioration, or slope failure.

**Drainage Ditches**—Rock-armored drainage ditches beneath the toe of the side slope on the northwest, south, and east sides of the disposal cell direct runoff into natural drainages that carry storm water away from the disposal site. Past erosion and sloughing in Ditch No. 1 have allowed wetland vegetation, including willows, to take root in areas where moist sediments have accumulated. In other places, trees as tall as 15 feet grow in the drainage ditches. The sediment deposits and vegetation currently will not compromise the drainage ditches’ performance in a large storm. Should colluvial deposits or excessive vegetation dam a drainage ditch so as to impound water, the deposits or vegetation will be removed. Inspectors saw no evidence of recent accumulations of sloughed material in the ditches (PL-2).

**4B** A security fence surrounds the retention pond, and a shed contains instrumentation to measure the transient drainage flow from the collection gallery. Both the fence and the shed were secure at the time of the inspection (PL-3). Inspectors noted that the shed door needed repairs, and repairs were made on September 21, 2011.

Historical rill and gully erosion has occurred at various locations on site, but most rills and gullies are stabilizing, and none are currently threatening the performance of the disposal cell or its associated surface water diversion structures. The establishment of vegetation and the exposure of resistant bedrock in the gullies are preventing further erosion in most of the gullies. No new headcutting was observed in 2011 (PL-4). DOE will continue to monitor the site for active erosion.
