## 11.0 Maybell, Colorado, Disposal Site

### 11.1 Compliance Summary

The Maybell, Colorado, Uranium Mill Tailings Radiation Control Act (UMTRCA) Title I Disposal Site was inspected on September 2, 2021. Standing water was observed in the disposal cell apron on the eastern toe slope. Inspectors identified several minor maintenance needs but found no cause for a follow-up inspection. Groundwater monitoring is not required.

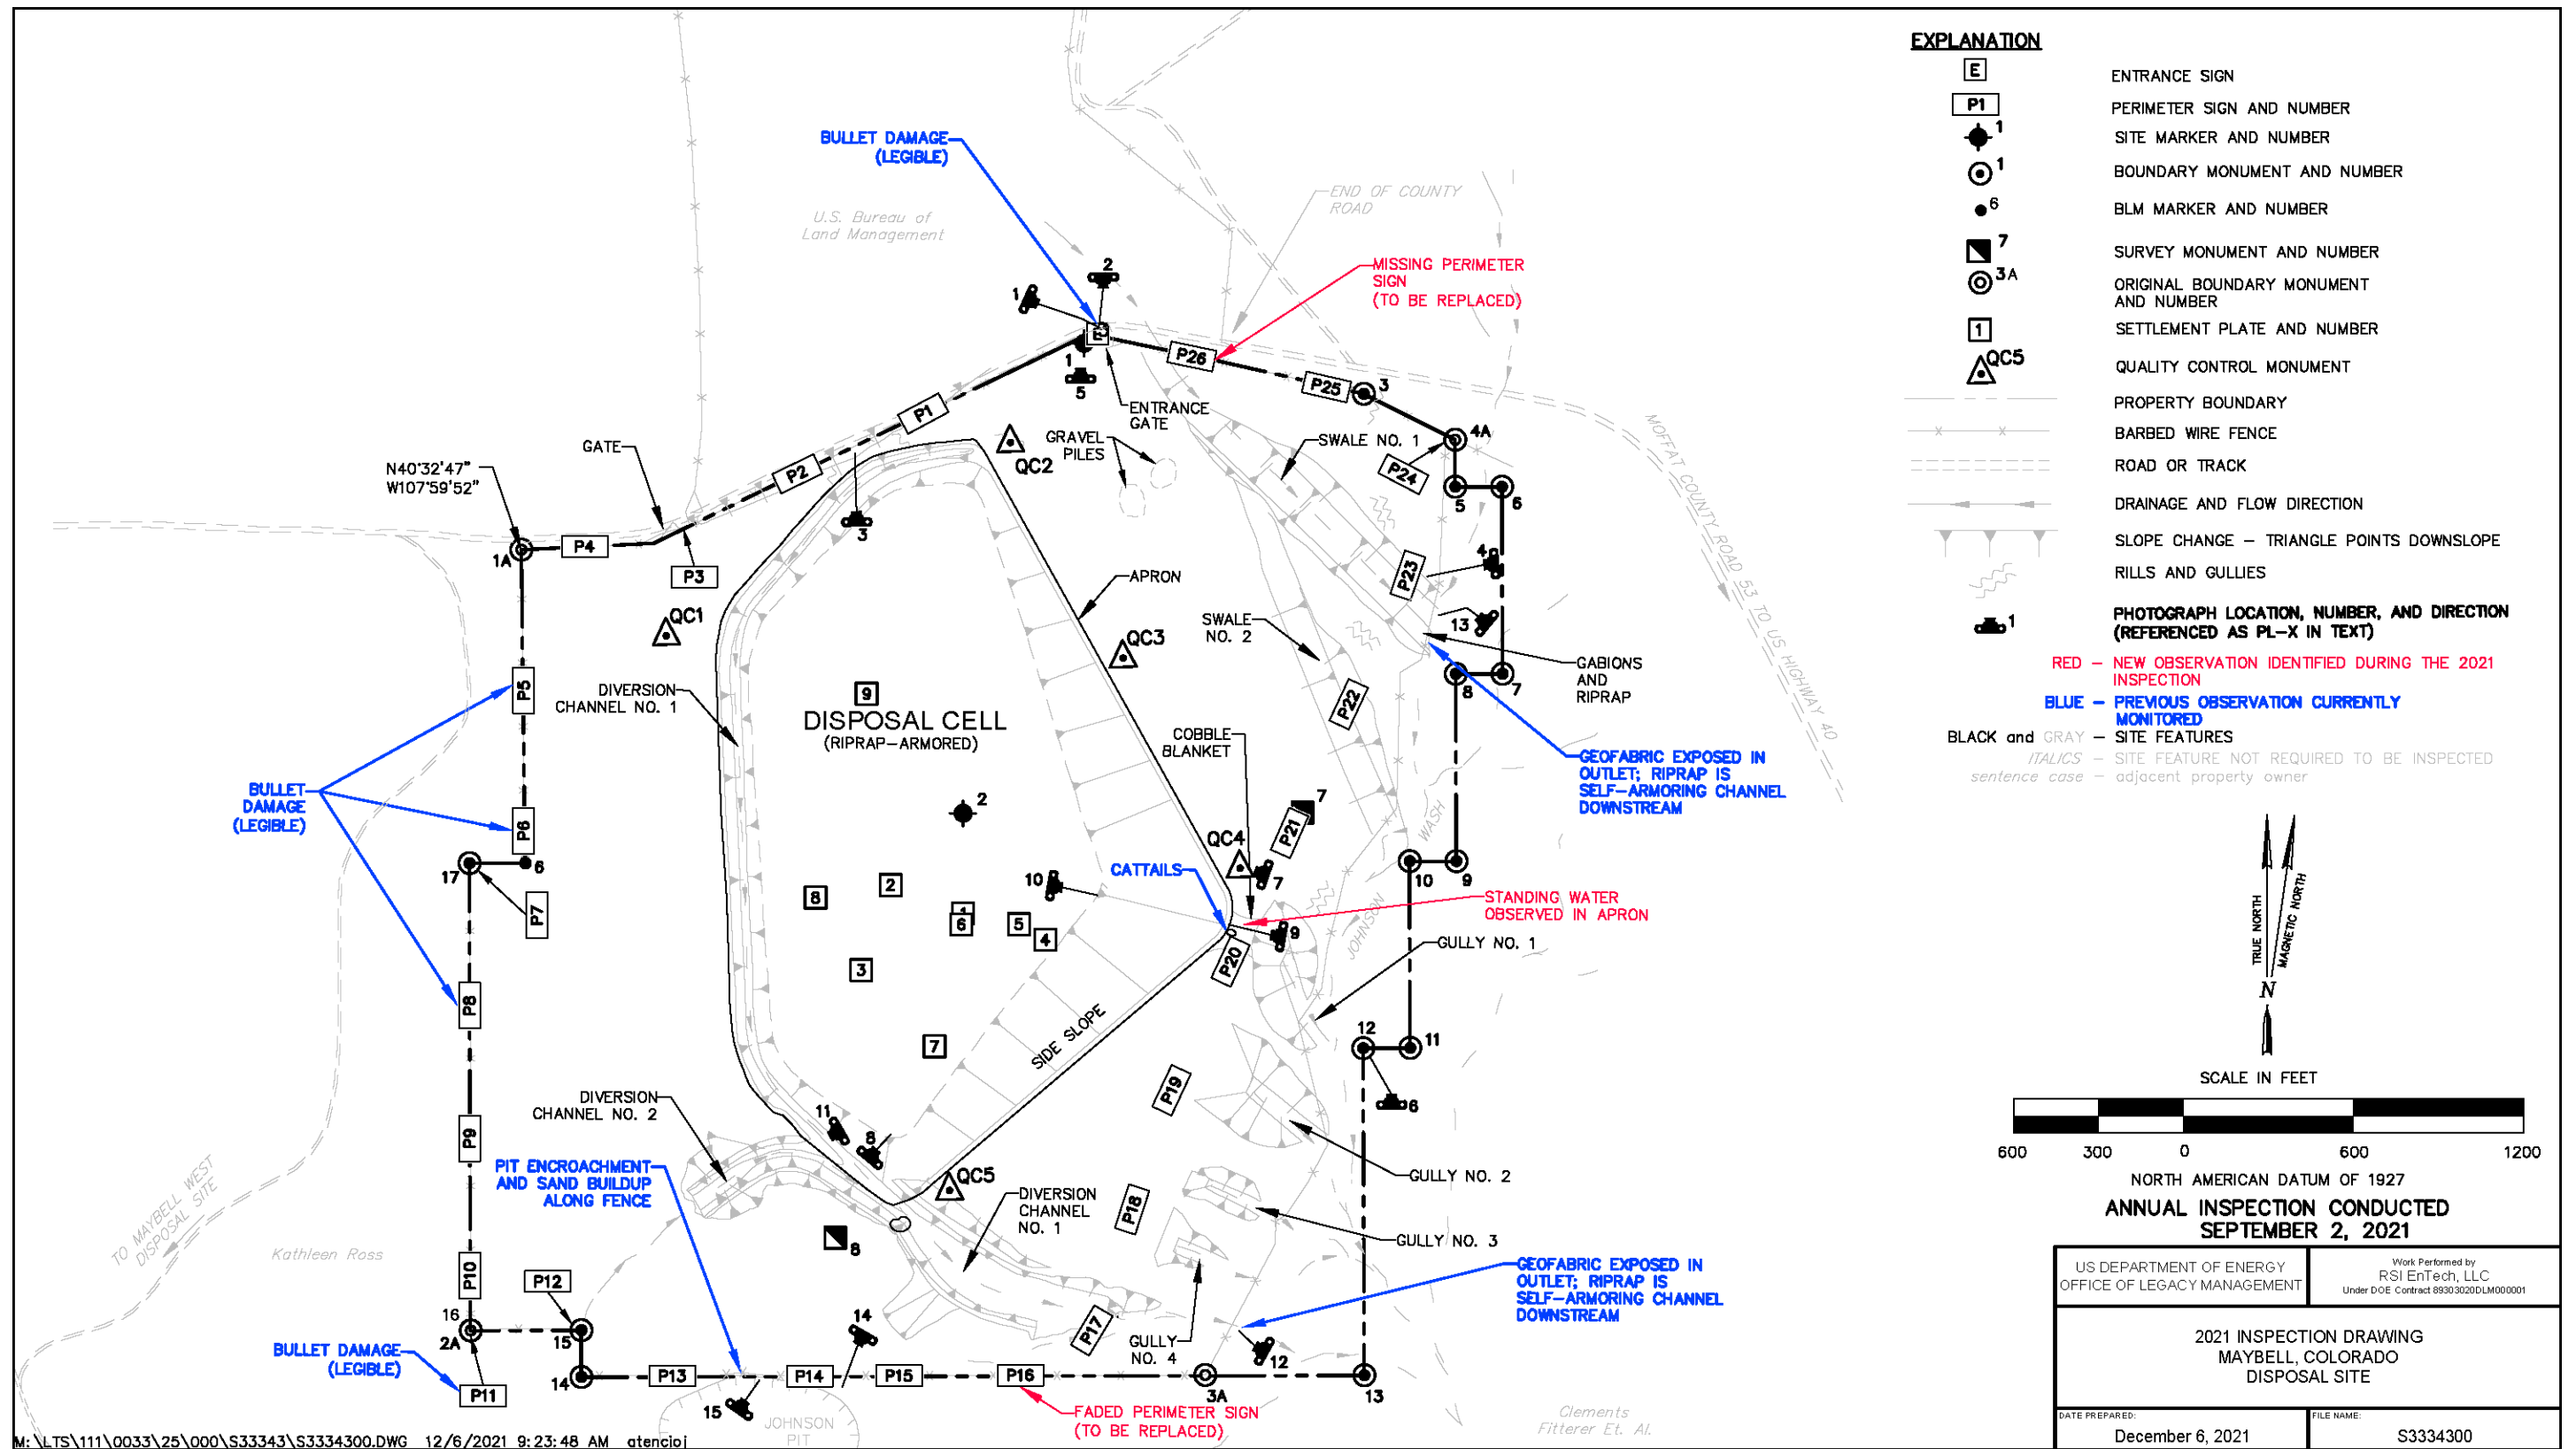
Figure 11-1. 2021 Annual Inspection Drawing for the Maybell, Colorado, Disposal Site

Figure 11-1 shows the locations of site features, including site surveillance features and inspection areas, in black and gray font. Site features that are present but not required to be inspected are shown in italic font. Observations from previous inspections that are currently monitored are shown in blue text, and new observations identified during the 2021 annual inspection are shown in red. Inspection results and recommended maintenance activities associated with site surveillance features are included in the following subsections. Photographs to support specific observations are identified in the text and in Figure 11-1 by photograph location (PL) numbers. The photographs and photograph log are presented in Section 11.10.
