11.0 Maybell, Colorado, Disposal Site

11.1 Compliance Summary

The Maybell, Colorado, Uranium Mill Tailings Radiation Control Act (UMTRCA) Title I Disposal Site was inspected on September 6, 2023. Inspectors identified several minor maintenance needs but found no cause for a follow-up inspection. Groundwater monitoring is not required.

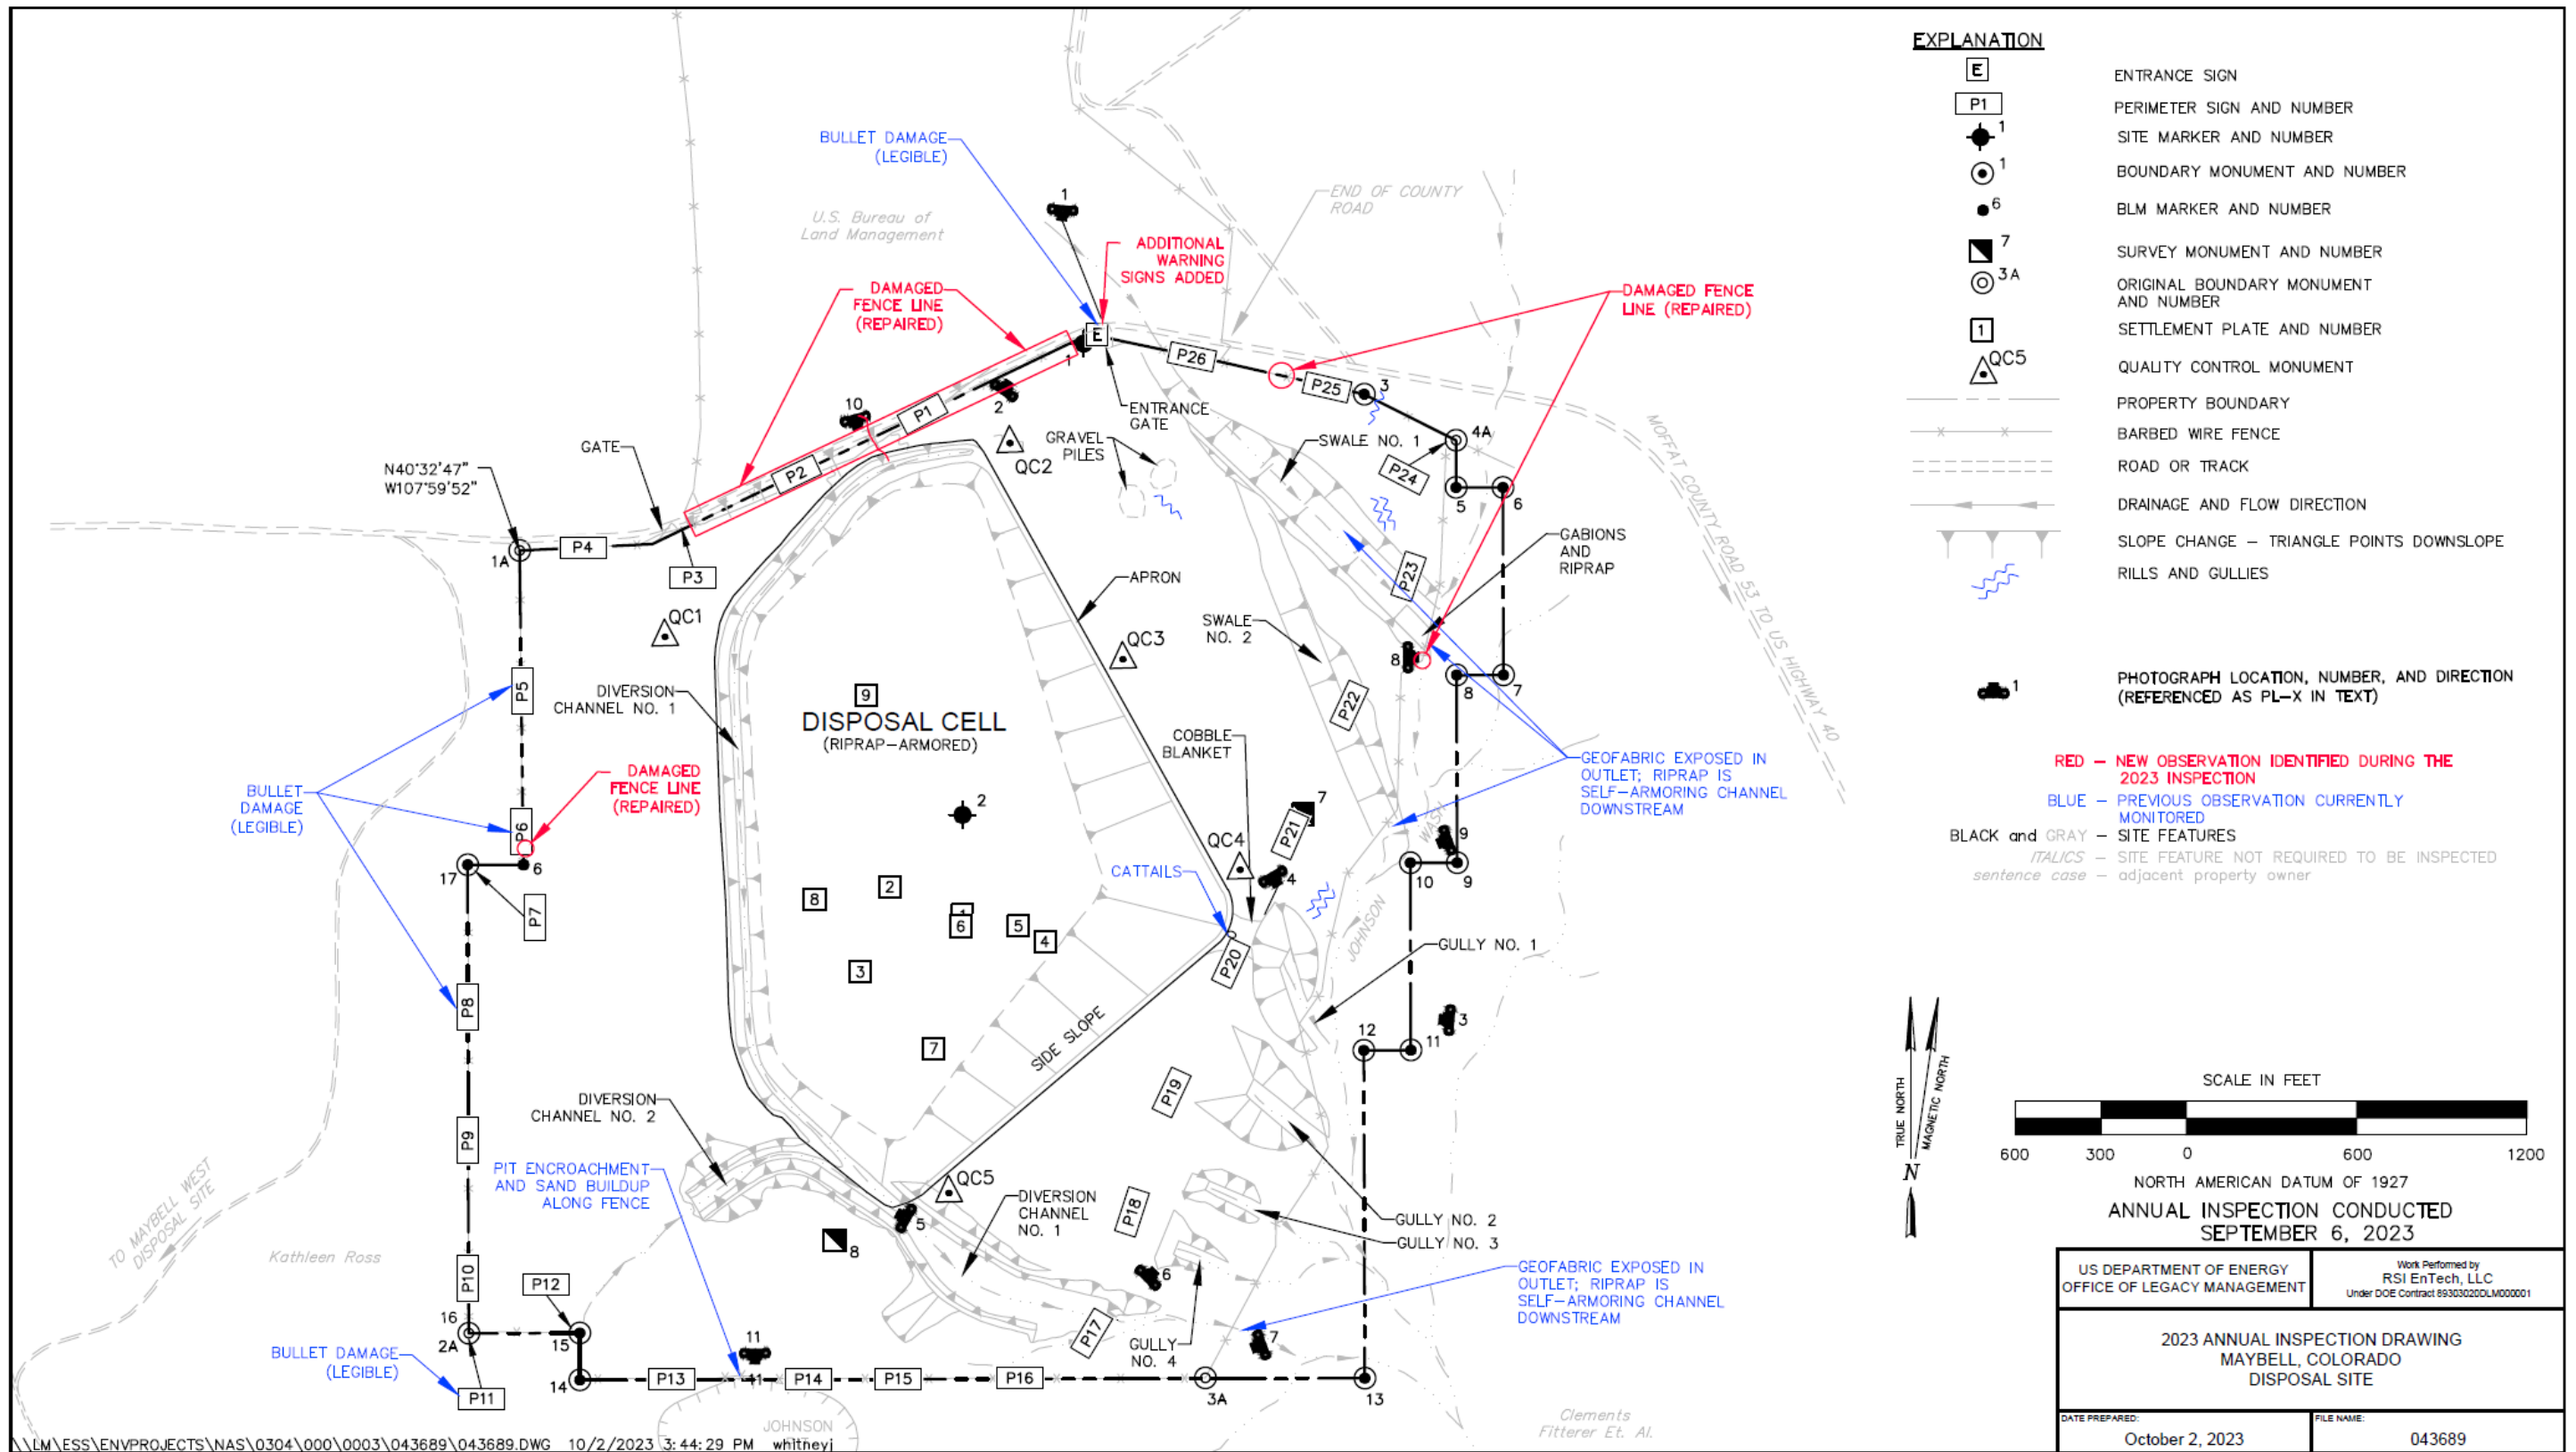
Figure 11-1. 2023 Annual Inspection Drawing for the Maybell, Colorado, Disposal Site

Figure 11-1 shows the locations of site features, including site surveillance features and inspection areas, in black and gray font. Some site features that are present but not required to be inspected are shown in italic font. Observations from previous inspections that are currently monitored are shown in blue, and new observations identified during the 2023 annual inspection are shown in red. Inspection results and recommended maintenance activities associated with site surveillance features are described in the following subsections. Photographs to support specific observations are noted in the text and in Figure 11-1 by photograph location (PL) numbers. The photographs and photograph log are presented in Section 11.10.
