4.0 Annual Inspection of the Durango, Colorado, UMTRCA Title I Disposal Site

4.1 Compliance Summary

Figure 4-1. 2012 Annual Compliance Drawing for the Durango Disposal Site

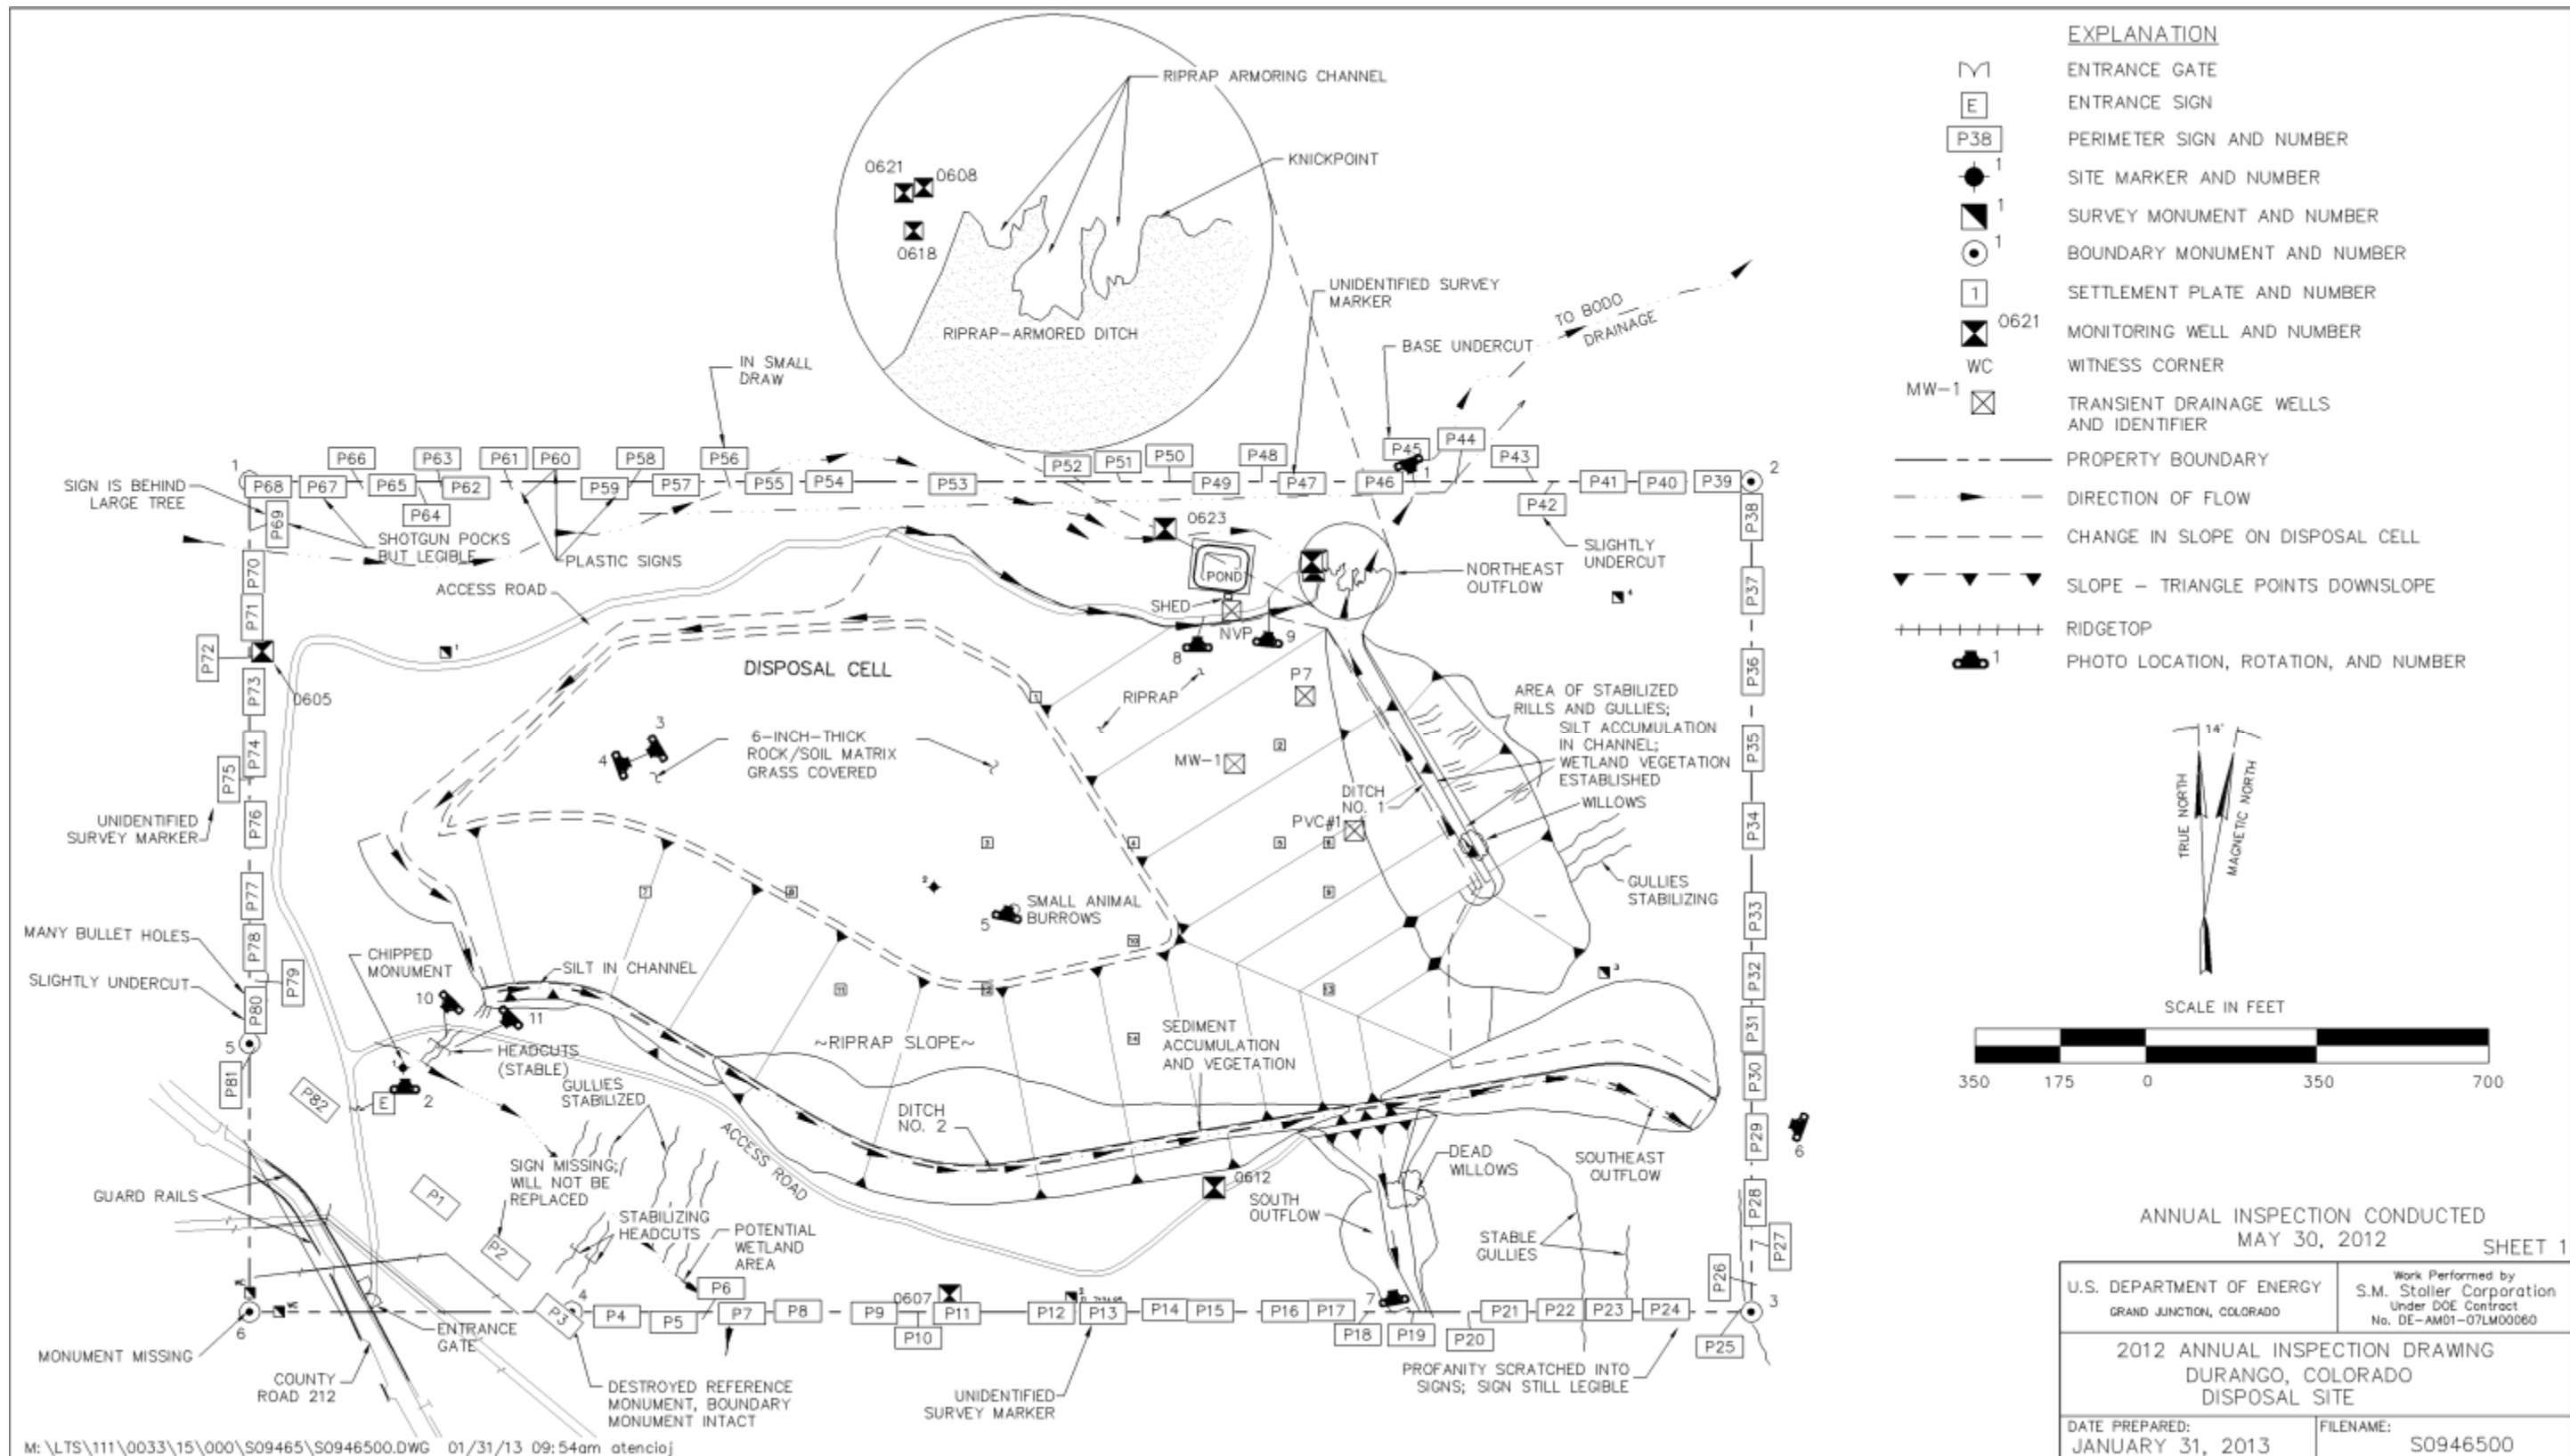
The locations of site surveillance features are shown in Figure 4–1. Inspection results and recommended maintenance activities associated with site surveillance features are included in the following subsections. Photographs to support specific observations are identified in the text and in Figure 4–1 by photograph location (PL) numbers.

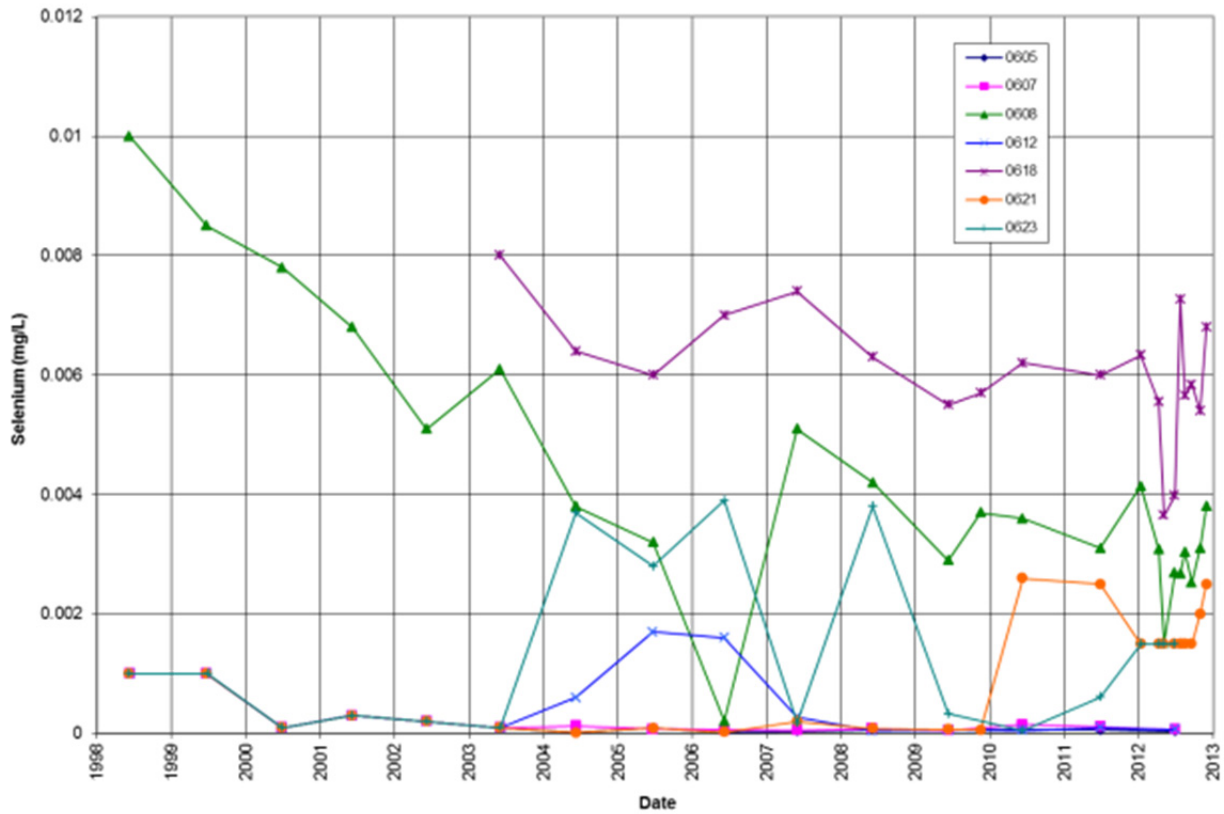
Figure 4-3. Time-Concentration Plot of Selenium in Groundwater at the Durango Disposal Site

Groundwater samples are collected annually and analyzed for three indicator parameters: molybdenum, selenium, and uranium. To monitor the increased uranium observed in well 0618, wells 0608, 0618, and 0621 have been increased to monthly sampling as weather permits. The site-specific standards used for the three indicator parameters are the respective maximum observed background concentrations reported in groundwater samples collected from wells completed in the bedrock aquifer as identified in Table 5–4 of the LTSP. These site-specific standards are provided below in Table 4–3. Time-concentration plots for uranium, selenium, and molybdenum monitoring results are included as Figures 4–2, 4–3, and 4–4, respectively.
