## 4.0 Durango, Colorado, Disposal Site

### 4.1 Compliance Summary

## **4.4 Inspection Results**

The site, southwest of Durango, Colorado, was inspected on June 3, 2014. The inspection was conducted by D. Miller and L. Sheader of Stoller Newport News Nuclear, Inc. (SN3), a wholly owned subsidiary of Huntington Ingalls Industries, Inc. SN3 is the DOE Legacy Management Support contractor. J. Dayvault (DOE Site Manager) and M. Cosby of the Colorado Department of Public Health and Environment attended the inspection.

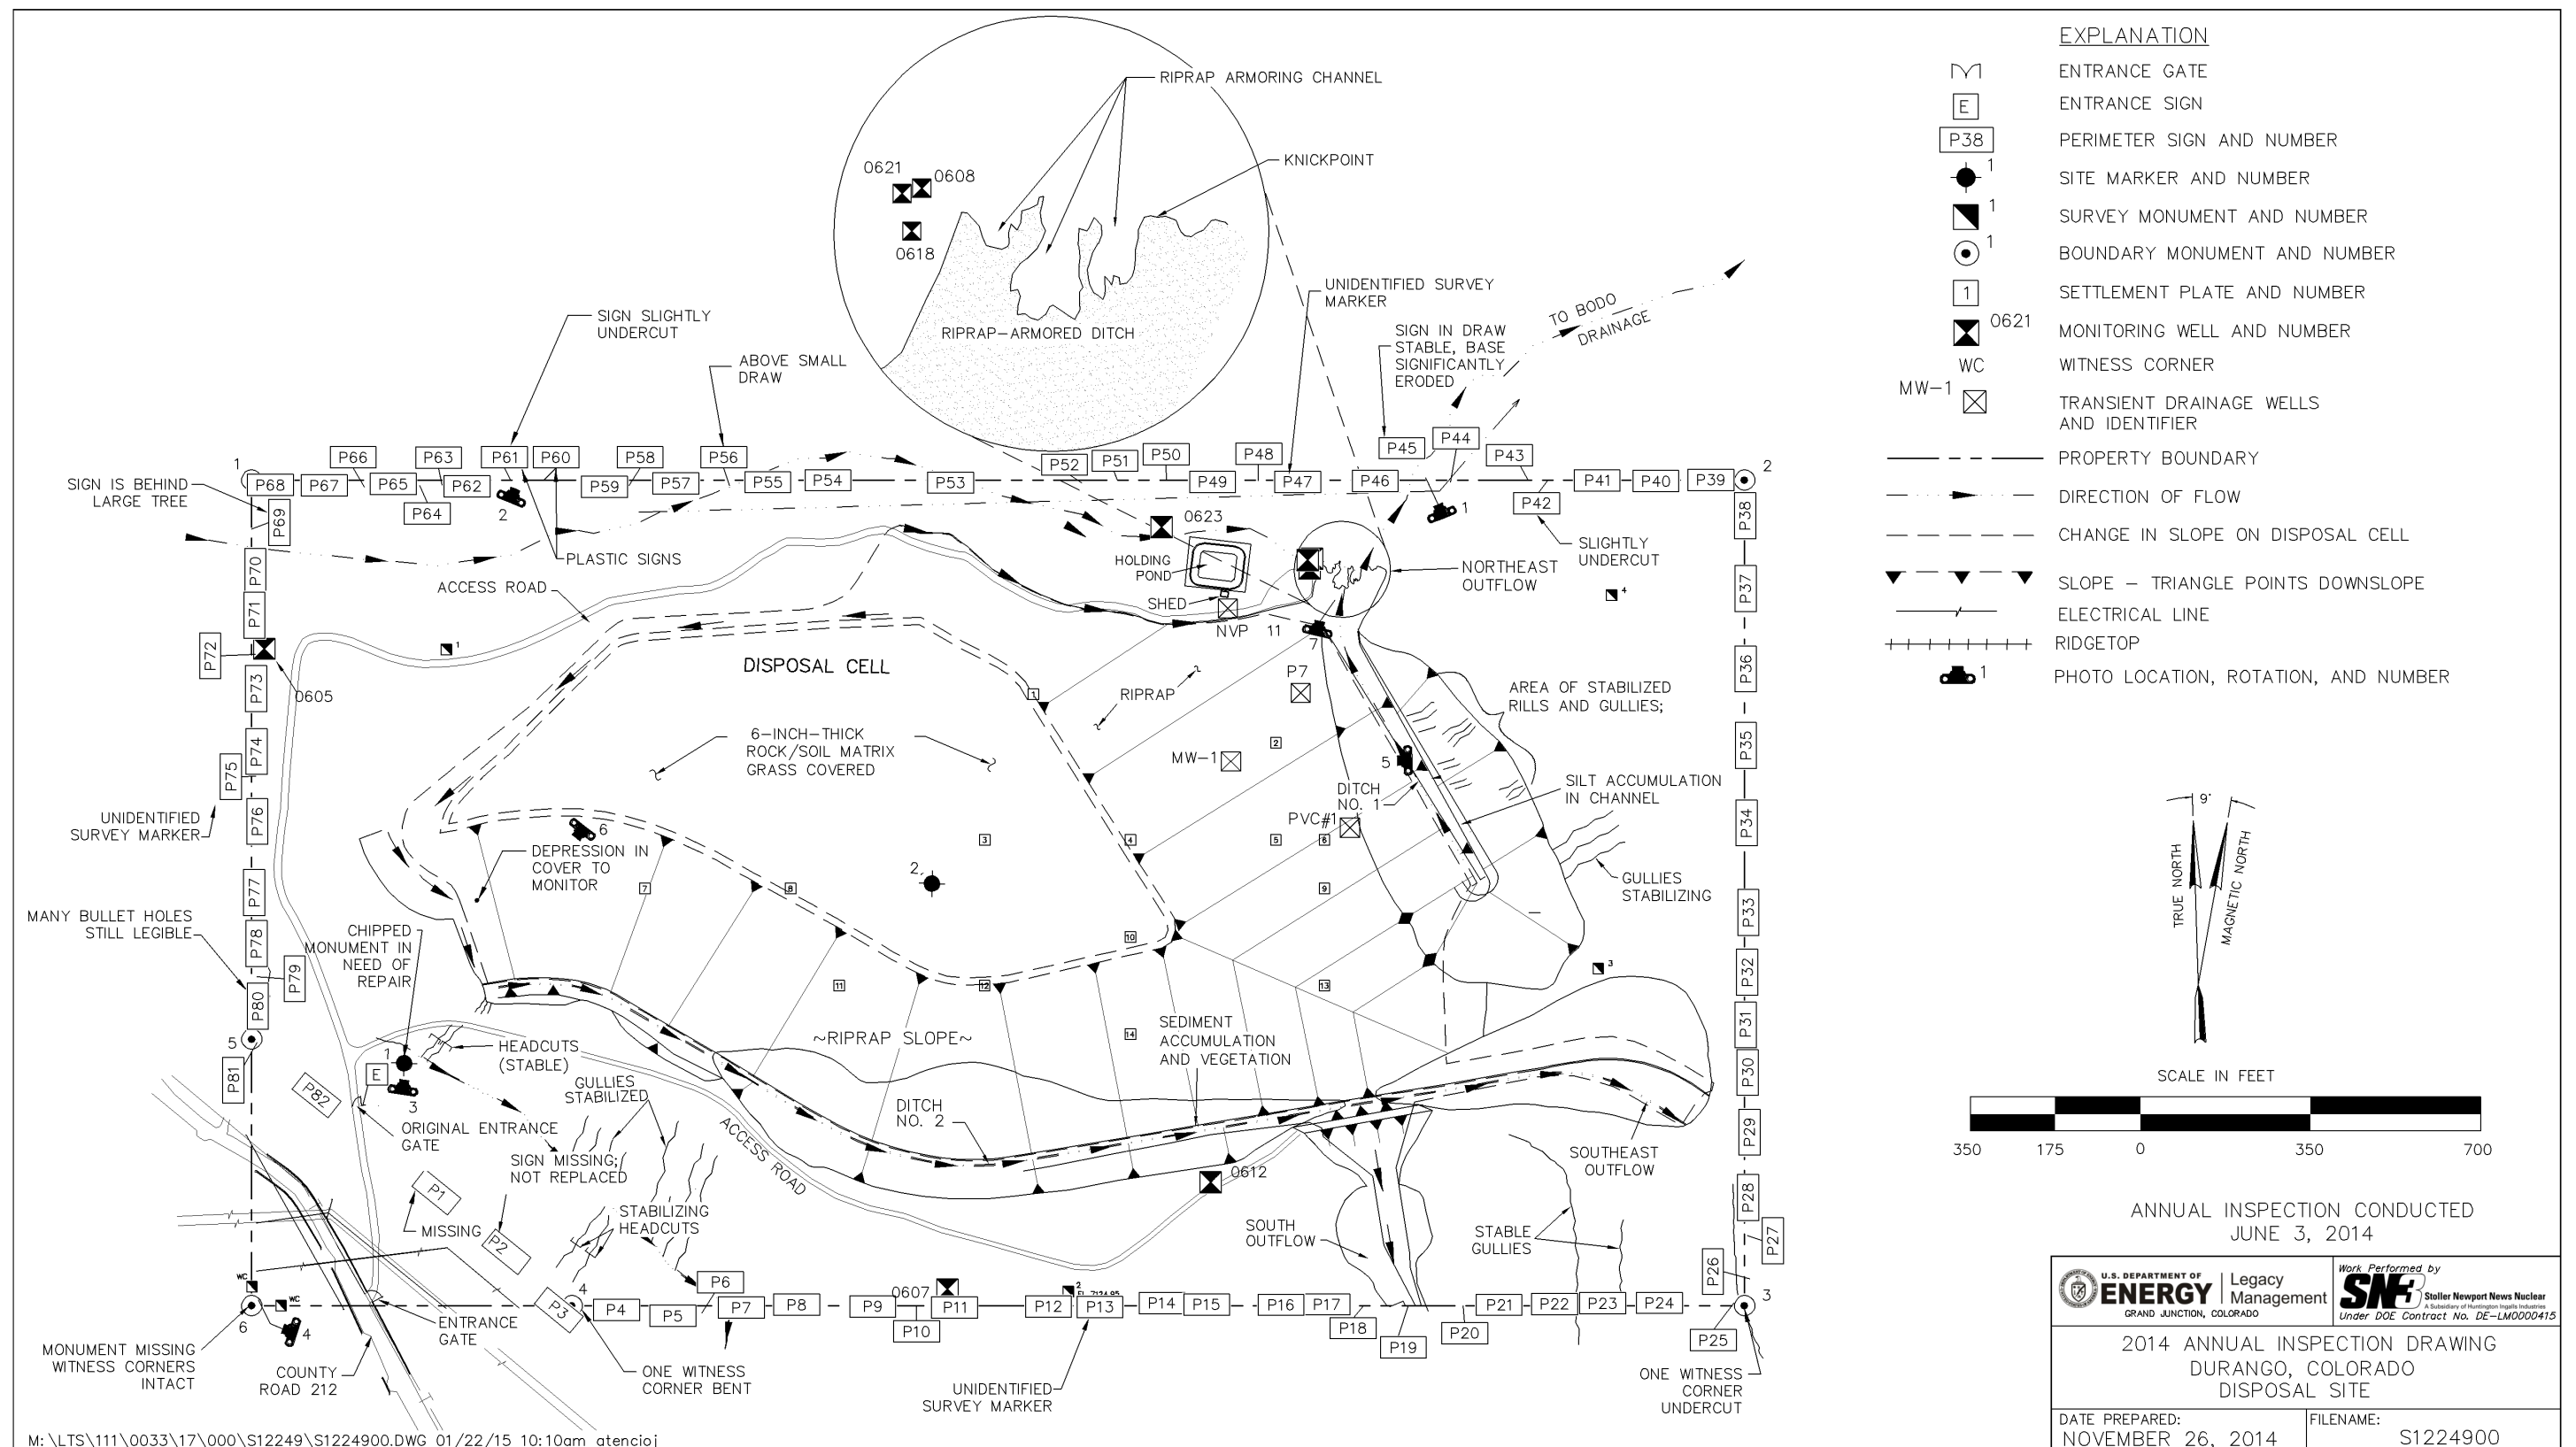
Figure 4-1. 2014 Annual Inspection Drawing for the Durango Disposal Site

Figure 4-1 shows the locations of site surveillance features. Inspection results and recommended maintenance activities associated with site surveillance features are included in the following subsections. Photographs to support specific observations are identified in the text and on Figure 4-1 by photograph location (PL) numbers.

Eighty-one perimeter signs mark the unfenced site boundary. Numerous perimeter signs have bullet holes or other markings but remain legible. Perimeter signs P1 and P2 are missing. Perimeter Sign P2 has been missing for several years and will not be replaced, as adjacent signs are within sight. Perimeter sign P1 will be replaced. In previous years, inspectors noted that the base of perimeter sign P45 was being undercut by erosion; the sign remains stable (PL-1). Sign P61 is also slightly undercut and will continue to be monitored (PL-2).

Site marker SMK-1 was historically damaged by gunfire and continues to degrade (PL-3). The site marker will be repaired.

All survey and boundary monuments are in good condition except as follows. Boundary monument BM-3 and two of its reference monuments are situated in a small gully and were threatened by erosion in the past; the monuments are now stable, but slight undercutting of one of the witness corners occurred in 2014. One of the reference monuments for boundary monument BM-4 has been bent to the ground and the cap has been removed, but BM-4 is stable. Repair of any of these features is not warranted at this time. Boundary monument BM-6 was destroyed prior to the 2004 inspection during construction of a pipeline near the site. It will not be replaced because both of its witness corners are present and remain in good condition (PL-4).
