4.0 Durango, Colorado, Disposal Site

4.1 Compliance Summary

4.4 Inspection Results

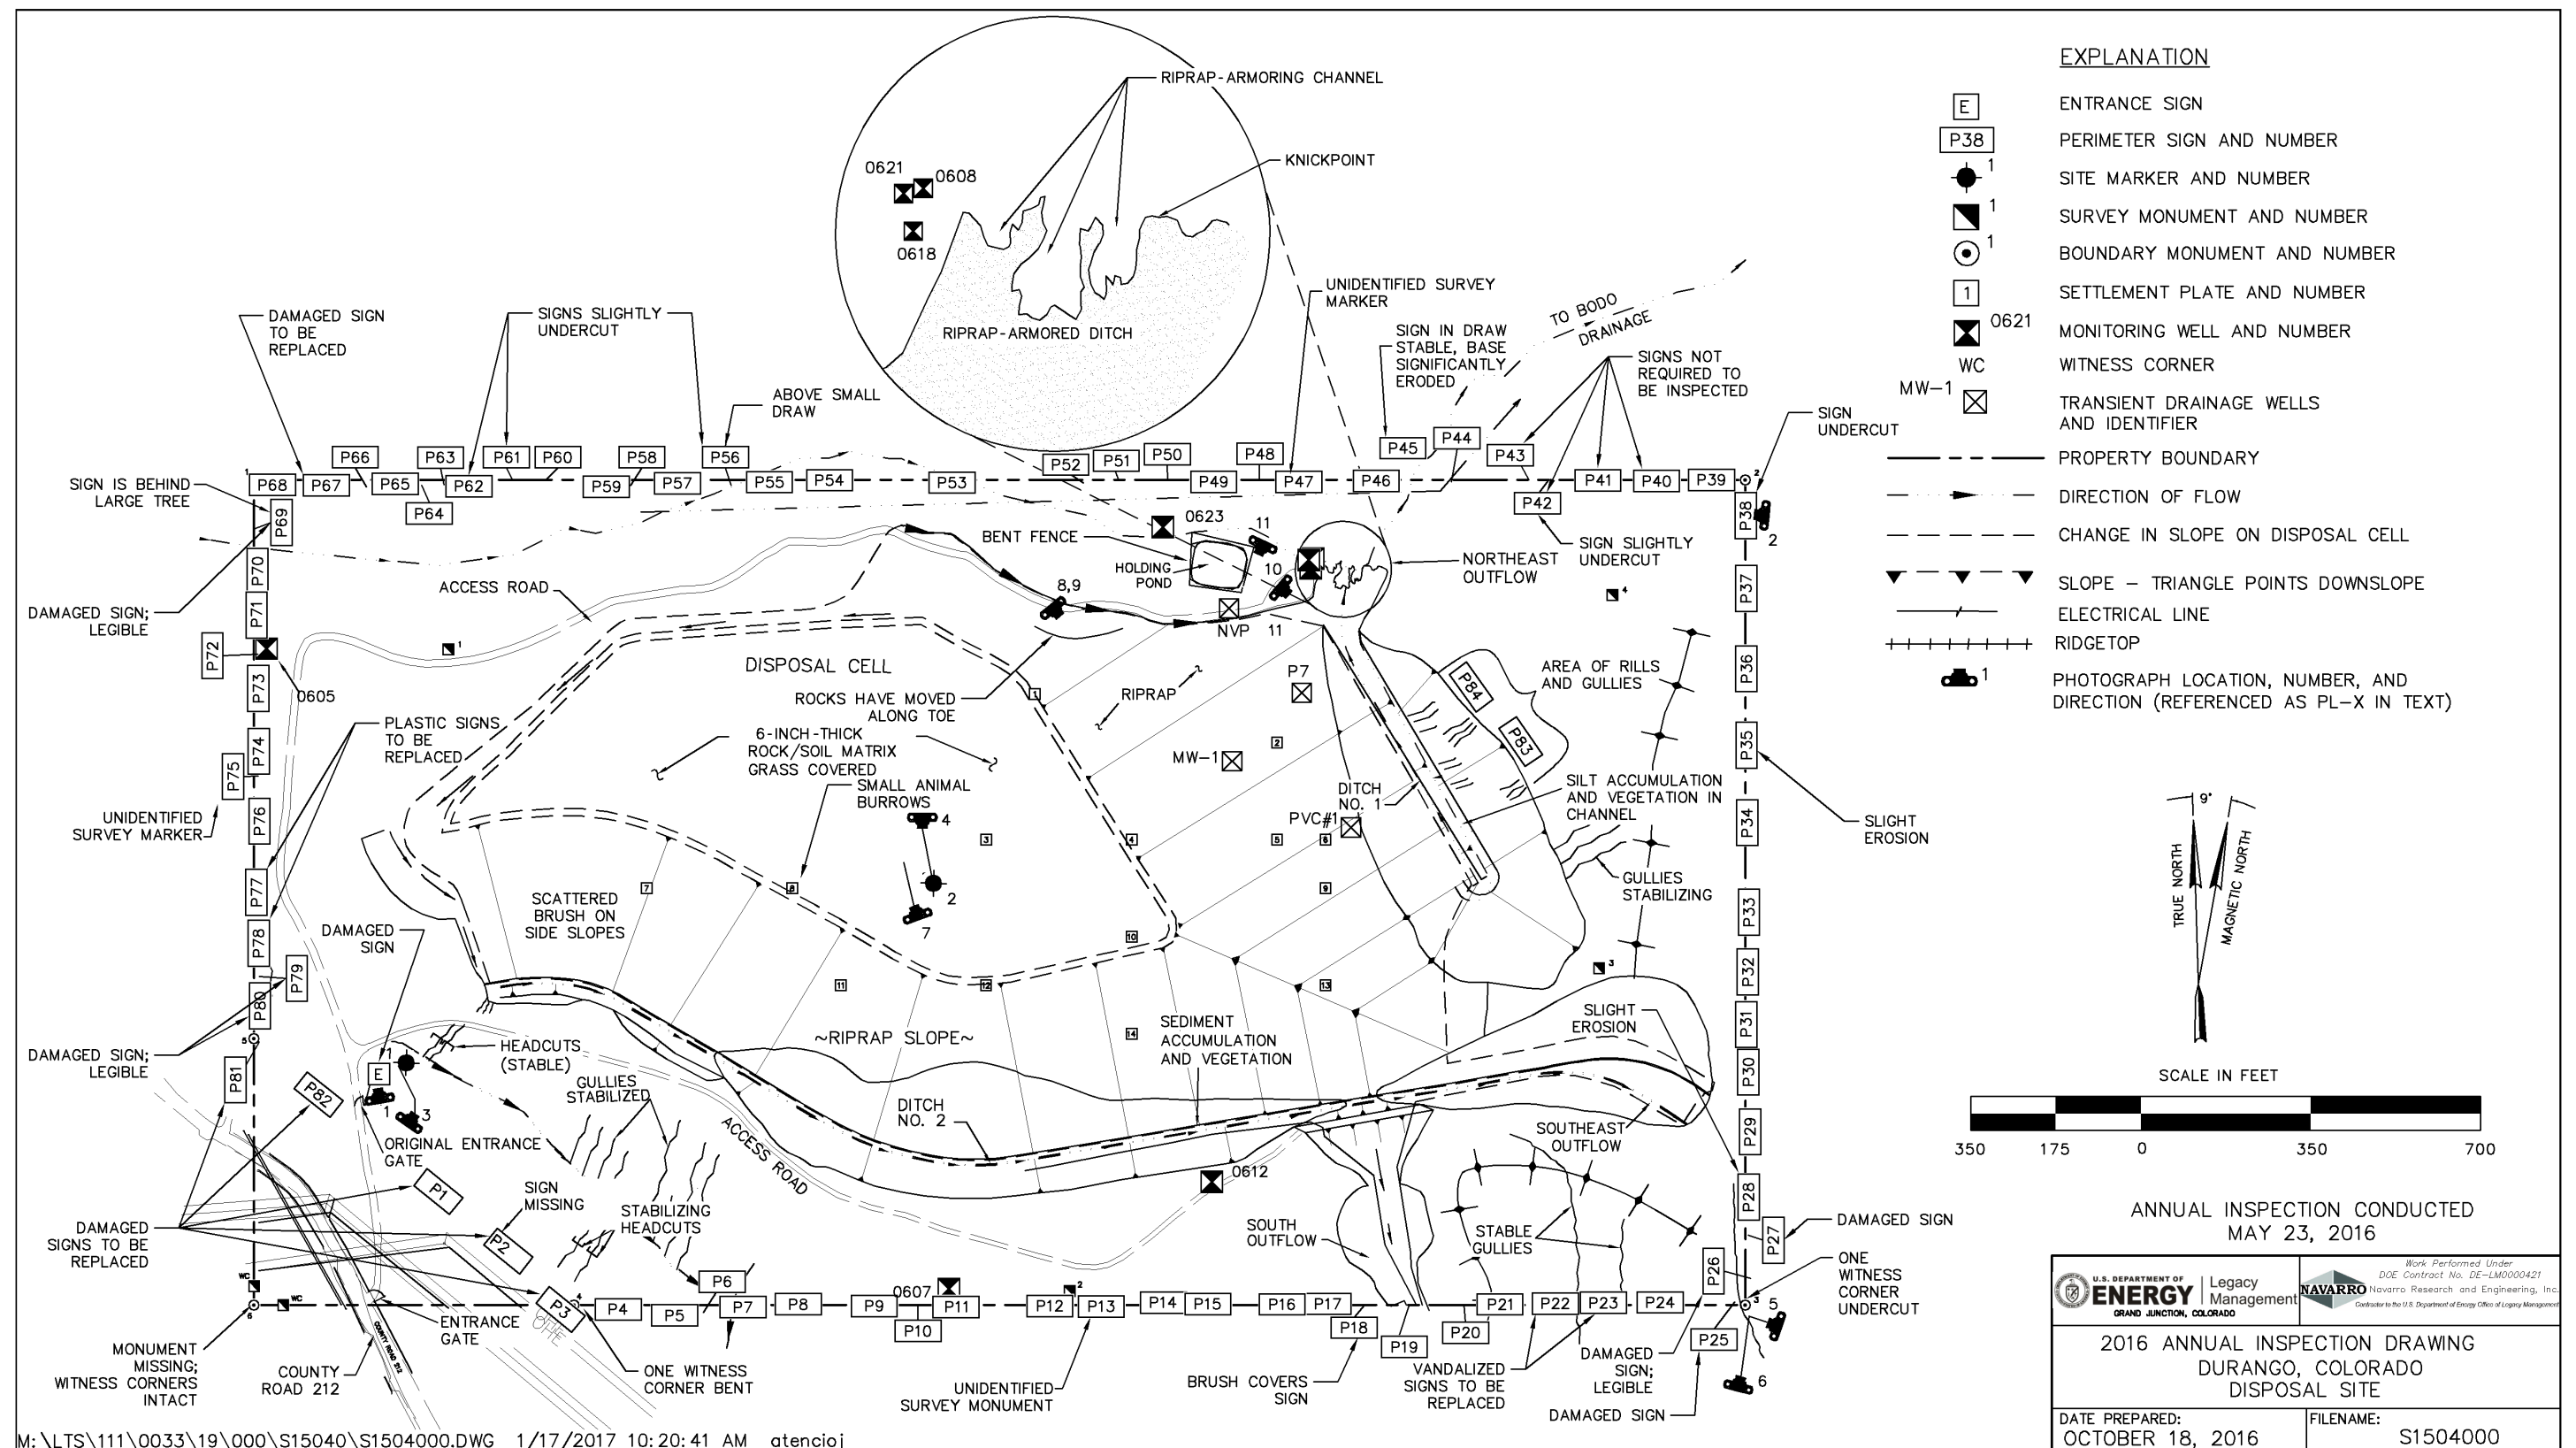
Figure 4-1. 2016 Annual Inspection Drawing for the Durango Disposal Site

Figure 4-1 shows the locations of site surveillance features. Inspection results and recommended maintenance activities associated with site surveillance features are included in the following subsections. Photographs to support specific observations are identified in the text and in Figure 4-1 by photograph location (PL) numbers.

There are four survey monuments positioned around the site. All were present and undamaged. There are six boundary monuments, each with two witness corners, along the site perimeter. Most of the boundary monuments and witness corners were present and stable. One witness corner for boundary monument BM-3 was undercut by erosion (PL-5), and monument BM-3 was also undercut (PL-6). One of the witness corners for boundary monument BM-4 was bent to the ground, and its cap was missing, but BM-4 was stable. Boundary monument BM-6 has been missing for years, but both witness corners were present. Repair or replacement of these features is not warranted at this time. No other maintenance needs were identified.

The side slopes of the disposal cell are armored with rock riprap. Along the north toe of the disposal cell, rock has moved, creating a linear depression approximately 18 feet long. The depression was first observed in 2015 (PL-8). No significant change was observed in 2016 (PL-9). Inspectors will continue to monitor and evaluate this area.

Erosion occurs on some of the steep slopes above these channels, depositing sediment in the rock-armored channel; this creates locales favoring plant growth (PL-10). As no excessive sediment deposits or vegetation were observed during the inspection, drainage ditches are expected to perform as designed. Inspectors will continue to monitor the ditches.

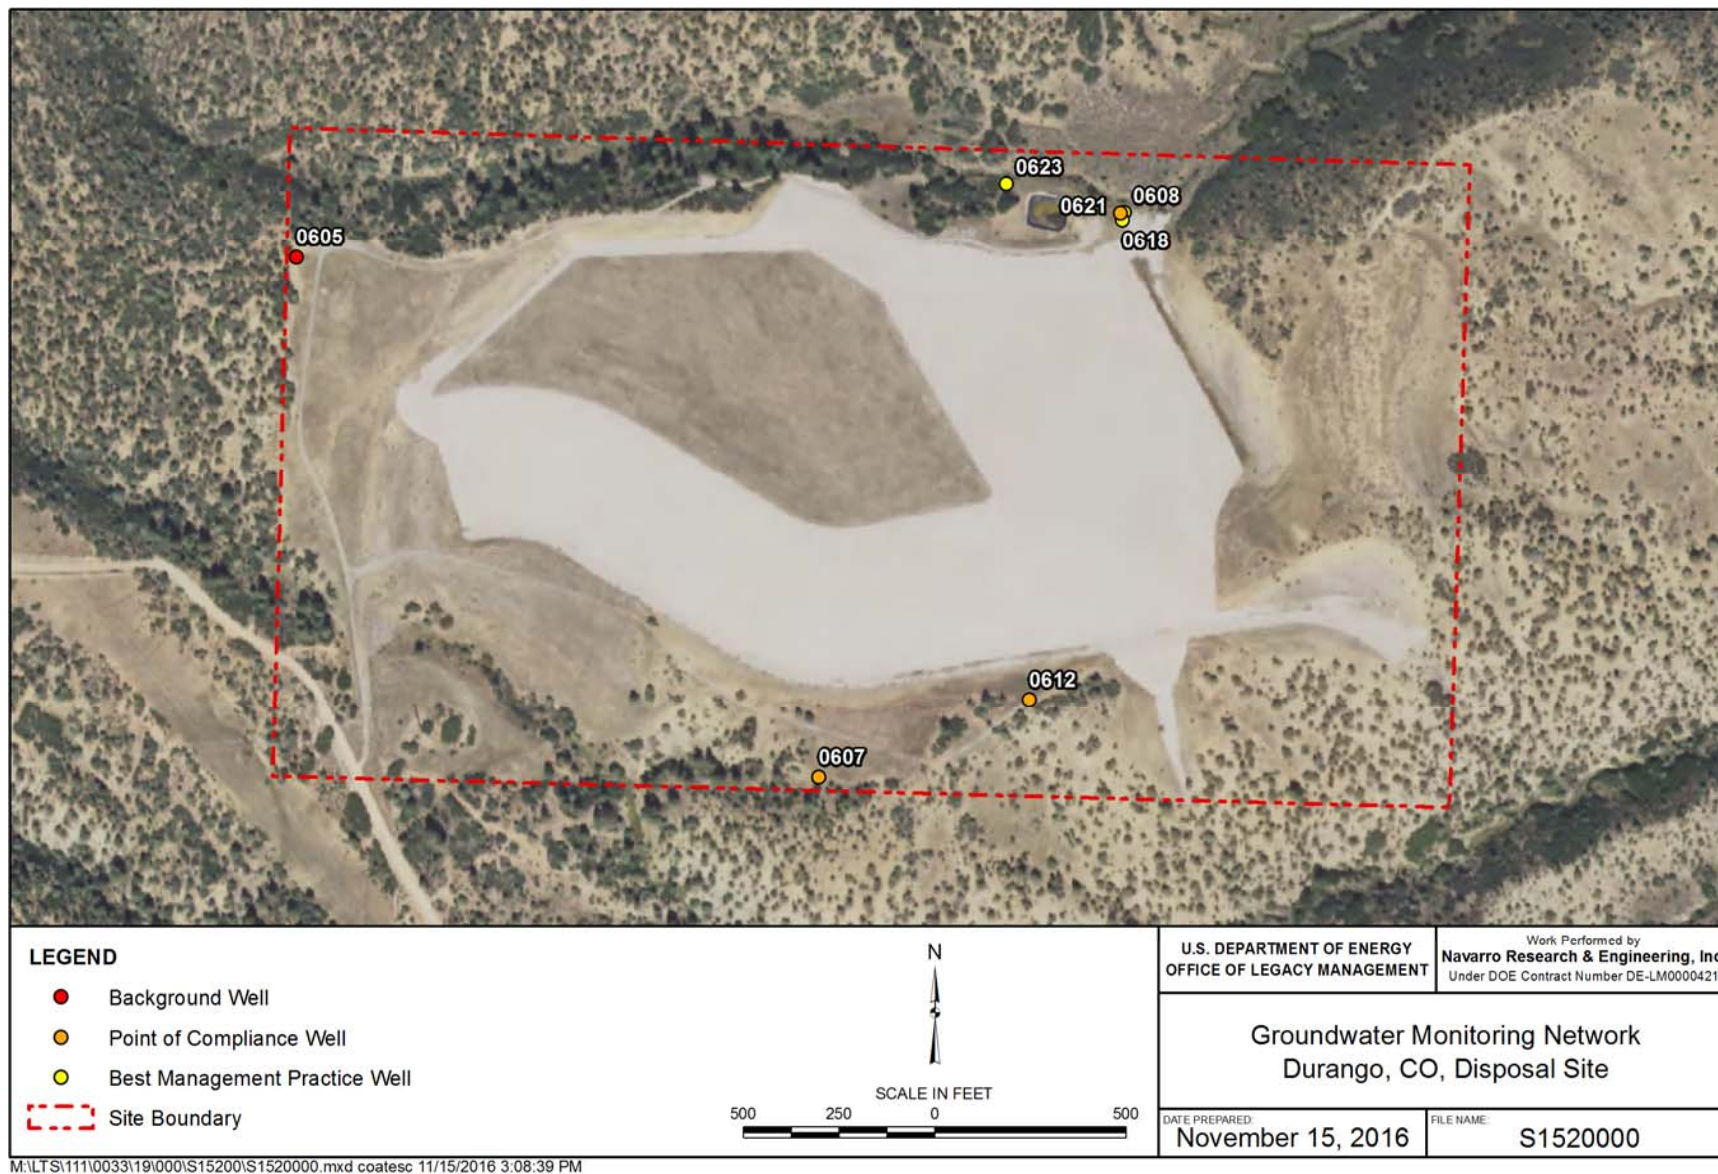
Figure 4-2. Groundwater Monitoring Network for the Durango Disposal Site

In accordance with the LTSP, groundwater is monitored at the site to verify the initial performance of the disposal cell. The monitoring network consists of seven wells (Table 4-2 and Figure 4-2). Four wells are completed in the uppermost aquifer (bedrock of the Cliff House Sandstone and the Menefee Formation), including one upgradient background well (0605) and three downgradient point-of-compliance (POC) wells (0607, 0612, and 0621). Three wells are completed in the alluvium (0608, 0618, and 0623).

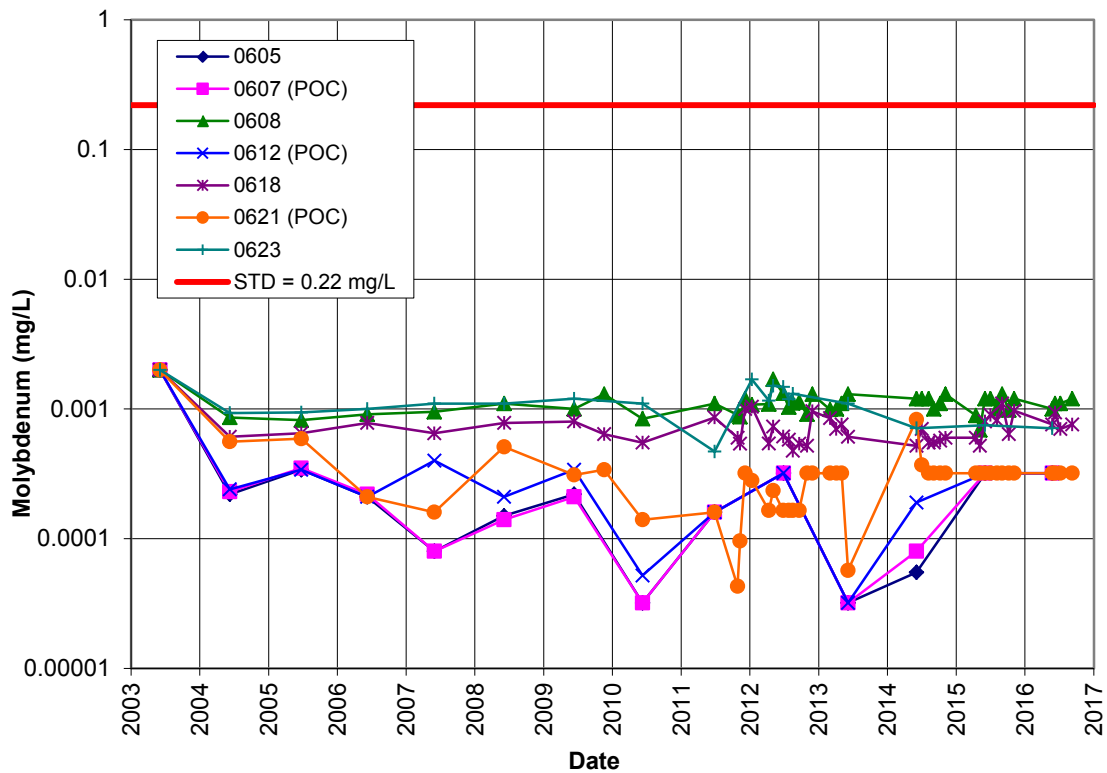
Figure 4-4. Time-Concentration Plot of Molybdenum in Groundwater at the Durango Disposal Site

Beginning in 2014, POC wells 0607 and 0612 have shown a slight increase in selenium concentrations (Figure 4-3). In the May 2016 sampling event, the selenium concentration continued to increase in well 0607 and it decreased in well 0612. Even so, selenium, molybdenum, and uranium concentrations in the POC wells in the uppermost aquifer are well below the respective standards (Figure 4-3 through Figure 4-5). Therefore, the aquifer is in compliance with the LTSP groundwater monitoring requirements.

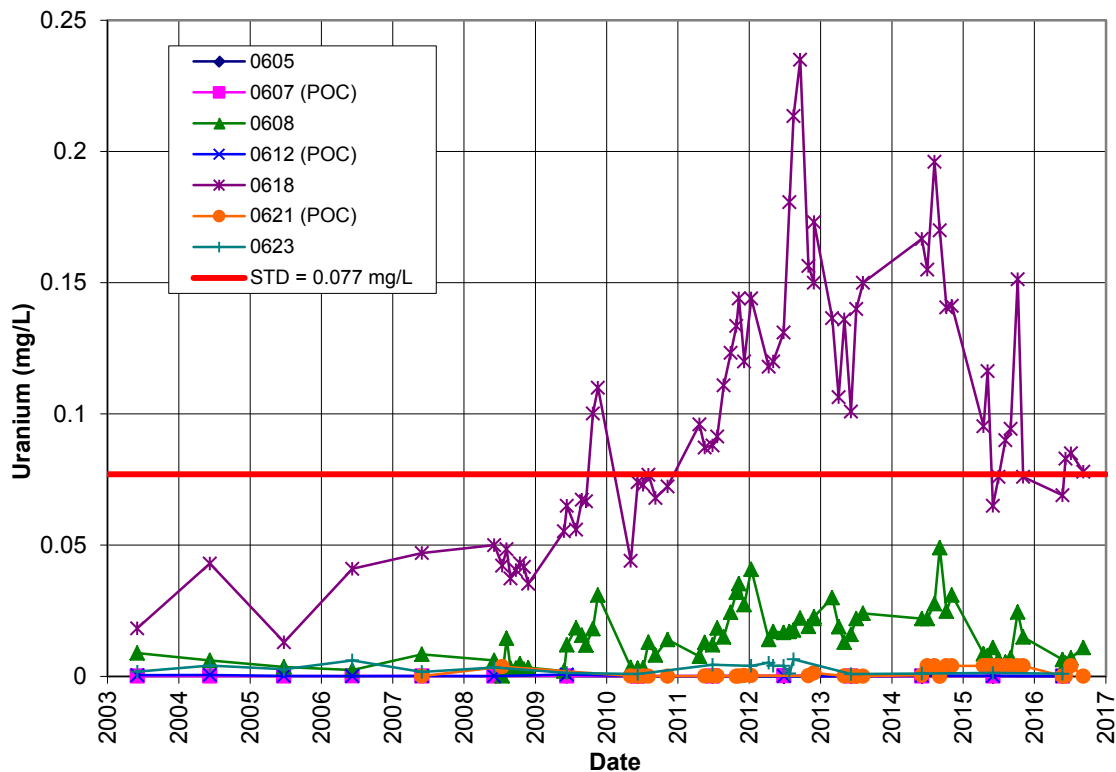
Figure 4-5. Time-Concentration Plot of Uranium in Groundwater at the Durango Disposal Site

Though not required for compliance, wells completed in the alluvium are monitored as a best management practice. Uranium concentrations in well 0618 have consistently been higher than concentrations in the other wells onsite. To monitor the increased uranium observed in well 0618, wells 0608, 0618, and 0621 are sampled monthly as weather permits. Figure 4-5 shows an overall decreasing trend in uranium concentrations in well 0618 since 2014, with concentrations below the standard on multiple occasions between 2015 and 2016. However periodic increases in uranium concentrations continue to occur in well 0618. Because well 0618 is not a POC well and not screened in the uppermost aquifer, the concentrations in this well do not affect compliance with the LTSP and do not pose a risk to human health and the environment. The potential cause of variability in this well continues to be investigated.
