## 4.0 Durango, Colorado, Disposal Site

The Durango, Colorado, Uranium Mill Tailings Radiation Control Act (UMTRCA) Title I Disposal Site (site) was inspected on May 24, 2017. Inspectors identified minor maintenance needs, but found no cause for a follow-up inspection.

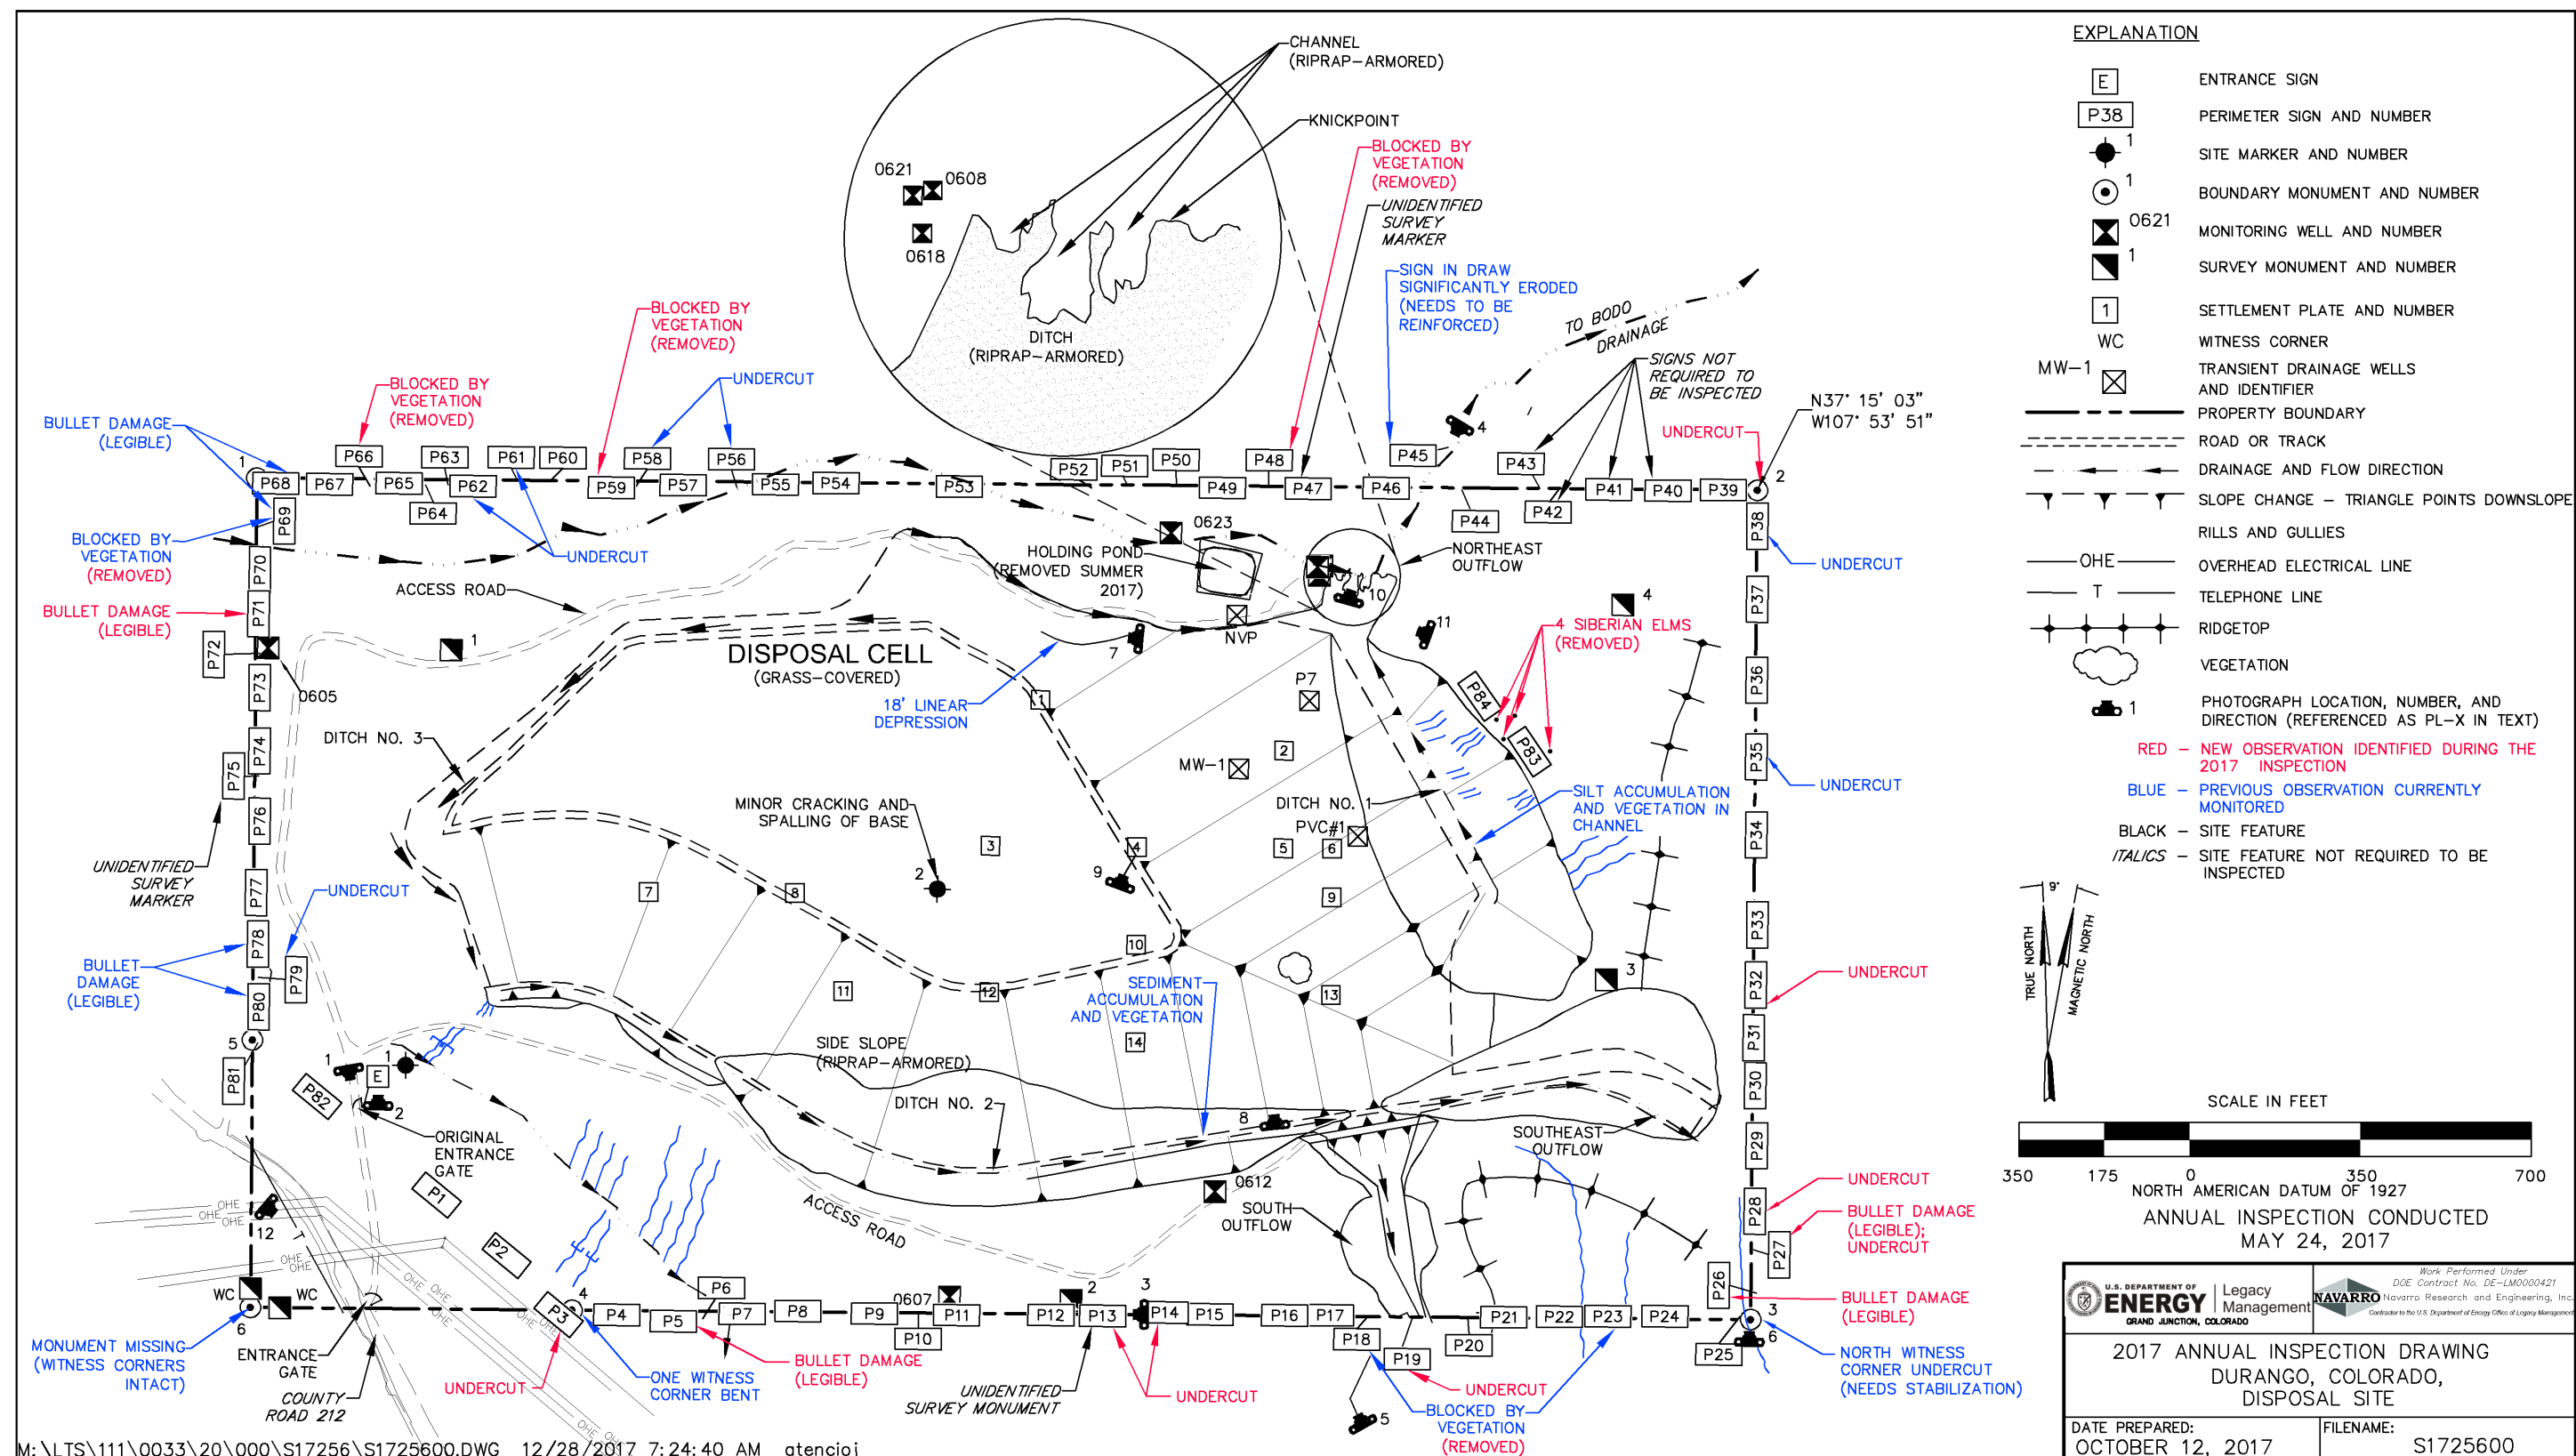
Figure 4-1. 2017 Annual Inspection Drawing for the Durango, Colorado, Disposal Site

The concrete bases of several perimeter signs have been and continue to be undercut by erosion (PL-3). The concrete base of perimeter sign P45, located in the natural drainage on the north end of the site, is almost entirely free-standing (PL-4), and maintenance is required to protect against further erosion. DOE will reinforce the base of perimeter sign P45 before the 2018 annual inspection. Several perimeter signs have new bullet damage (P5, P26, P27, and P71) but remain legible. Several perimeter signs (P68, P69, P79, and P80) have bullet damage as identified in previous annual inspections but remain legible. Several perimeter signs (P18, P23, P48, P59, P66, and P69) were blocked from view by vegetation (PL-5) during the inspection; the vegetation was removed during a later site visit. No other maintenance needs were identified.

Four survey monuments and six boundary monuments (each with two witness corners) delineate the property boundary. The north witness corner for boundary monument BM-3 is undercut by erosion and in need of stabilization (PL-6). Boundary monument BM-3 also was undercut, although not as significantly. Both will be stabilized before the 2018 annual inspection. One of the witness corners for boundary monument BM-4 was bent to the ground, and its cap was missing (as it has been for years), but boundary monument BM-4 was stable. Boundary monument BM-6 has been missing since the adjacent U.S. Bureau of Reclamation pipeline was installed, but both witness corners were present, although they were somewhat hidden by vegetation. Replacement of these features is not warranted at this time. The vegetation was removed during a later site visit; no other maintenance needs were identified.

The side slopes of the disposal cell are armored with riprap. Along the north toe of the disposal cell, rock has moved, resulting in a linear depression approximately 18 feet long. The depression was first observed in 2015. No significant change was observed in 2016 or 2017 (PL-7). Inspectors will continue to monitor this area.

Inspectors observed subtle topographic variations in the surface of the south side slope that had not been noticed during previous inspections (PL-8). The variations, while barely perceptible, appeared as a wavelike series of gentle ridges and swales across and parallel to the slope. It was hypothesized that the variations had not previously been noted because past inspections were typically conducted in afternoons, when the light was flatter, rather than in morning light, as in 2017, when shadows provided additional contrast and revealed topographic variations. The cause of the variations is unknown, but because of their subtle nature, they likely did not form abruptly between the 2016 and 2017 inspections and have been present for some time. Inspectors found no evidence that the side slope was eroding, which would prompt concern, and determined that the observed variations did not pose concerns about disposal cell integrity. Inspectors will continue to monitor this side slope during future inspections.

A dug-out hole was observed around settlement plate 4 on the east-facing side slope (PL-9). It was likely dug out by a large animal. Inspectors replaced the rock around the settlement plate. No maintenance needs were identified.

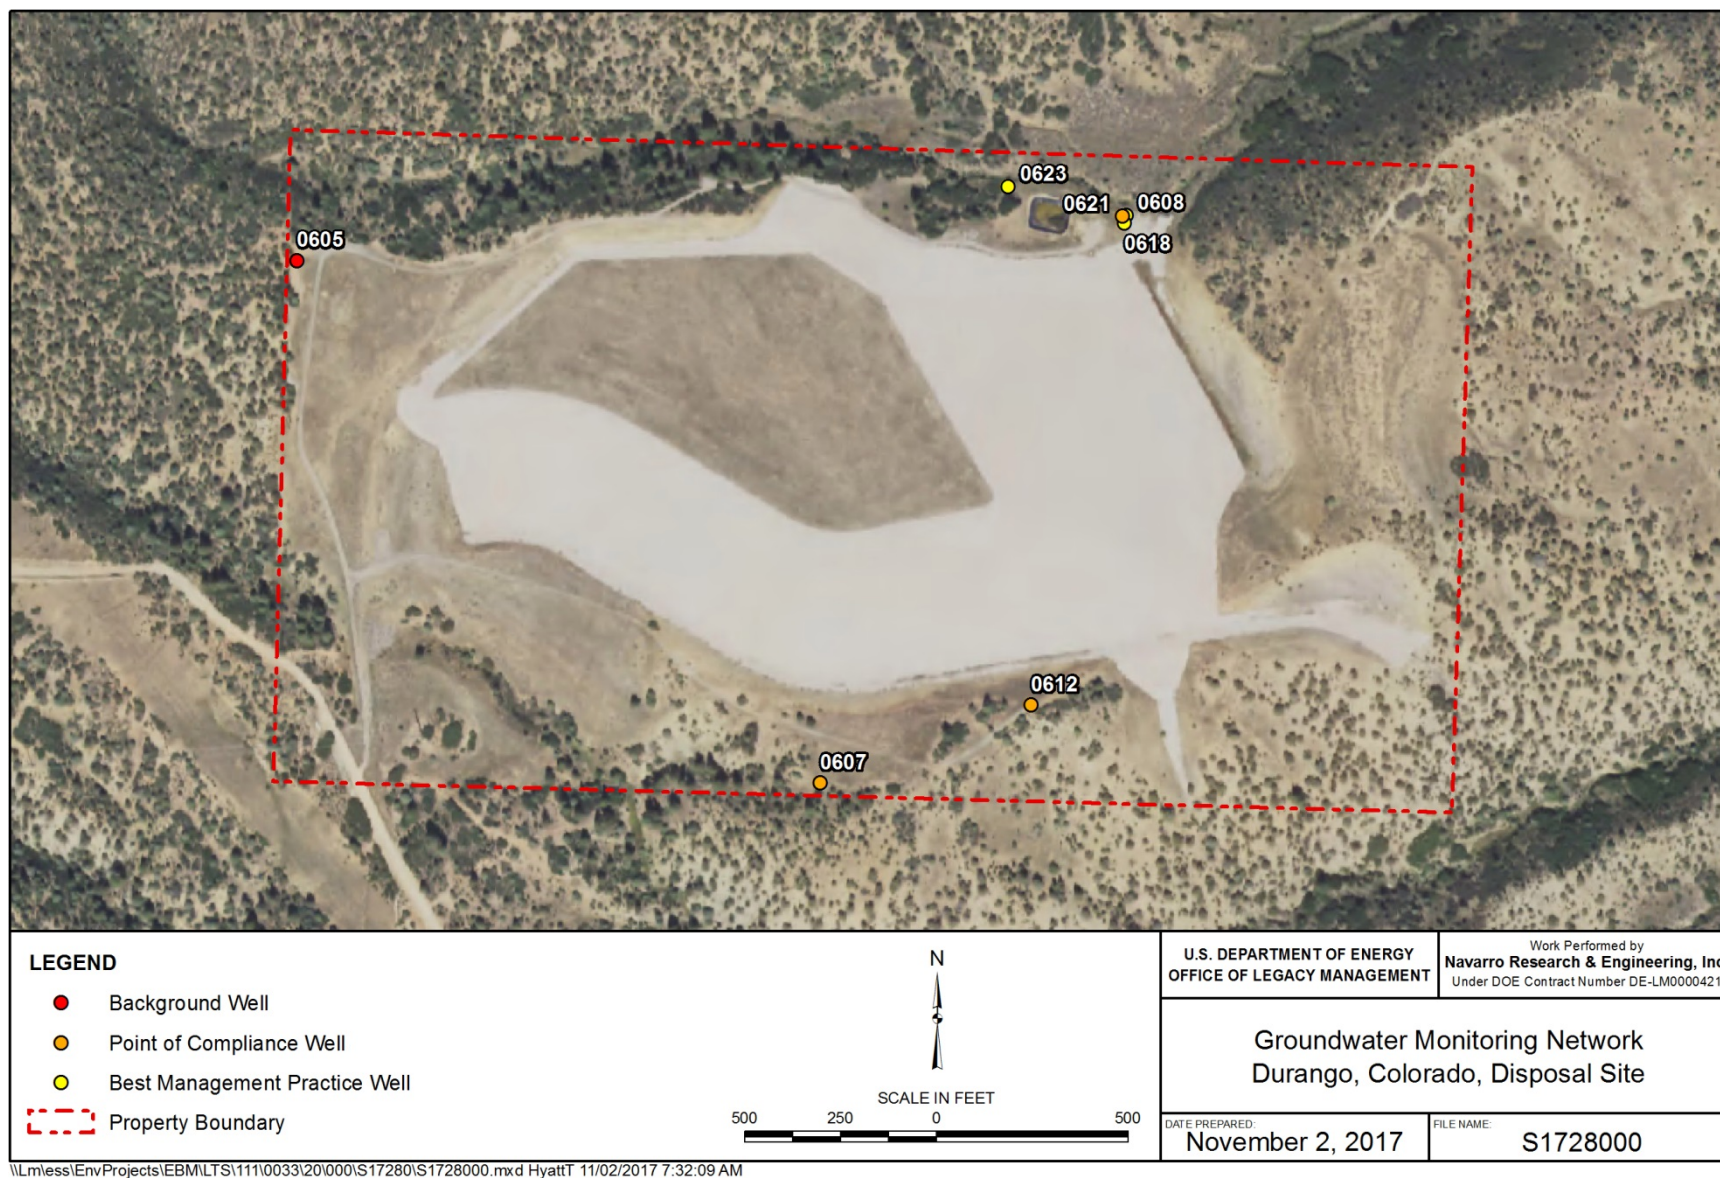
Figure 4-2. Groundwater Monitoring Network for the Durango, Colorado, Disposal Site

Selenium, molybdenum, and uranium concentrations in POC wells (0607, 0612, 0621) in the uppermost aquifer are below the respective standards. Therefore, the uppermost aquifer is in compliance with the LTSP groundwater monitoring requirements.

Though not required for compliance, monitoring wells completed in the alluvium are monitored as a best management practice. Uranium concentrations in monitoring well 0618 have consistently been higher than concentrations in the other wells onsite. To monitor the elevated and variable uranium concentrations observed in monitoring well 0618, monitoring wells 0608, 0618, and 0621 are sampled monthly as weather permits. Monthly monitoring was not conducted during summer 2017 while the evaporation pond removal was in progress. Sampling resumed in October 2017. Figure 4-5 shows an overall decreasing trend in uranium concentrations in well 0618 since 2014, with concentrations varying around 0.08 mg/L since 2016. Because well 0618 is not a POC well and not screened in the uppermost aquifer, the concentrations in this well do not affect compliance with the LTSP and do not pose a risk to human health and the environment. The potential cause of variability in this well continues to be investigated.
