4.0 Durango, Colorado, Disposal Site

The U.S Department of Energy (DOE) Office of Legacy Management (LM) conducted the Durango, Colorado, Uranium Mill Tailings Radiation Control Act (UMTRCA) Title I Disposal Site (site) annual site inspection on June 20, 2018 and the annual groundwater monitoring event in May 2018. No cause for a follow-up inspection was identified.

Figure 4-1. 2018 Annual Inspection Drawing for the Durango, Colorado, Disposal Site

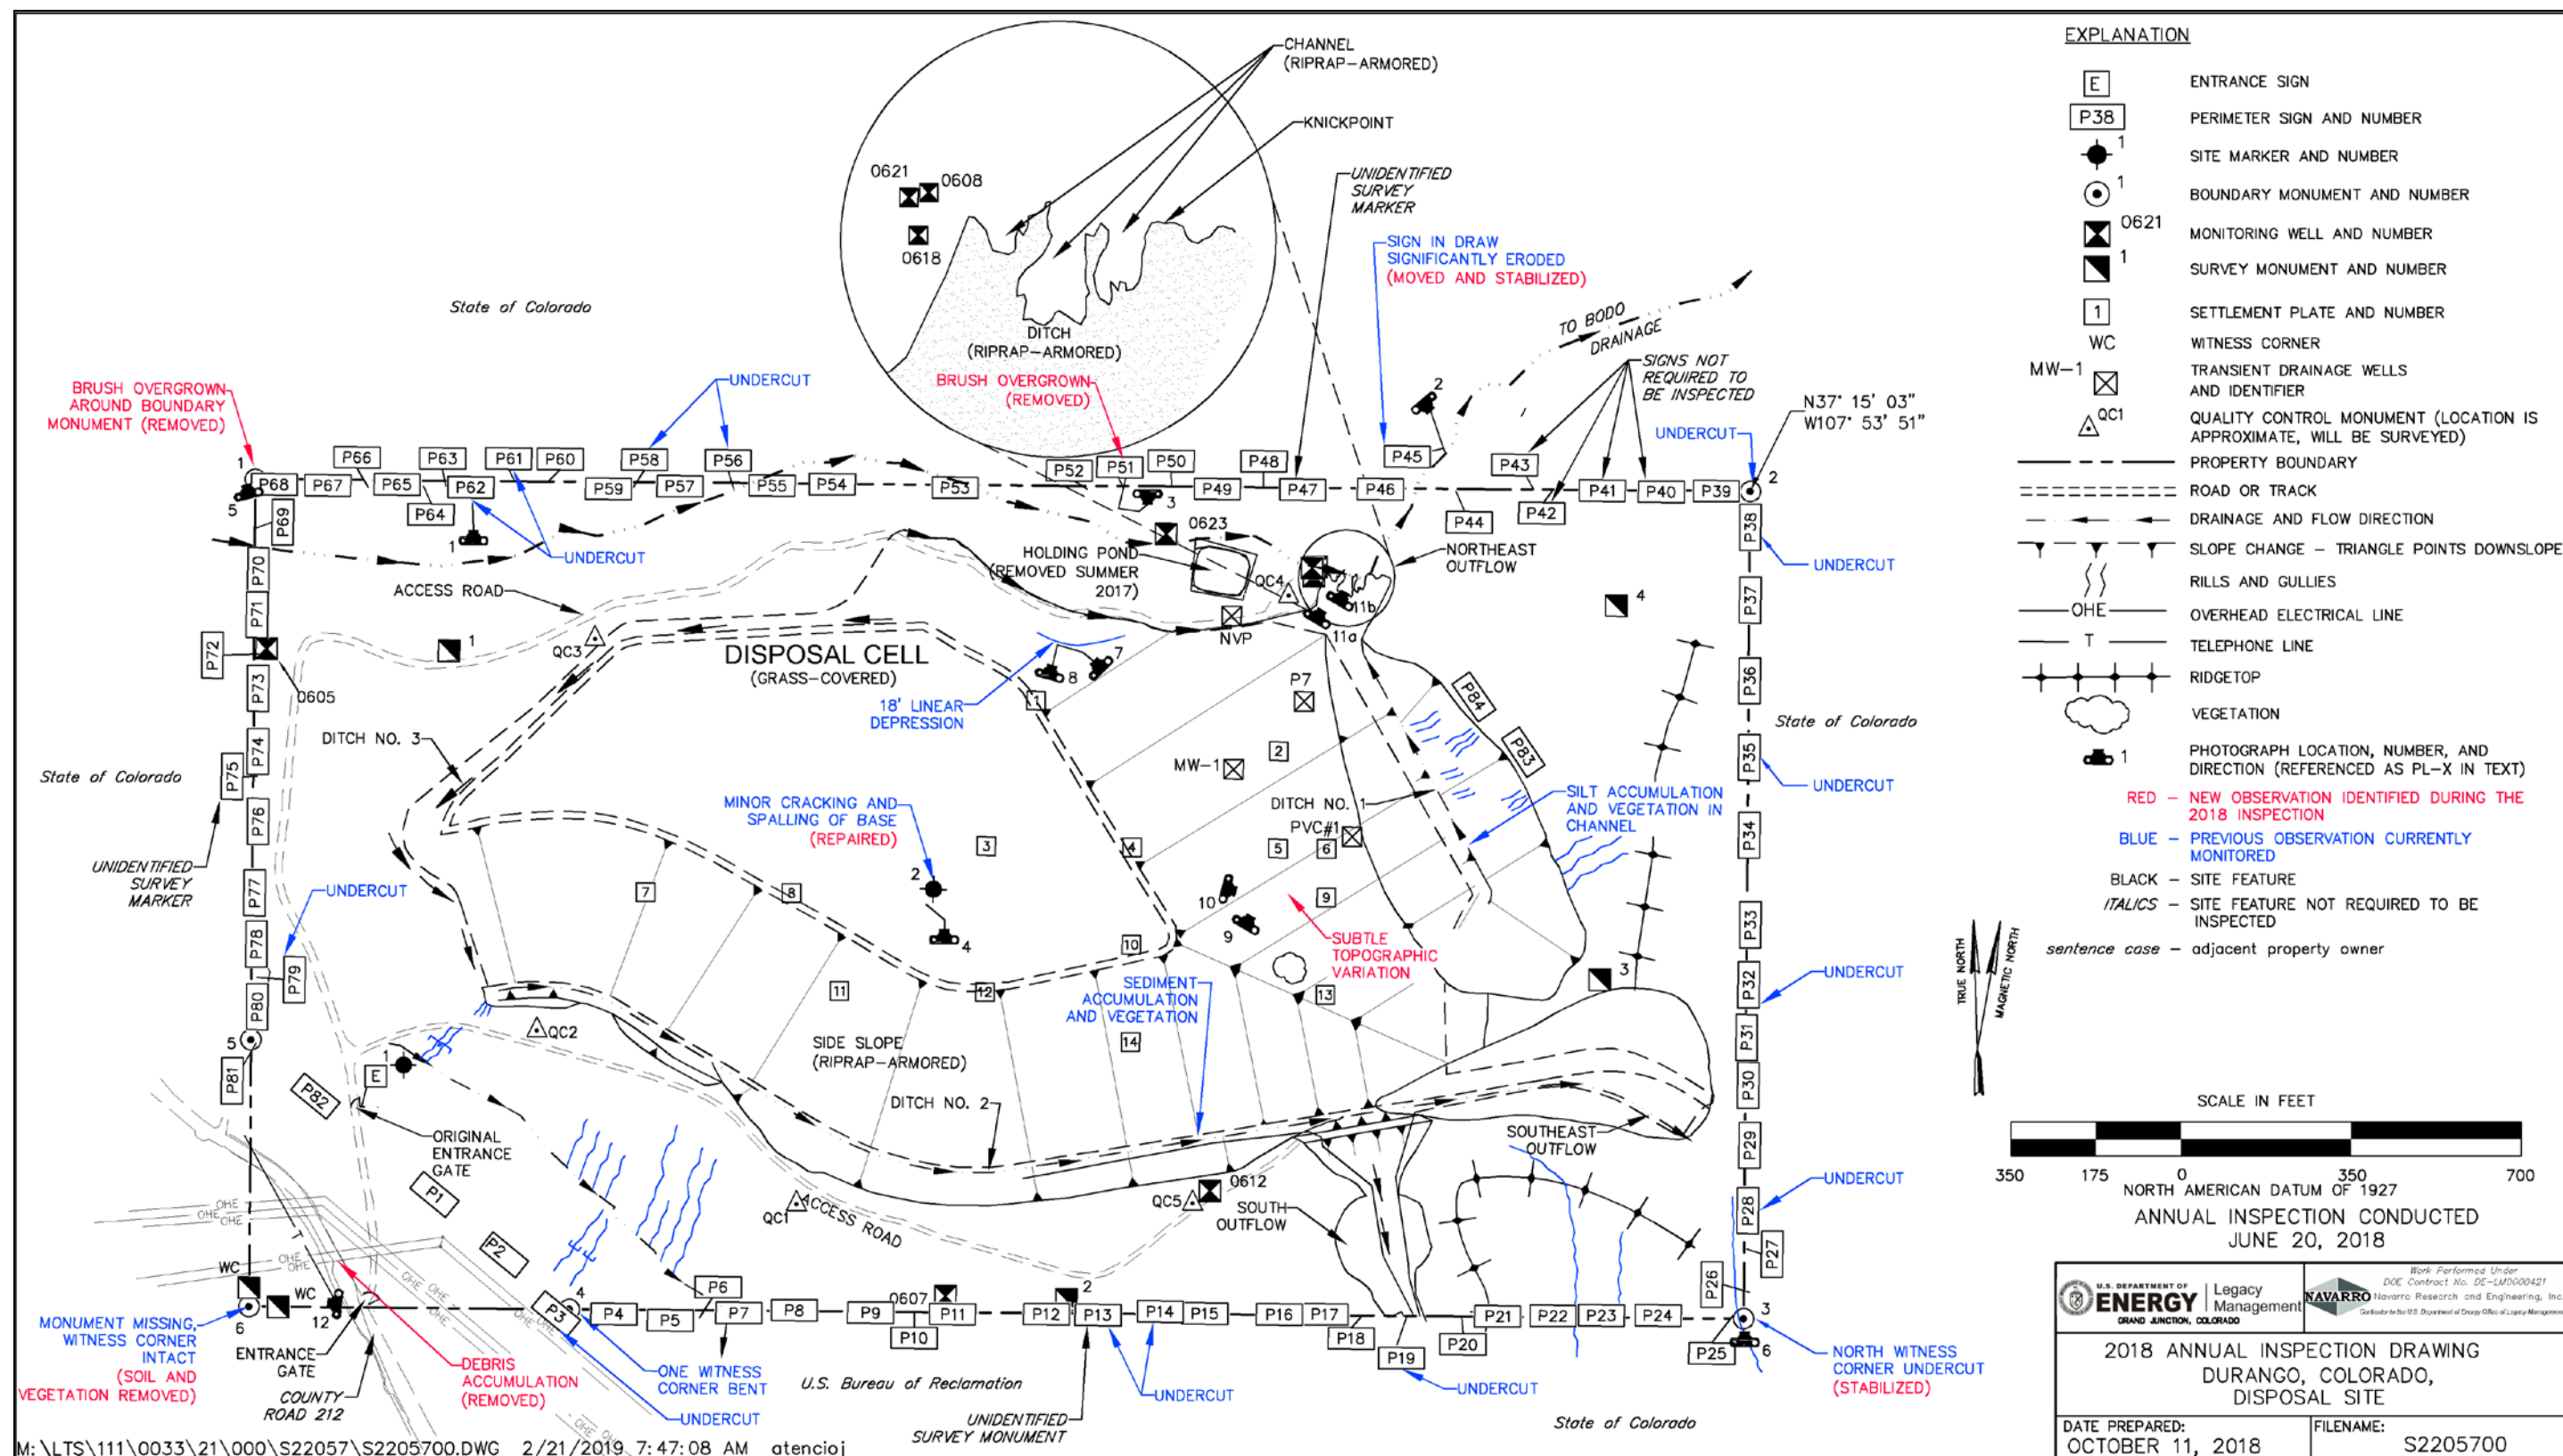
Figure 4-1 shows the locations of site features in black, including site surveillance features and inspection areas. Site features that are present but not required to be inspected are shown in italic font. Observations from previous inspections that are currently monitored are shown in blue text, and new observations identified during the 2018 annual inspection are shown in red. Inspection results and recommended maintenance activities associated with site surveillance features are described in the following subsections. Photographs to support specific observations are identified in the text and in Figure 4-1 by photograph location (PL) numbers. The photographs and photograph log are presented in Section 4.11.

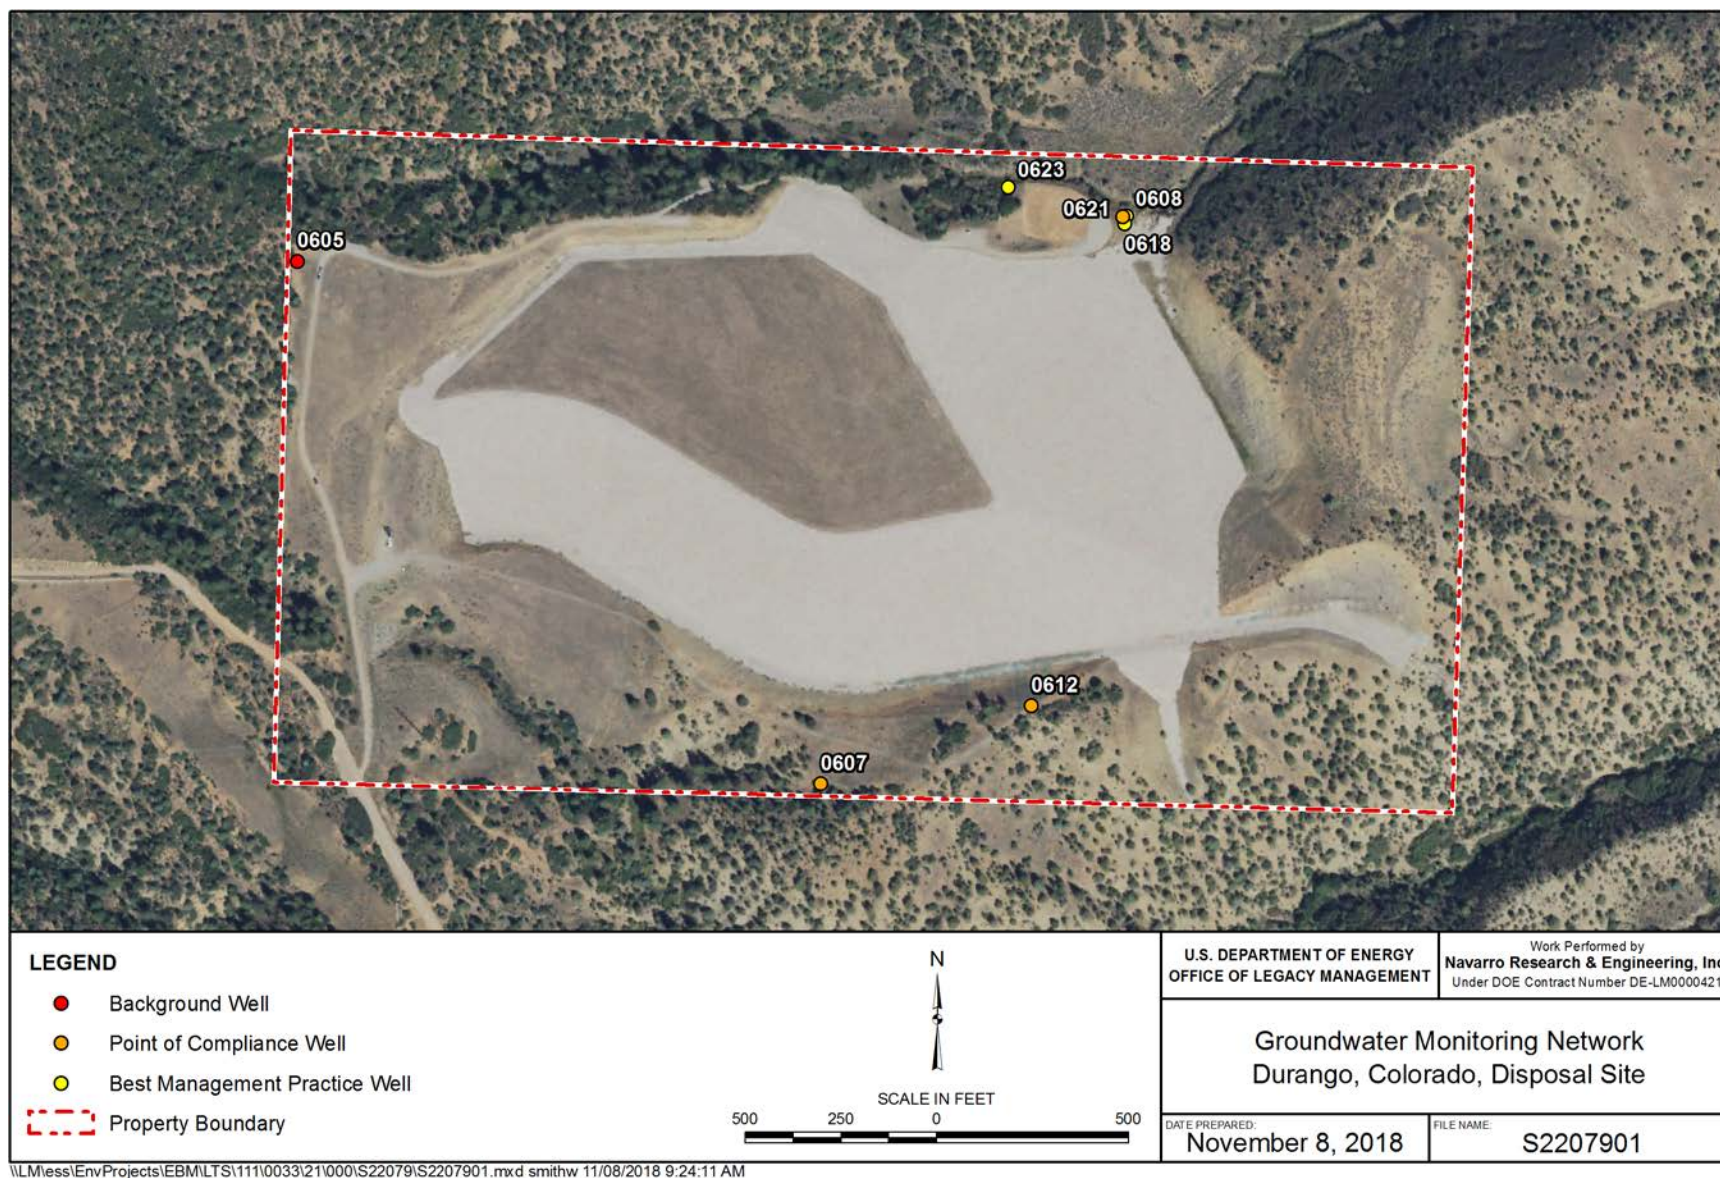
Figure 4-2. Groundwater Monitoring Network for the Durango, Colorado, Disposal Site

The LTSP establishes three POC wells at the site. The POC wells are completed in the uppermost aquifer (bedrock of the Cliff House Sandstone and the Menefee Formation) underlying the site. A background well is also completed in the uppermost aquifer. Three additional monitoring wells are completed in the alluvium and monitored as a best management practice. The LTSP describes the Cliff House/Menefee aquifer as the uppermost aquifer because of the limited area of the alluvial system saturation under natural conditions beneath the disposal cell. Previous annual site inspections have not identified any discharge of alluvial groundwater to the surface, and discharge of alluvial groundwater to the surface was not detected in 2018. Table 4-2 and Figure 4-2 show the current groundwater monitoring network at the site.

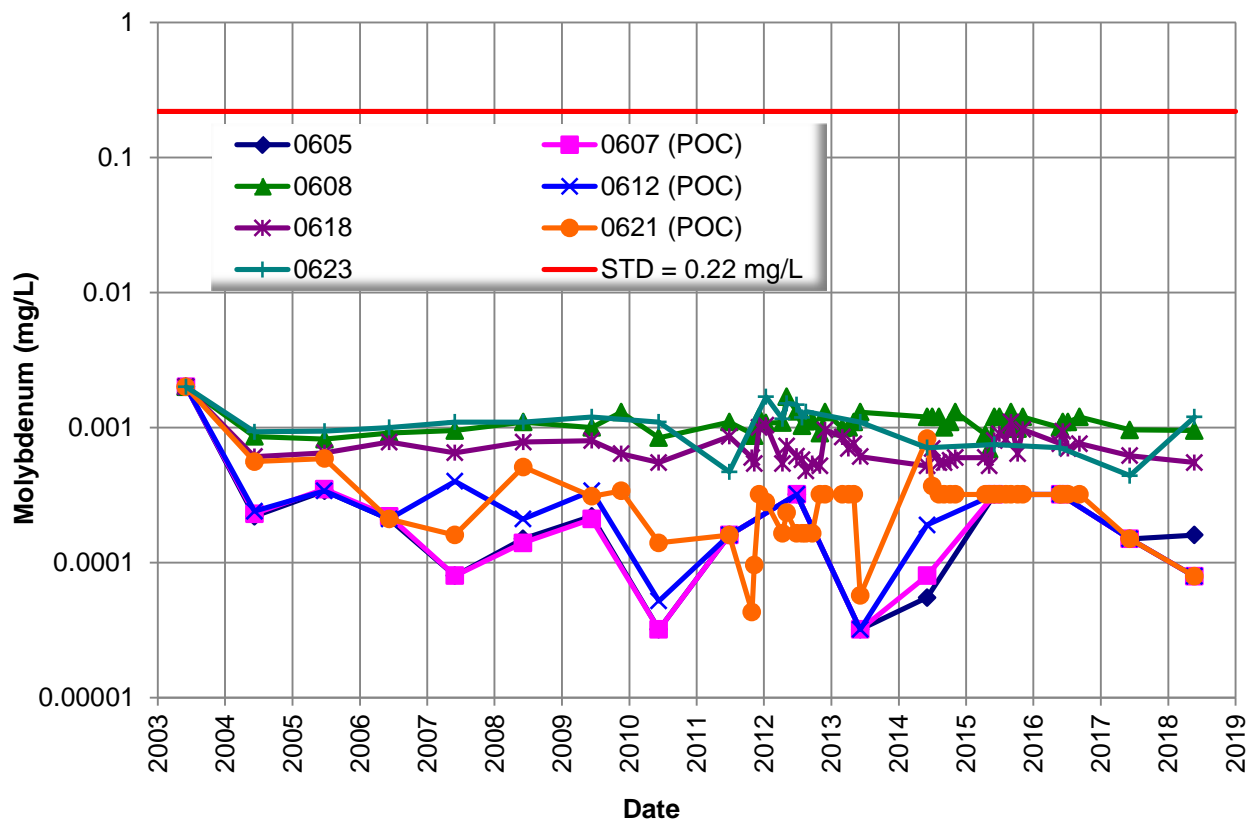
Figure 4-3. Molybdenum in Groundwater at the Durango, Colorado, Disposal Site

Molybdenum, selenium, and uranium concentrations in POC wells (0607, 0612, and 0621) in the uppermost aquifer are below the respective standards. Therefore, disposal cell performance remains unaffected.

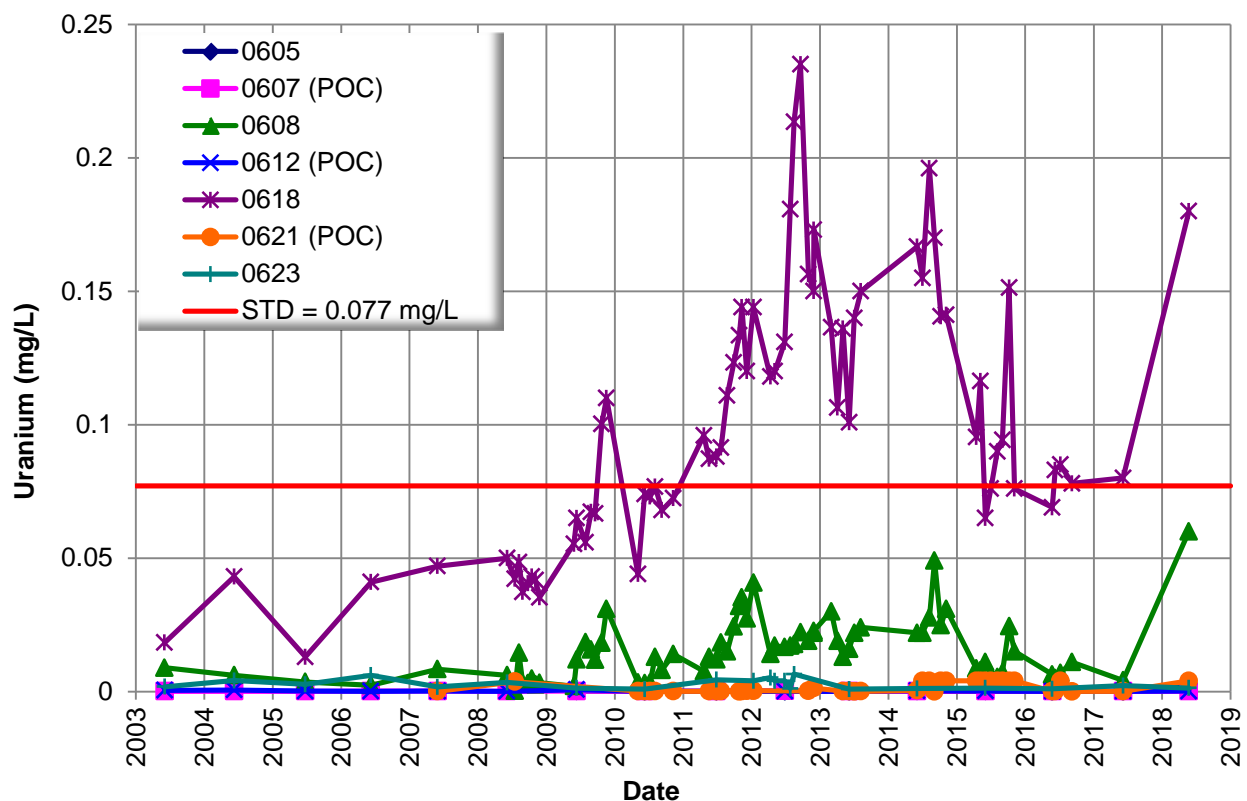
Figure 4-5. Uranium in Groundwater at the Durango, Colorado, Disposal Site

Wells completed in the alluvium are sampled as a best management practice. Uranium concentrations in well 0618 have consistently been higher than concentrations in the other wells onsite. To monitor and compare the elevated and variable uranium concentrations observed in this well, wells 0608, 0618, and 0621 are sampled monthly as weather permits. Figure 4-5 shows an overall decreasing trend in uranium concentrations in well 0618 from 2014 to 2017, with concentrations varying around 0.08 milligrams per liter (mg/L). In 2018, uranium concentrations in well 0618 increased from 0.08 mg/L to 0.18 mg/L, which is within the range of measured historical concentrations. Compliance with the LTSP is not affected by this increase or exceedance of the site-specific standard because well 0618 is not a POC well. Investigating the cause of this variability continues.
