4.0 Durango, Colorado, Disposal Site

The U.S. Department of Energy (DOE) Office of Legacy Management (LM) conducted the Durango, Colorado, Uranium Mill Tailings Radiation Control Act (UMTRCA) Title I Disposal Site (site) annual inspection on May 13, 2019, and the annual groundwater monitoring event in May 2018. No cause for a follow-up inspection was identified.

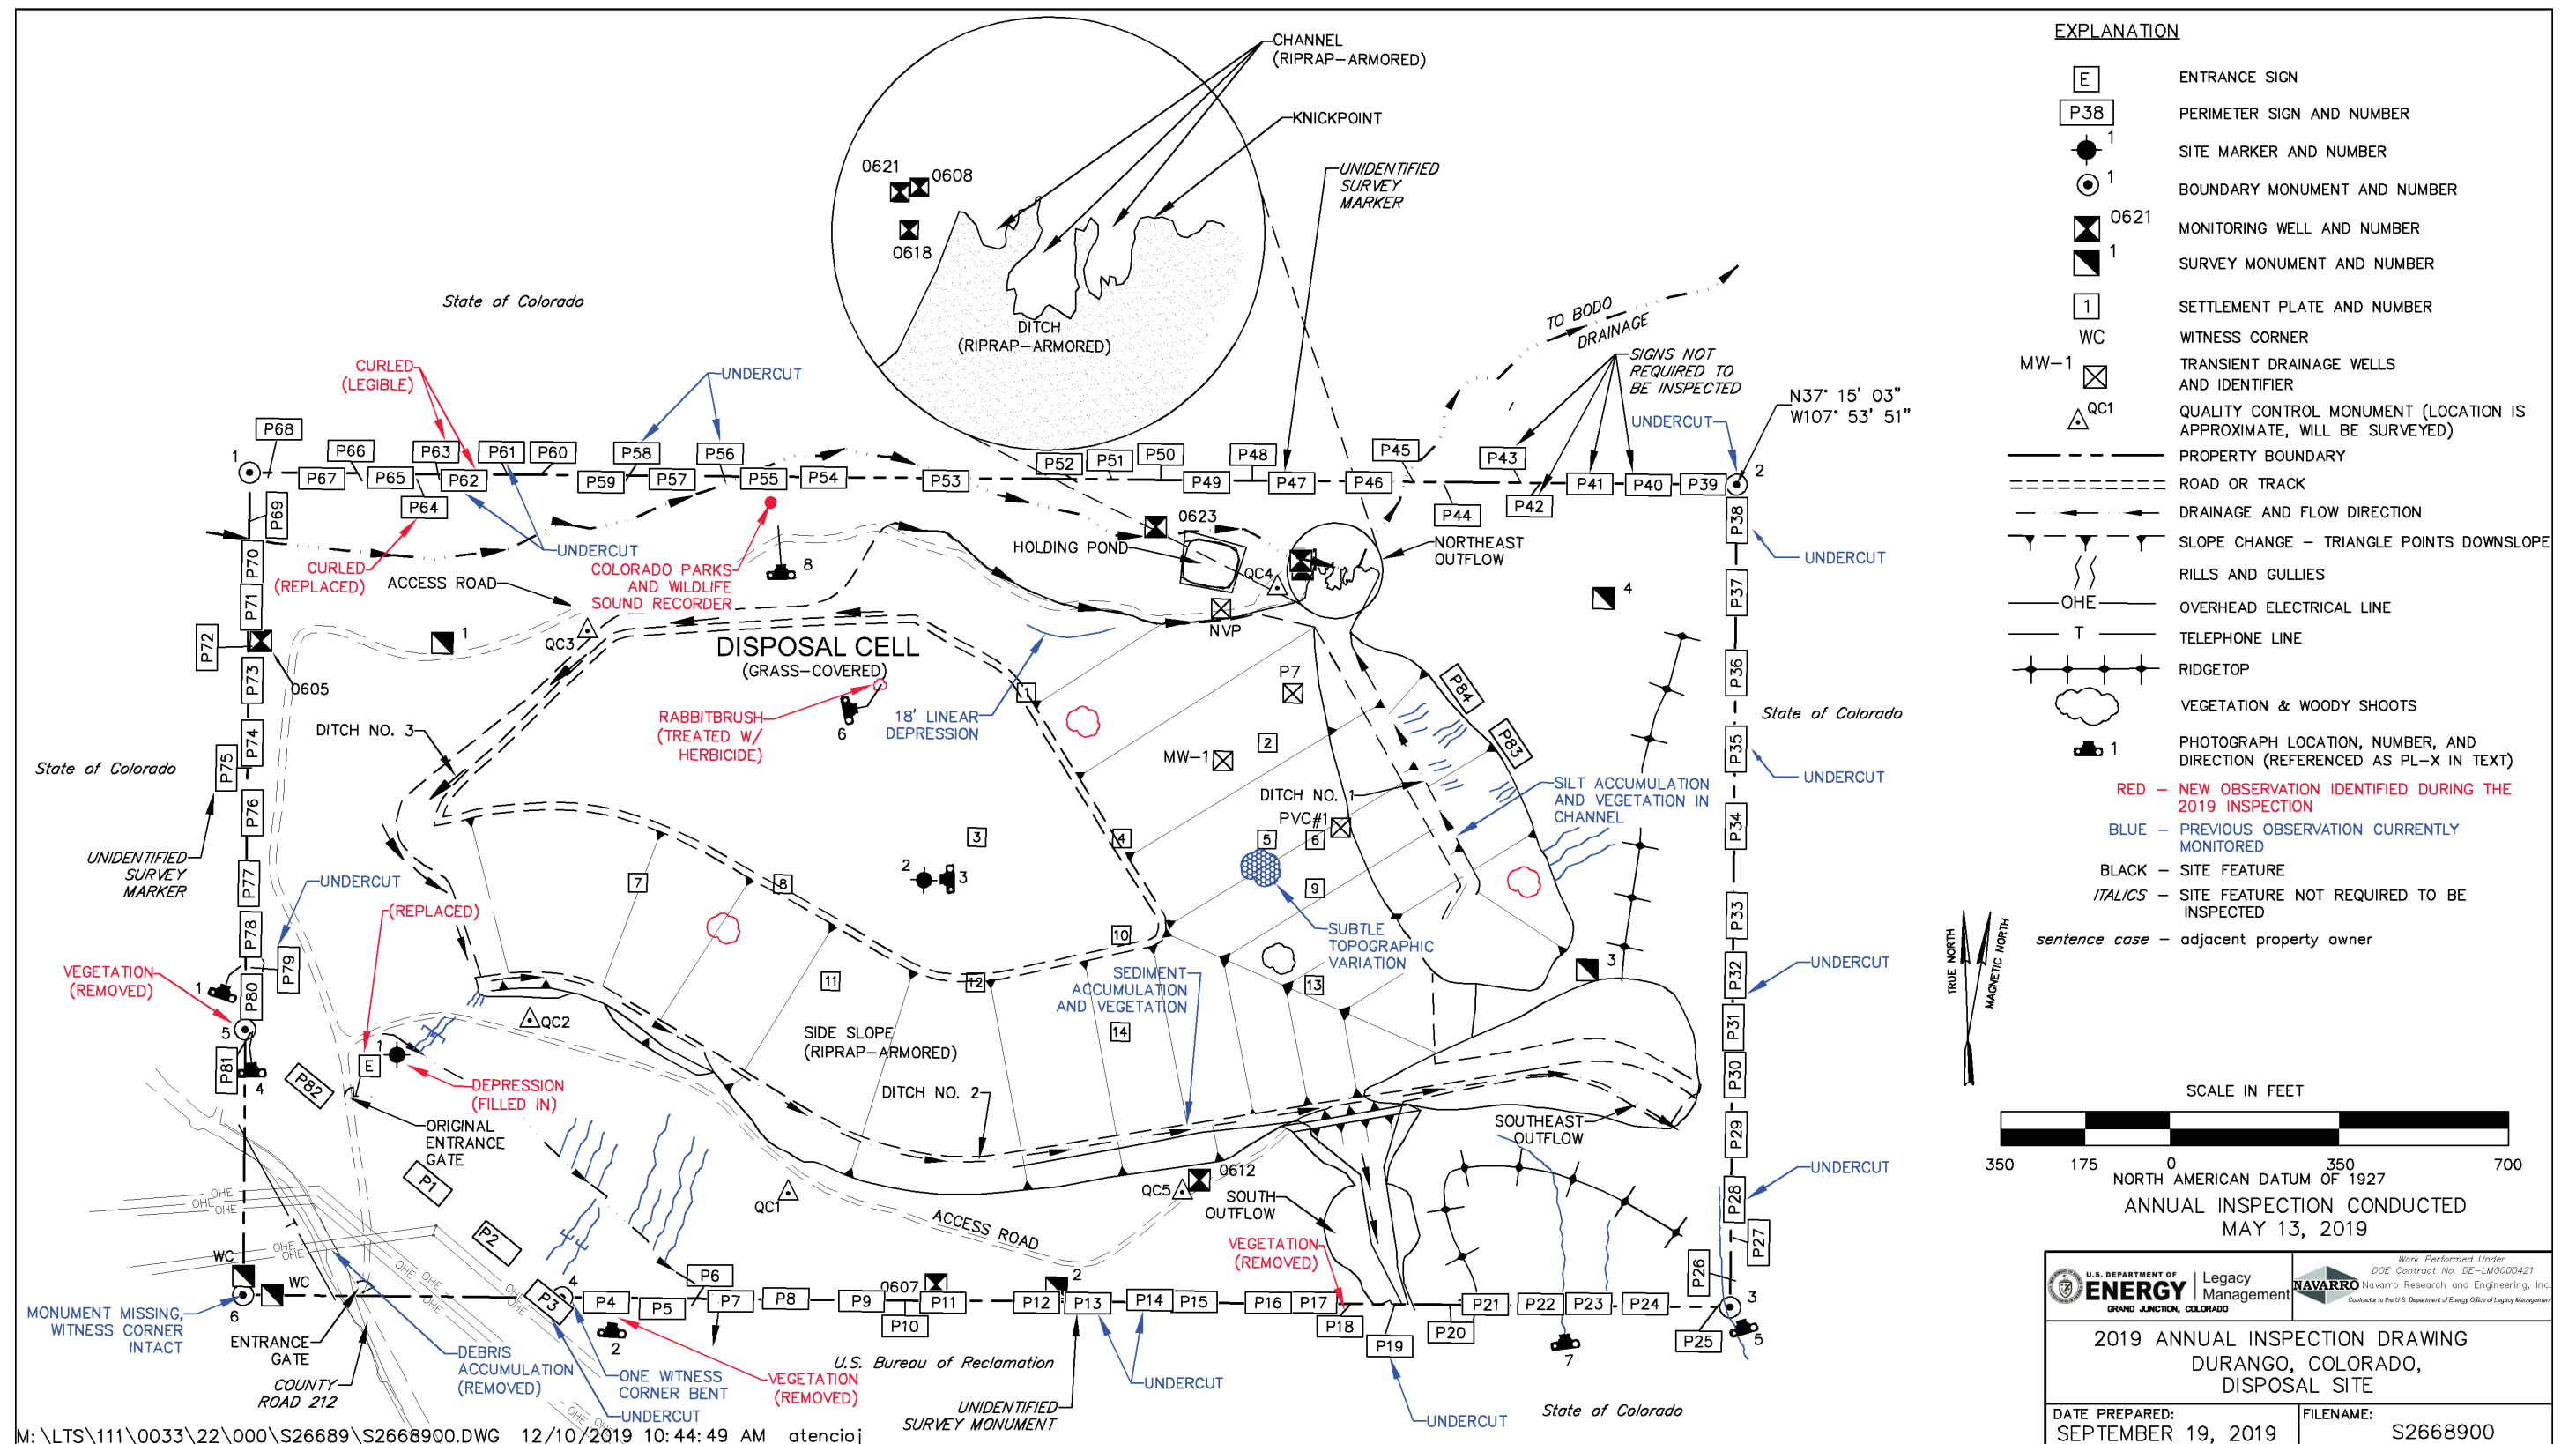
Figure 4-1. 2019 Annual Inspection Drawing for the Durango, Colorado, Disposal Site

Figure 4-1 shows the locations of site features in black, including site surveillance features and inspection areas. Site features that are present but not required by the LTSP to be inspected are shown in italic font. Observations from previous inspections that are currently monitored are shown in blue text, and new observations identified during the 2019 annual inspection are shown in red. Inspection results and recommended maintenance activities associated with site surveillance features are described in the following subsections. Photographs to support specific observations are identified in the text and in Figure 4-1 by photograph location (PL) numbers. The photographs and photograph log are presented in Section 4.11.

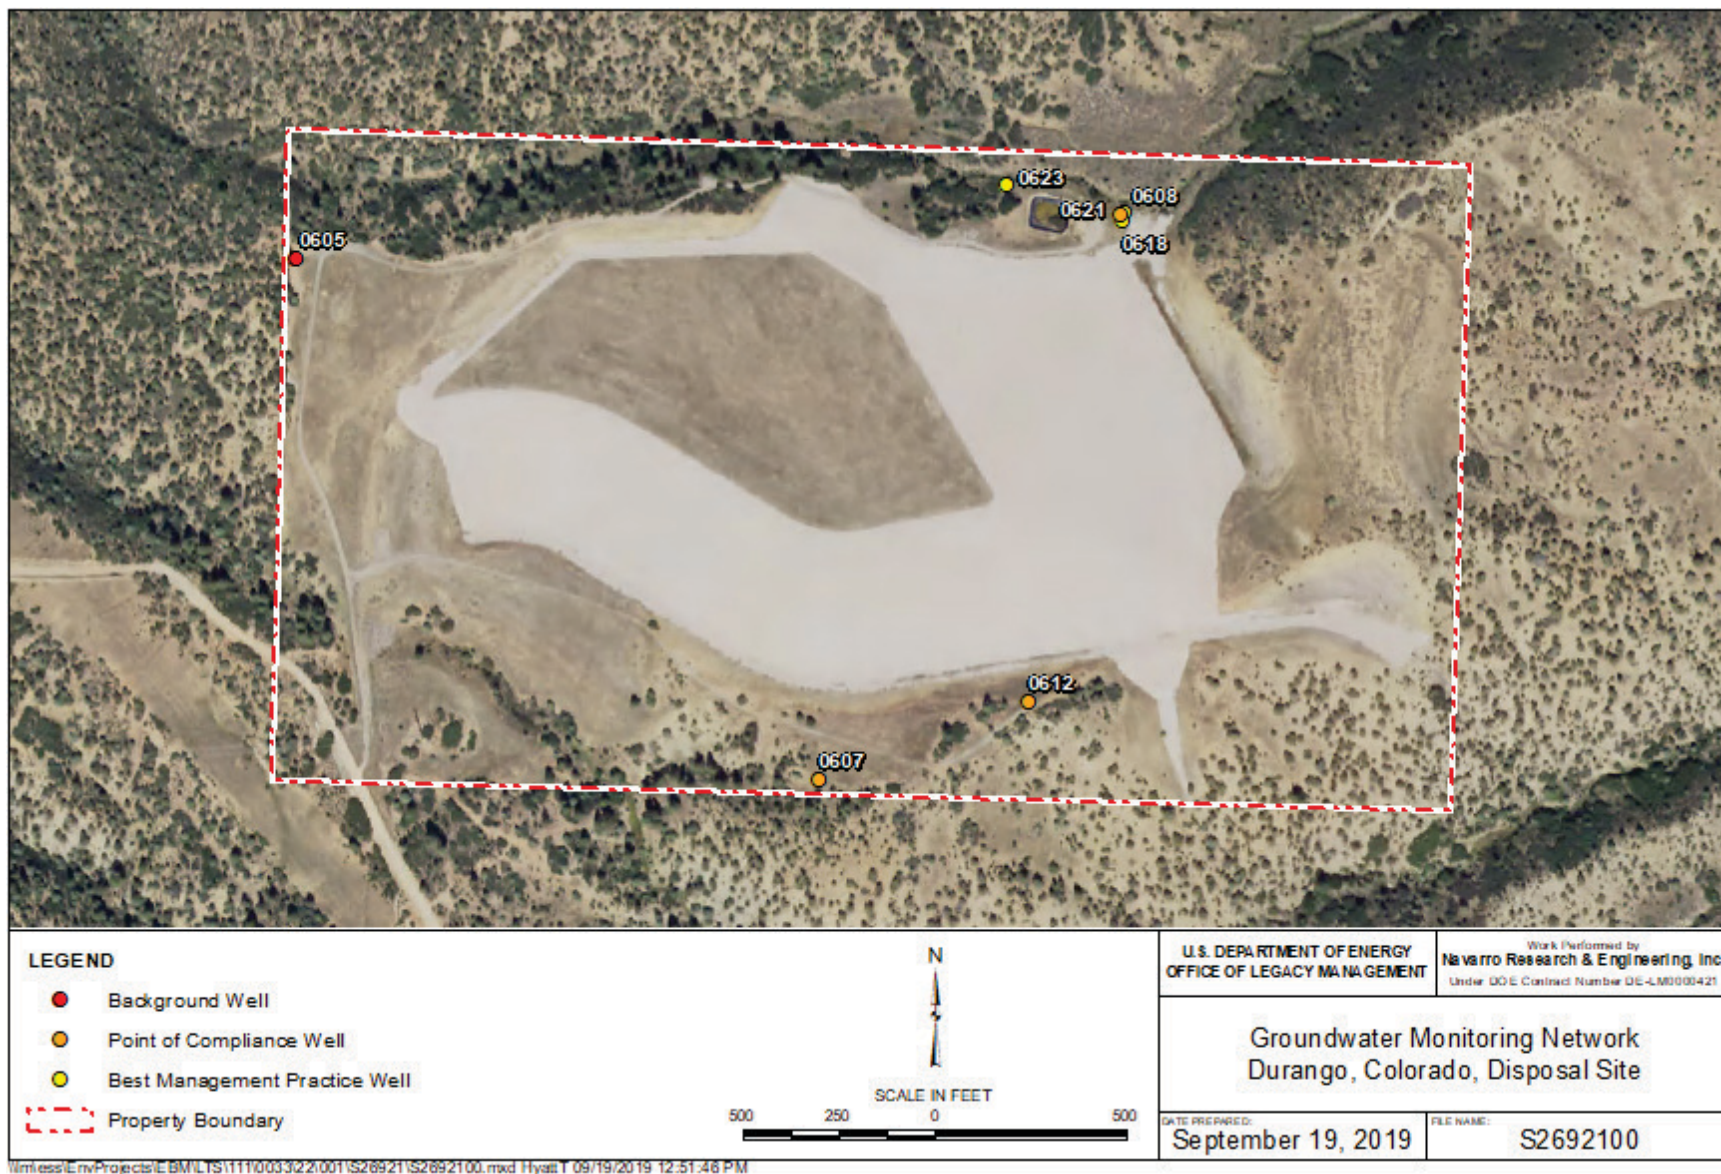
Figure 4-2. Groundwater Monitoring Network for the Durango, Colorado, Disposal Site

Table 4-2 and Figure 4-2 show the current groundwater monitoring network at the site.

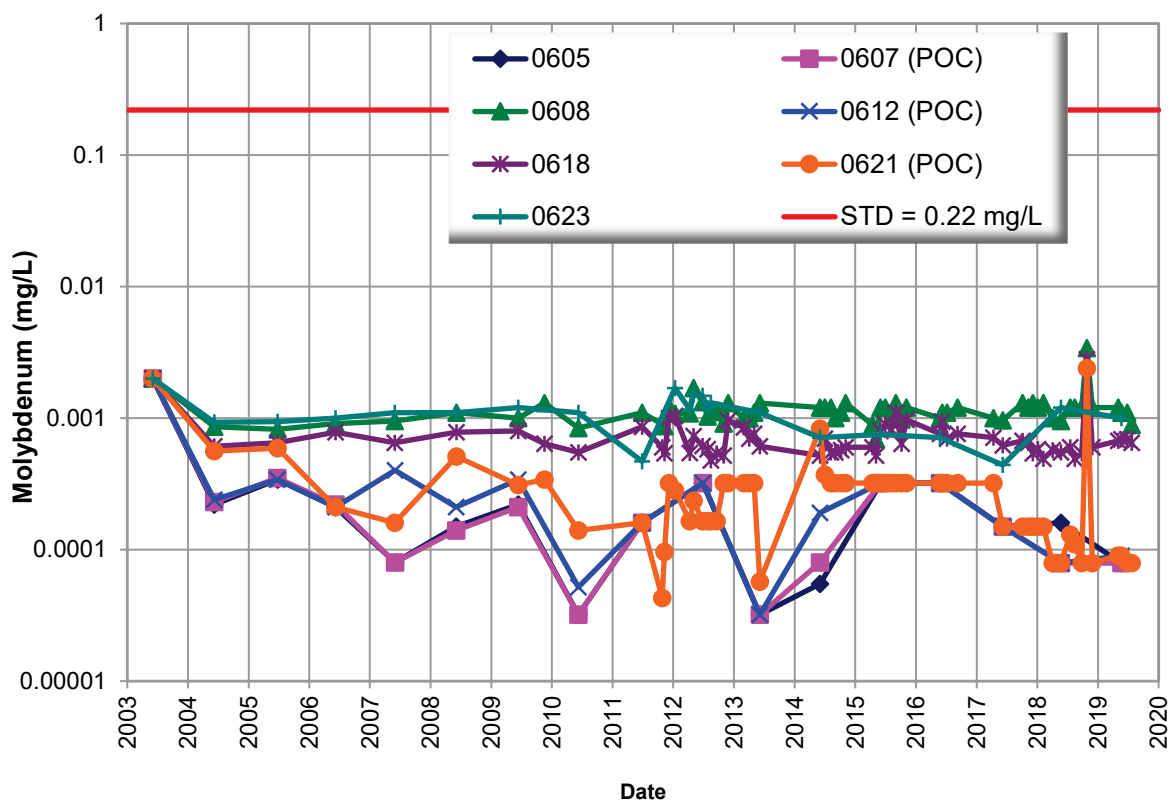
Figure 4-3. Molybdenum in Groundwater at the Durango, Colorado, Disposal Site

LM conducts annual groundwater sampling and analysis to monitor potential contaminant migration downgradient from the disposal cell. The most recent annual sampling event occurred in May 2019. Concentrations in the three point-of-compliance (POC) wells are below site-specific thresholds. In addition, LM monitors one background well and three best management practice (BMP) wells or noncompliance wells. BMP well 0618 is monitored more frequently in response to variable uranium concentrations that are typically above site-specific thresholds. Increased monitoring of BMP well 0618 will continue to assess any influence from the holding pond removal and transient drainage system closure.
