12.0 Mexican Hat, Utah, Disposal Site

12.1 Compliance Summary

The Mexican Hat, Utah, Uranium Mill Tailings Radiation Control Act (UMTRCA) Title I Disposal Site was inspected on August 8, 2023.

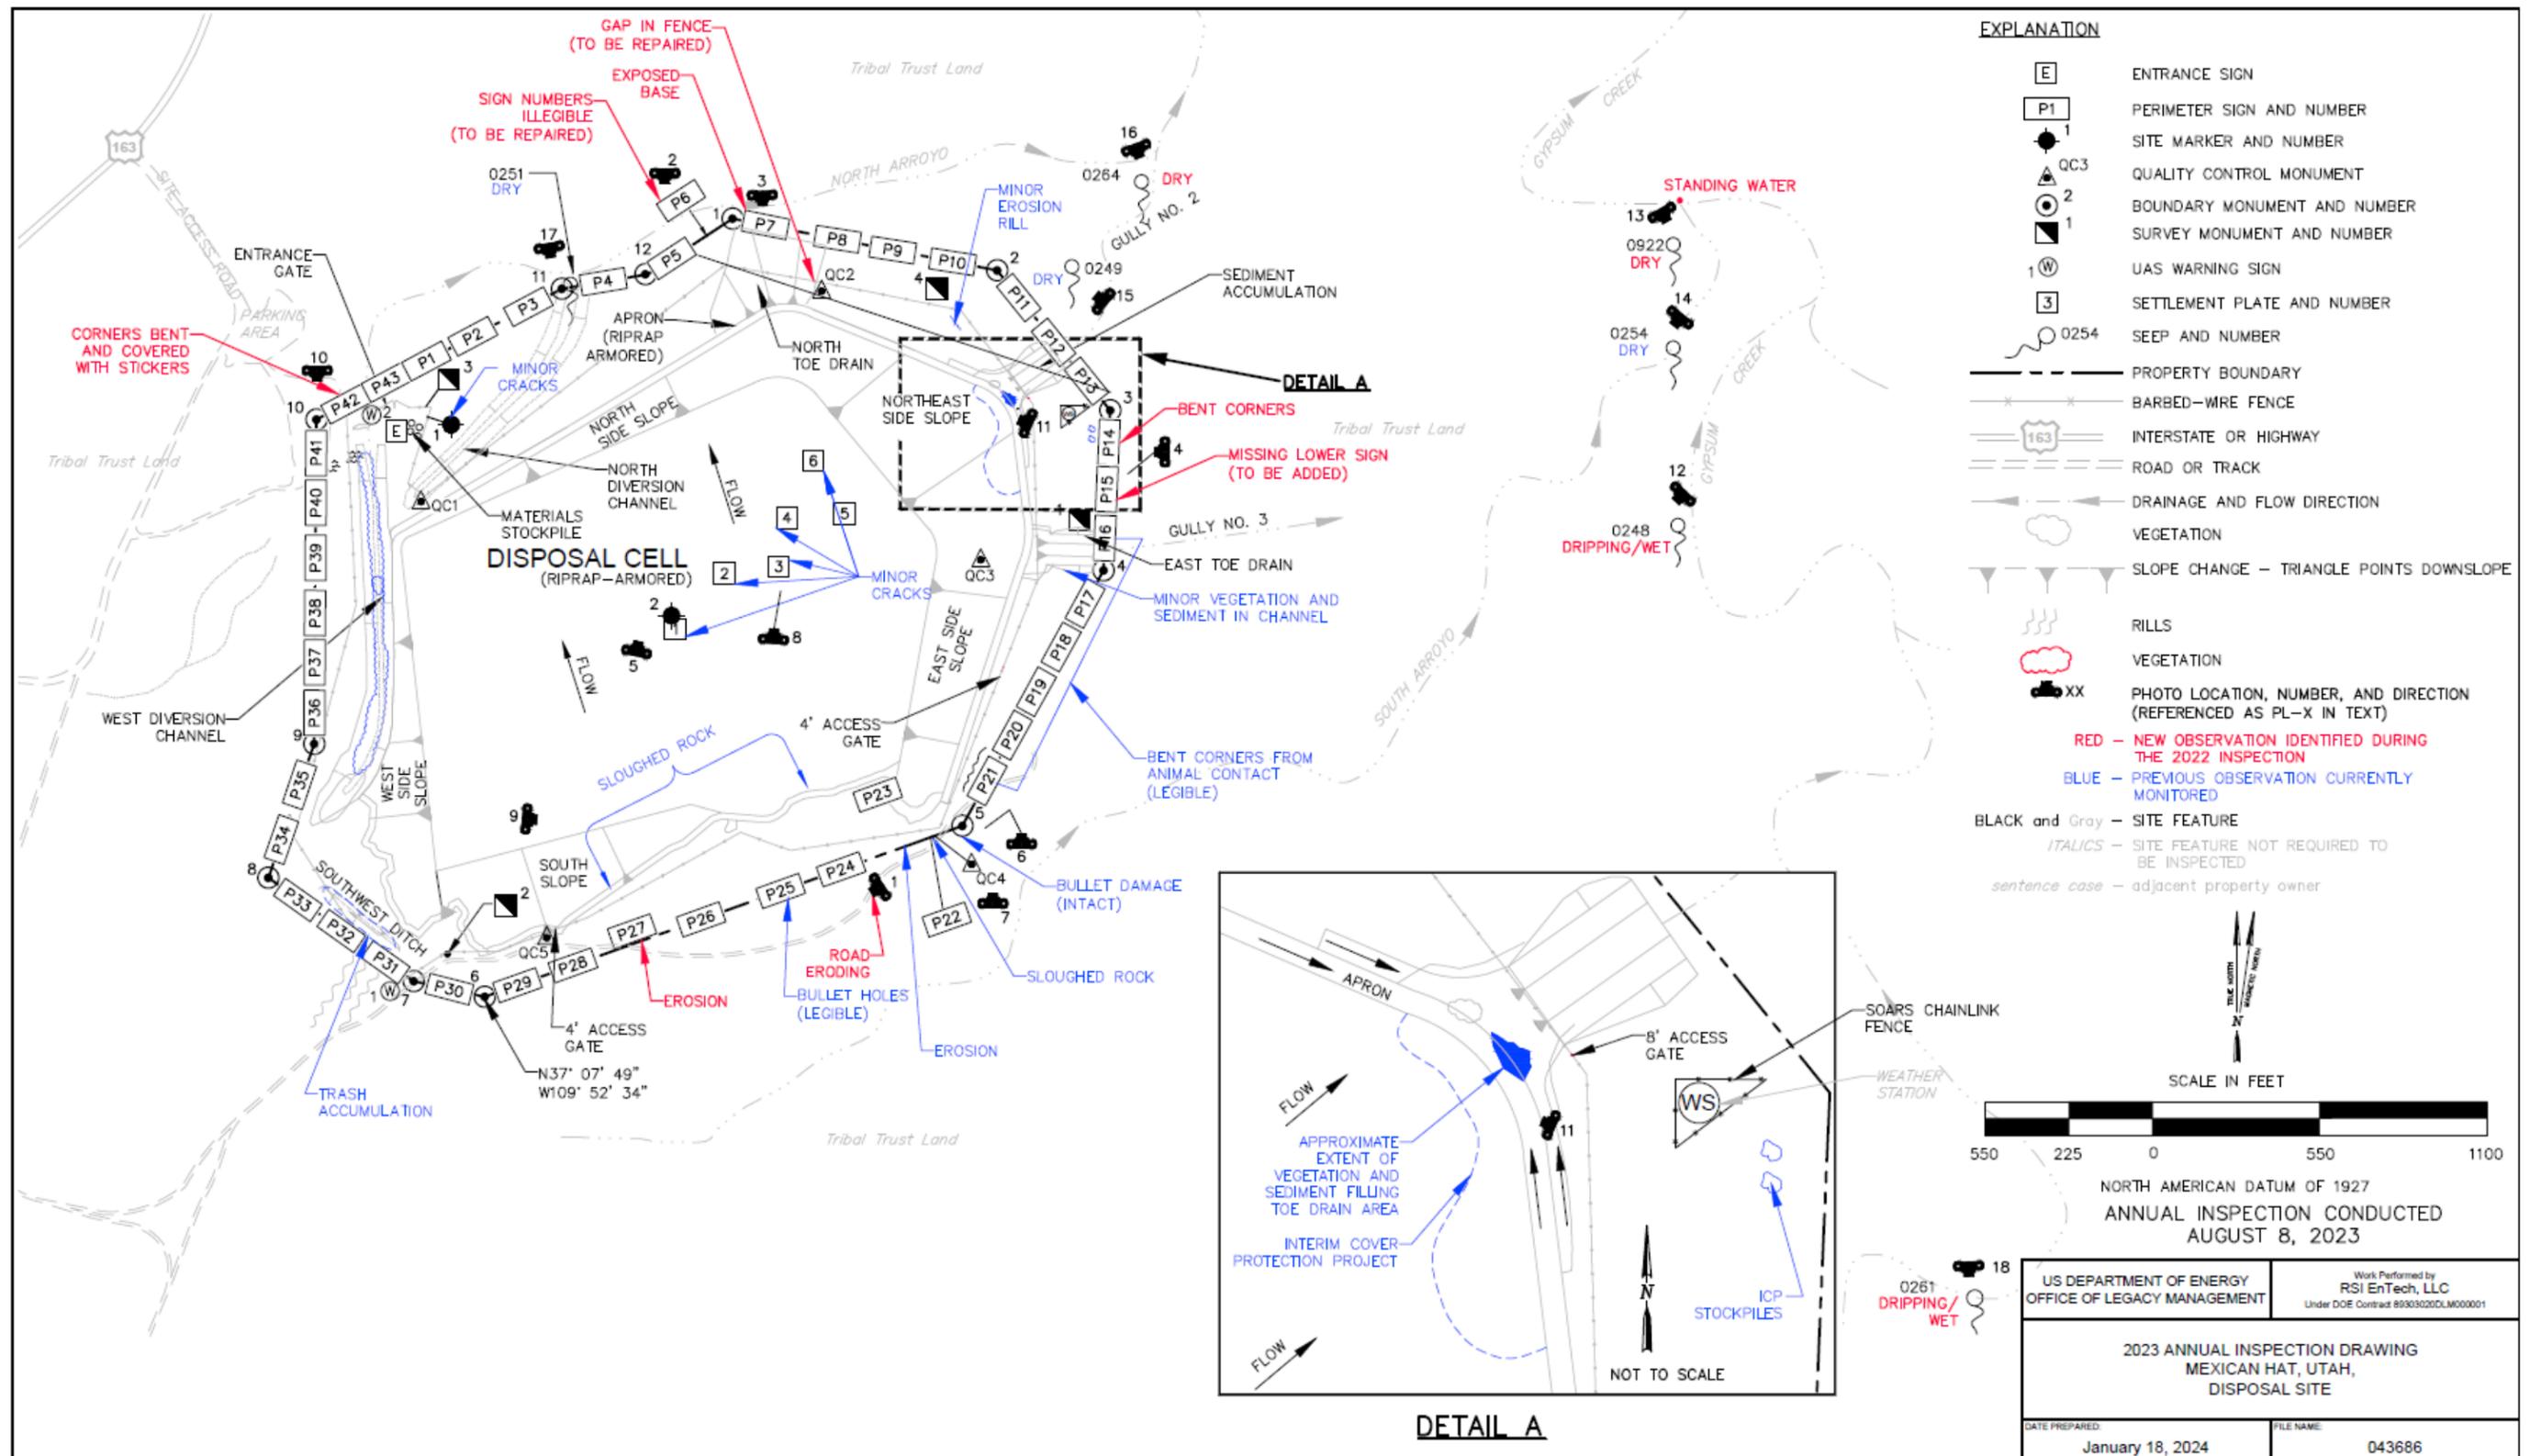
Figure 12-1. 2023 Annual Inspection Drawing for the Mexican Hat, Utah, Disposal Site

Figure 12-1 shows the locations of site features, including site surveillance features and inspection areas, in black and gray font. Some site features that are present but not required to be inspected are shown in italic font. Observations from previous inspections that are currently monitored are shown in blue, and new observations identified during the 2023 annual inspection are shown in red. Inspection results and recommended maintenance activities associated with site surveillance features are described in the following subsections. Photographs to support specific observations are noted in the text and in Figure 12-1 by photograph location (PL) numbers. The photographs and photograph log are presented in Section 12.10.

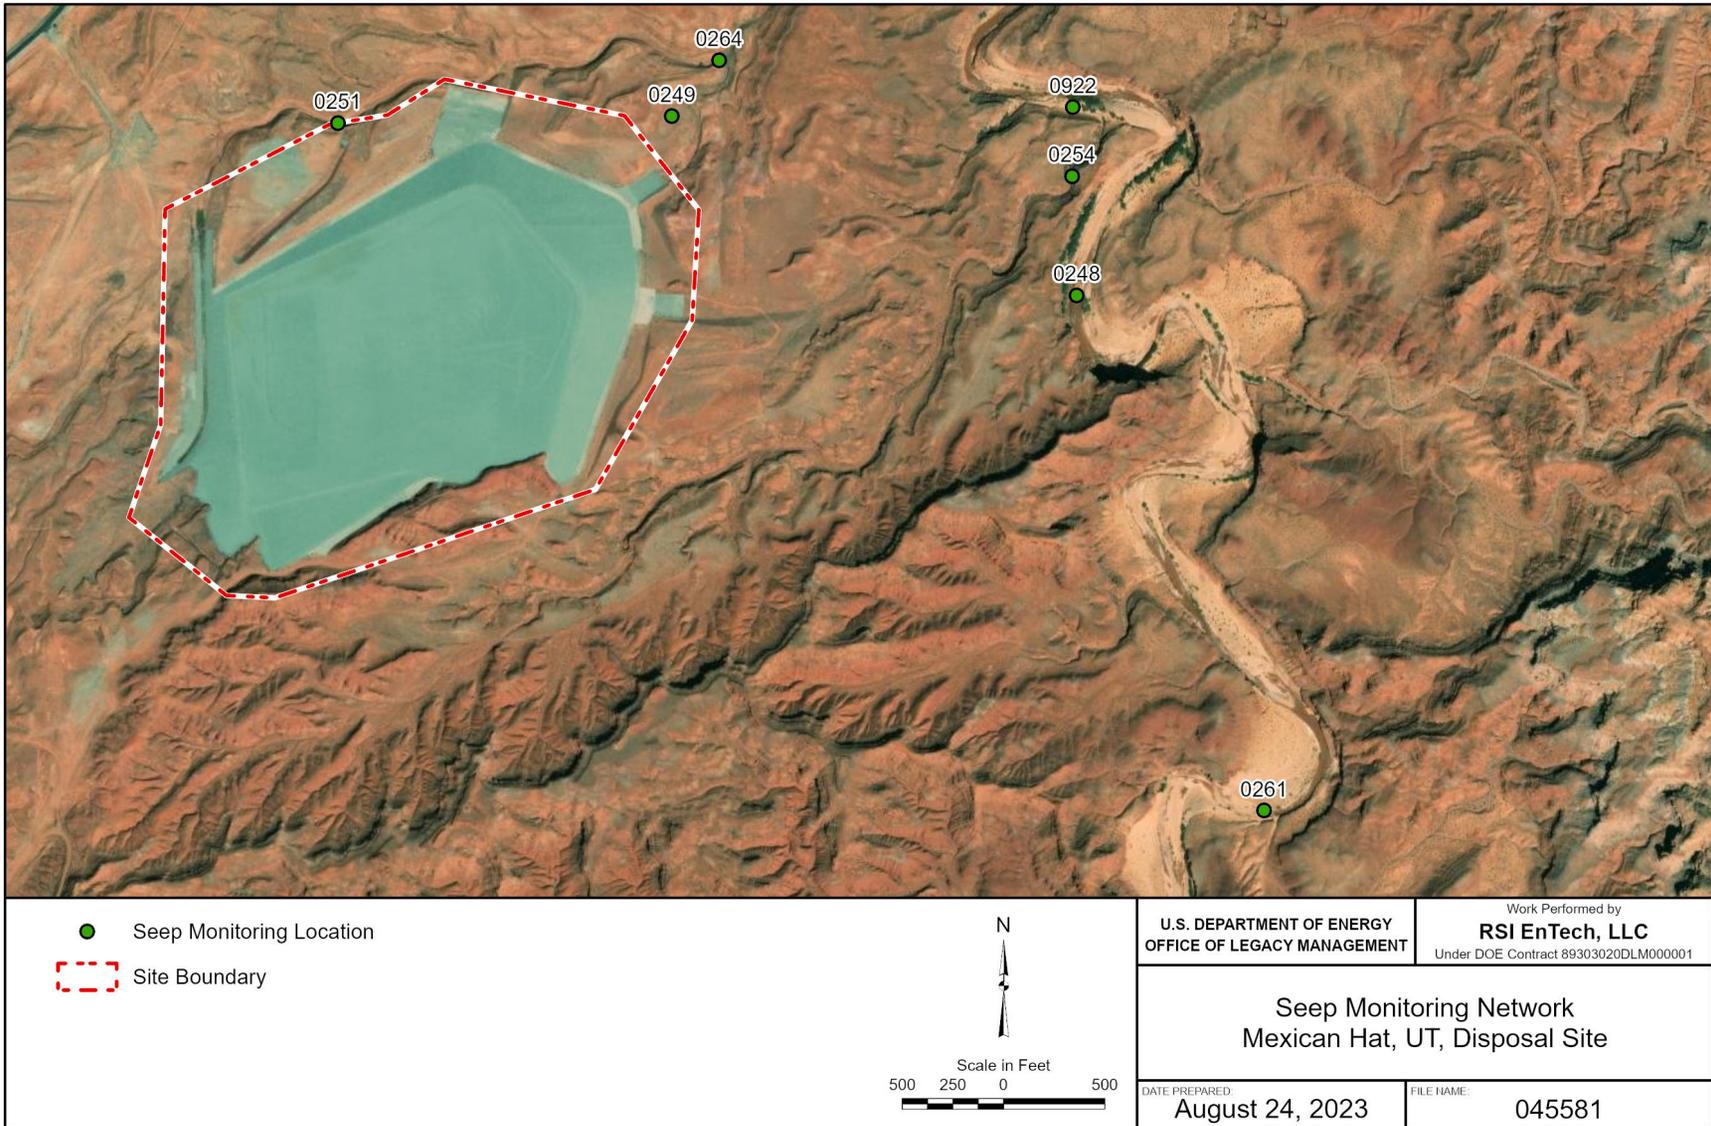
Figure 12-2. Seep Monitoring Locations at the Mexican Hat, Utah, Disposal Site

Table 12-2 documents the conditions of each monitored seep observed during the inspection with the respective drainage in which each seep occurs and a reference to photographic documentation.
