8.0 Gunnison, Colorado, Disposal Site

8.1 Compliance Summary

The Gunnison, Colorado, Uranium Mill Tailings Radiation Control Act (UMTRCA) Title I Disposal Site, was inspected on June 3, 2008. The disposal cell and all associated surface water diversion and drainage structures were in excellent condition and functioning as designed. Six riprap test areas on the cell apron and diversion ditches were visually inspected; no apparent rock degradation was noted when compared to previous photos. A deep-rooted shrub was removed from the top of the disposal cell. The perimeter fence was repaired at several locations from damage caused by significant snow accumulations during the winter. Several damaged and missing perimeter signs were replaced. Snowmelt runoff resulted in minor erosion near the southeast corner of the site; repair is not warranted at this time. No other maintenance needs or cause for a follow-up or contingency inspection was identified.

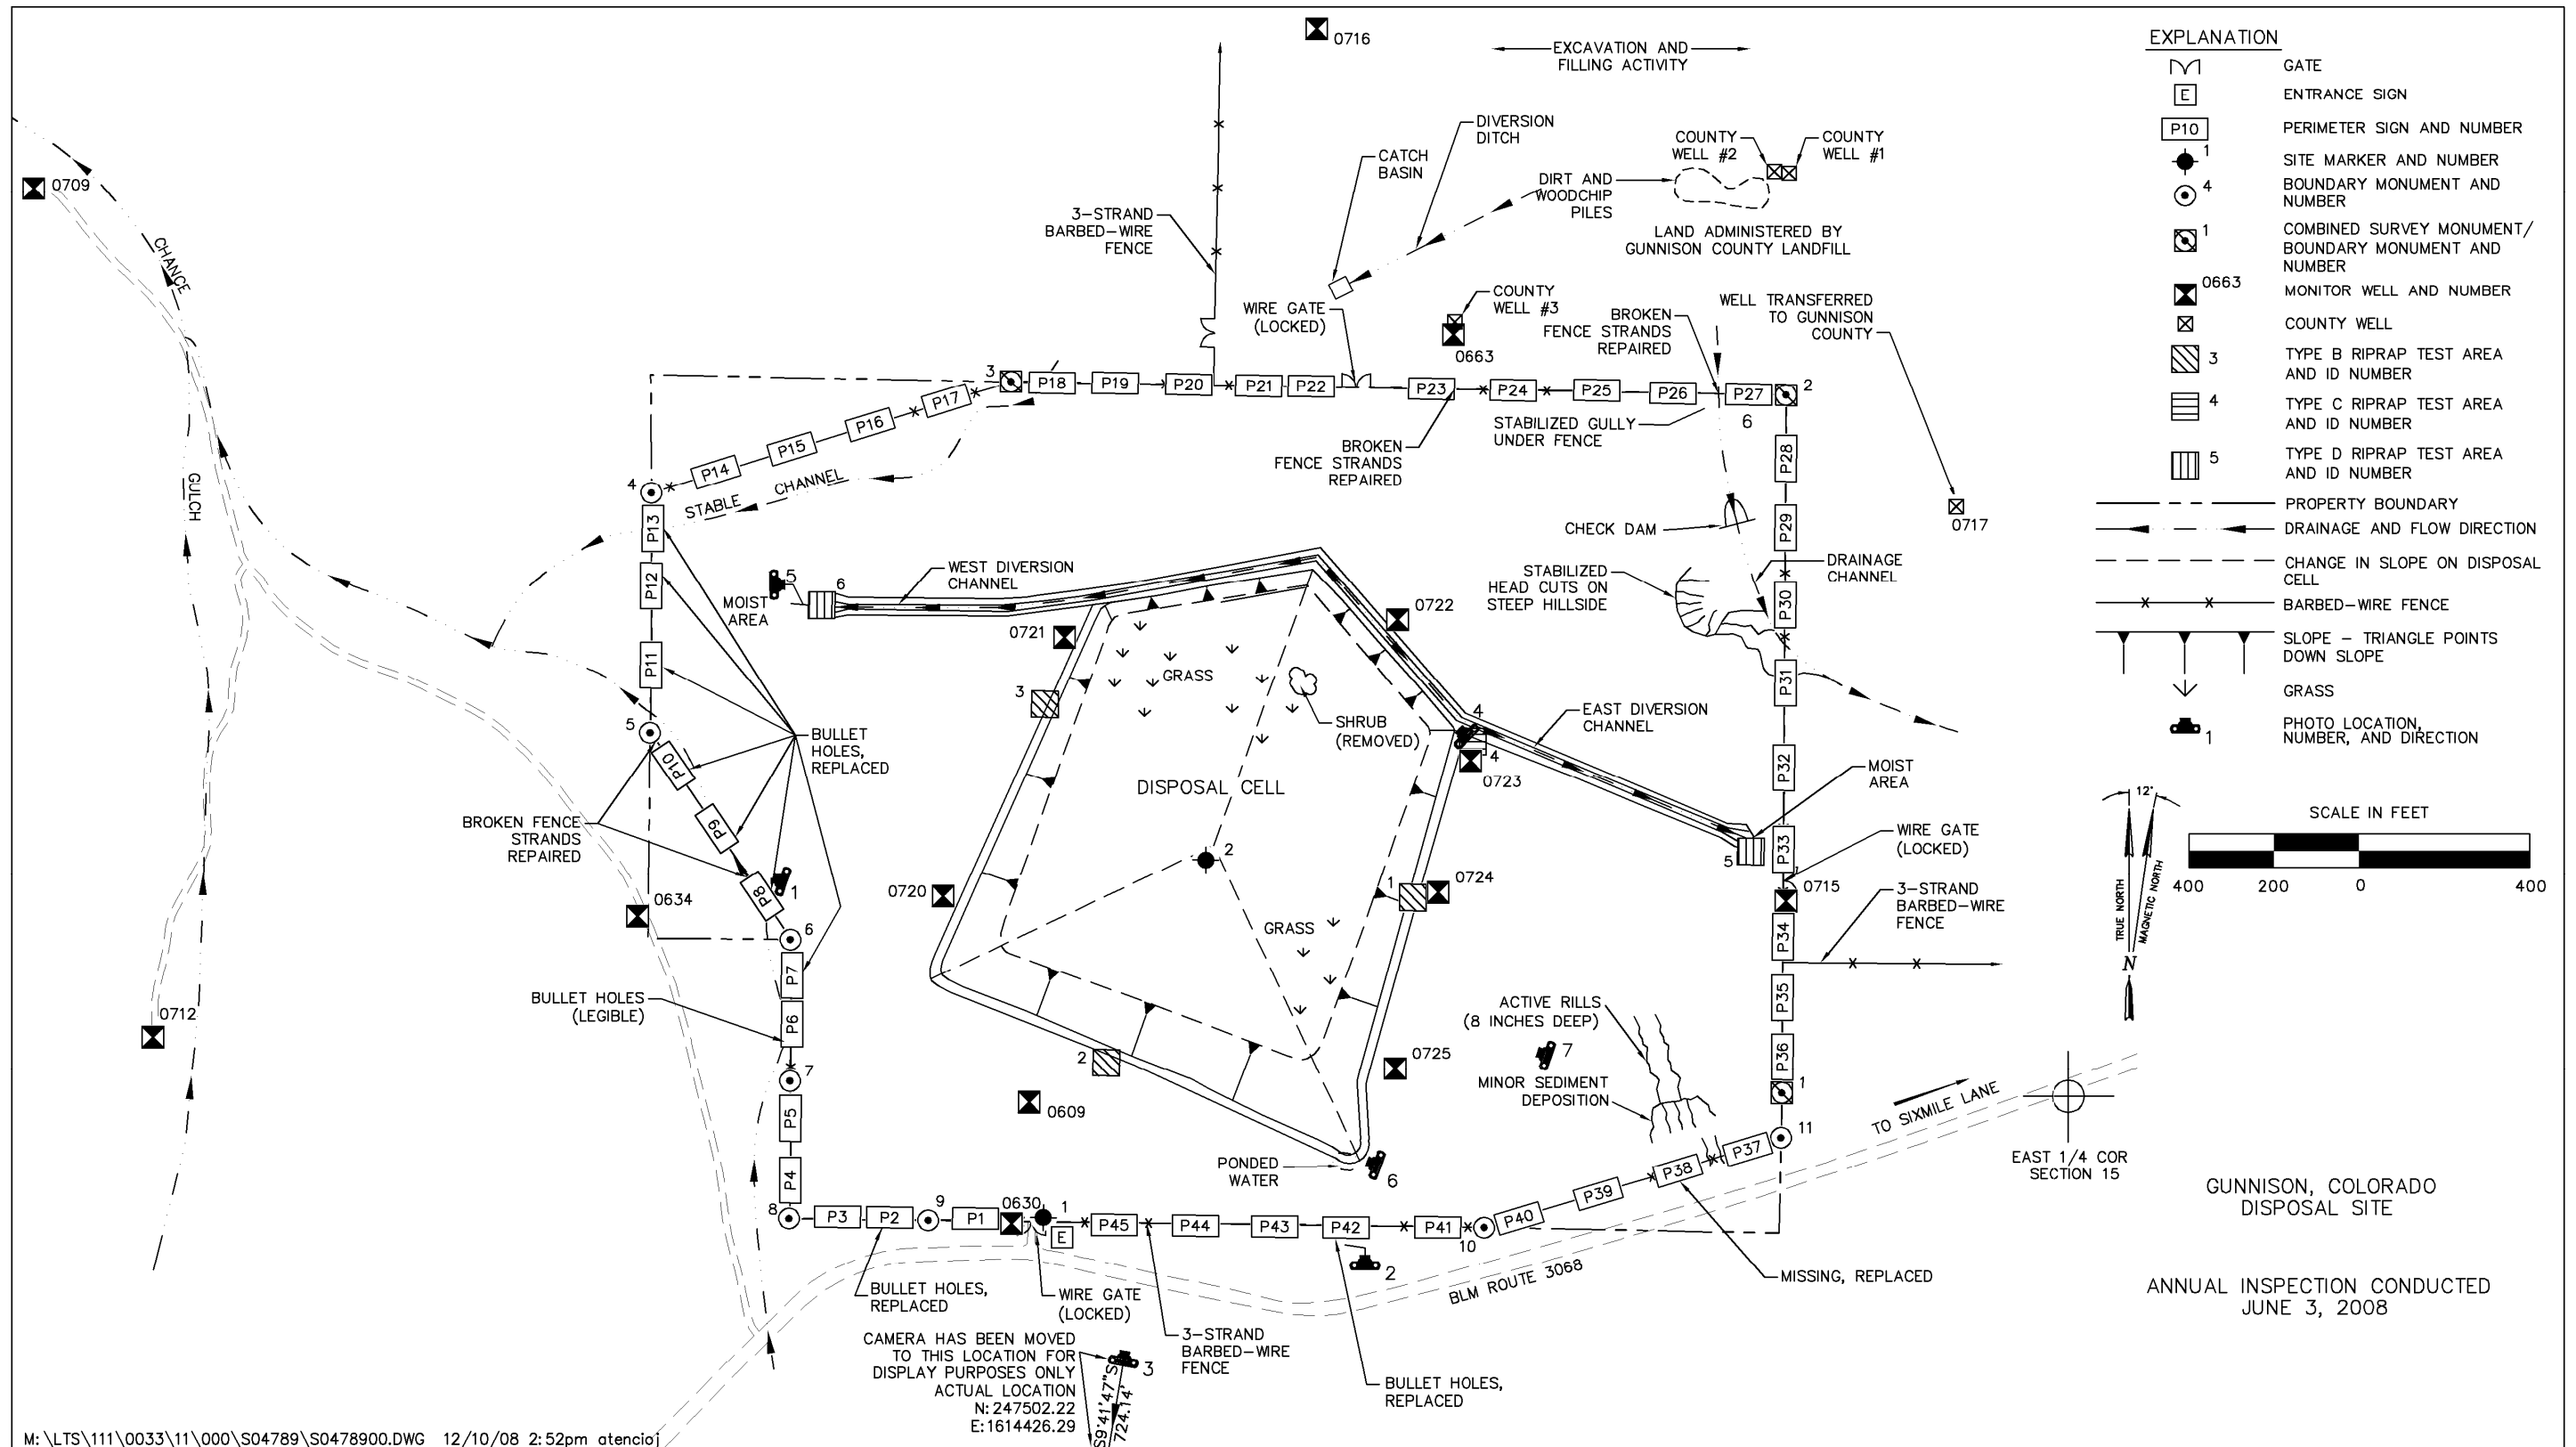
Figure 8-1. 2008 Annual Compliance Drawing for the Gunnison Disposal Site

8A A three-strand, barbed-wire fence delineates the site; most of it is set along the property boundary. Fence strands were broken at several locations along the north and west sides of the site (PL–1). This damage is attributed to the above-average snow accumulation that occurred during the past winter. The broken strands were repaired on June 19, 2008.

8B The entrance sign, located at the south entrance gate, is in good condition. Forty-five perimeter signs are bolted to the perimeter fence posts. Nine perimeter signs (P2, P7, P8, P9, P10, P11, P12, P13, and P42) were heavily damaged by bullets (PL–2), and one perimeter sign (P38) was missing; new signs were installed at these locations on June 19, 2008. The remaining signs were in good condition.

8C Top of Disposal Cell—The top of the disposal cell was in excellent condition. There was no evidence of erosion, settling, slumping, or rock degradation (PL-3). Several isolated patches of grass were randomly distributed over the disposal cell cover; however, these shallow-rooted plants are not a cause for concern. One small deep-rooted shrub was found on the cell top and was cut and treated with herbicide in accordance with the LTSP. Many small indentations continue to be present on the cell cover. The indentations, with dimensions up to 4 inches across and up to 4 inches deep, appear to have been caused by pronghorn antelope. None of the indentations penetrate into the bedding layer under the rock cover, and they are not a cause for concern.
