## 8.0 Gunnison, Colorado, Disposal Site

### 8.1 Compliance Summary

#### 8.3.1 Annual Inspection and Report

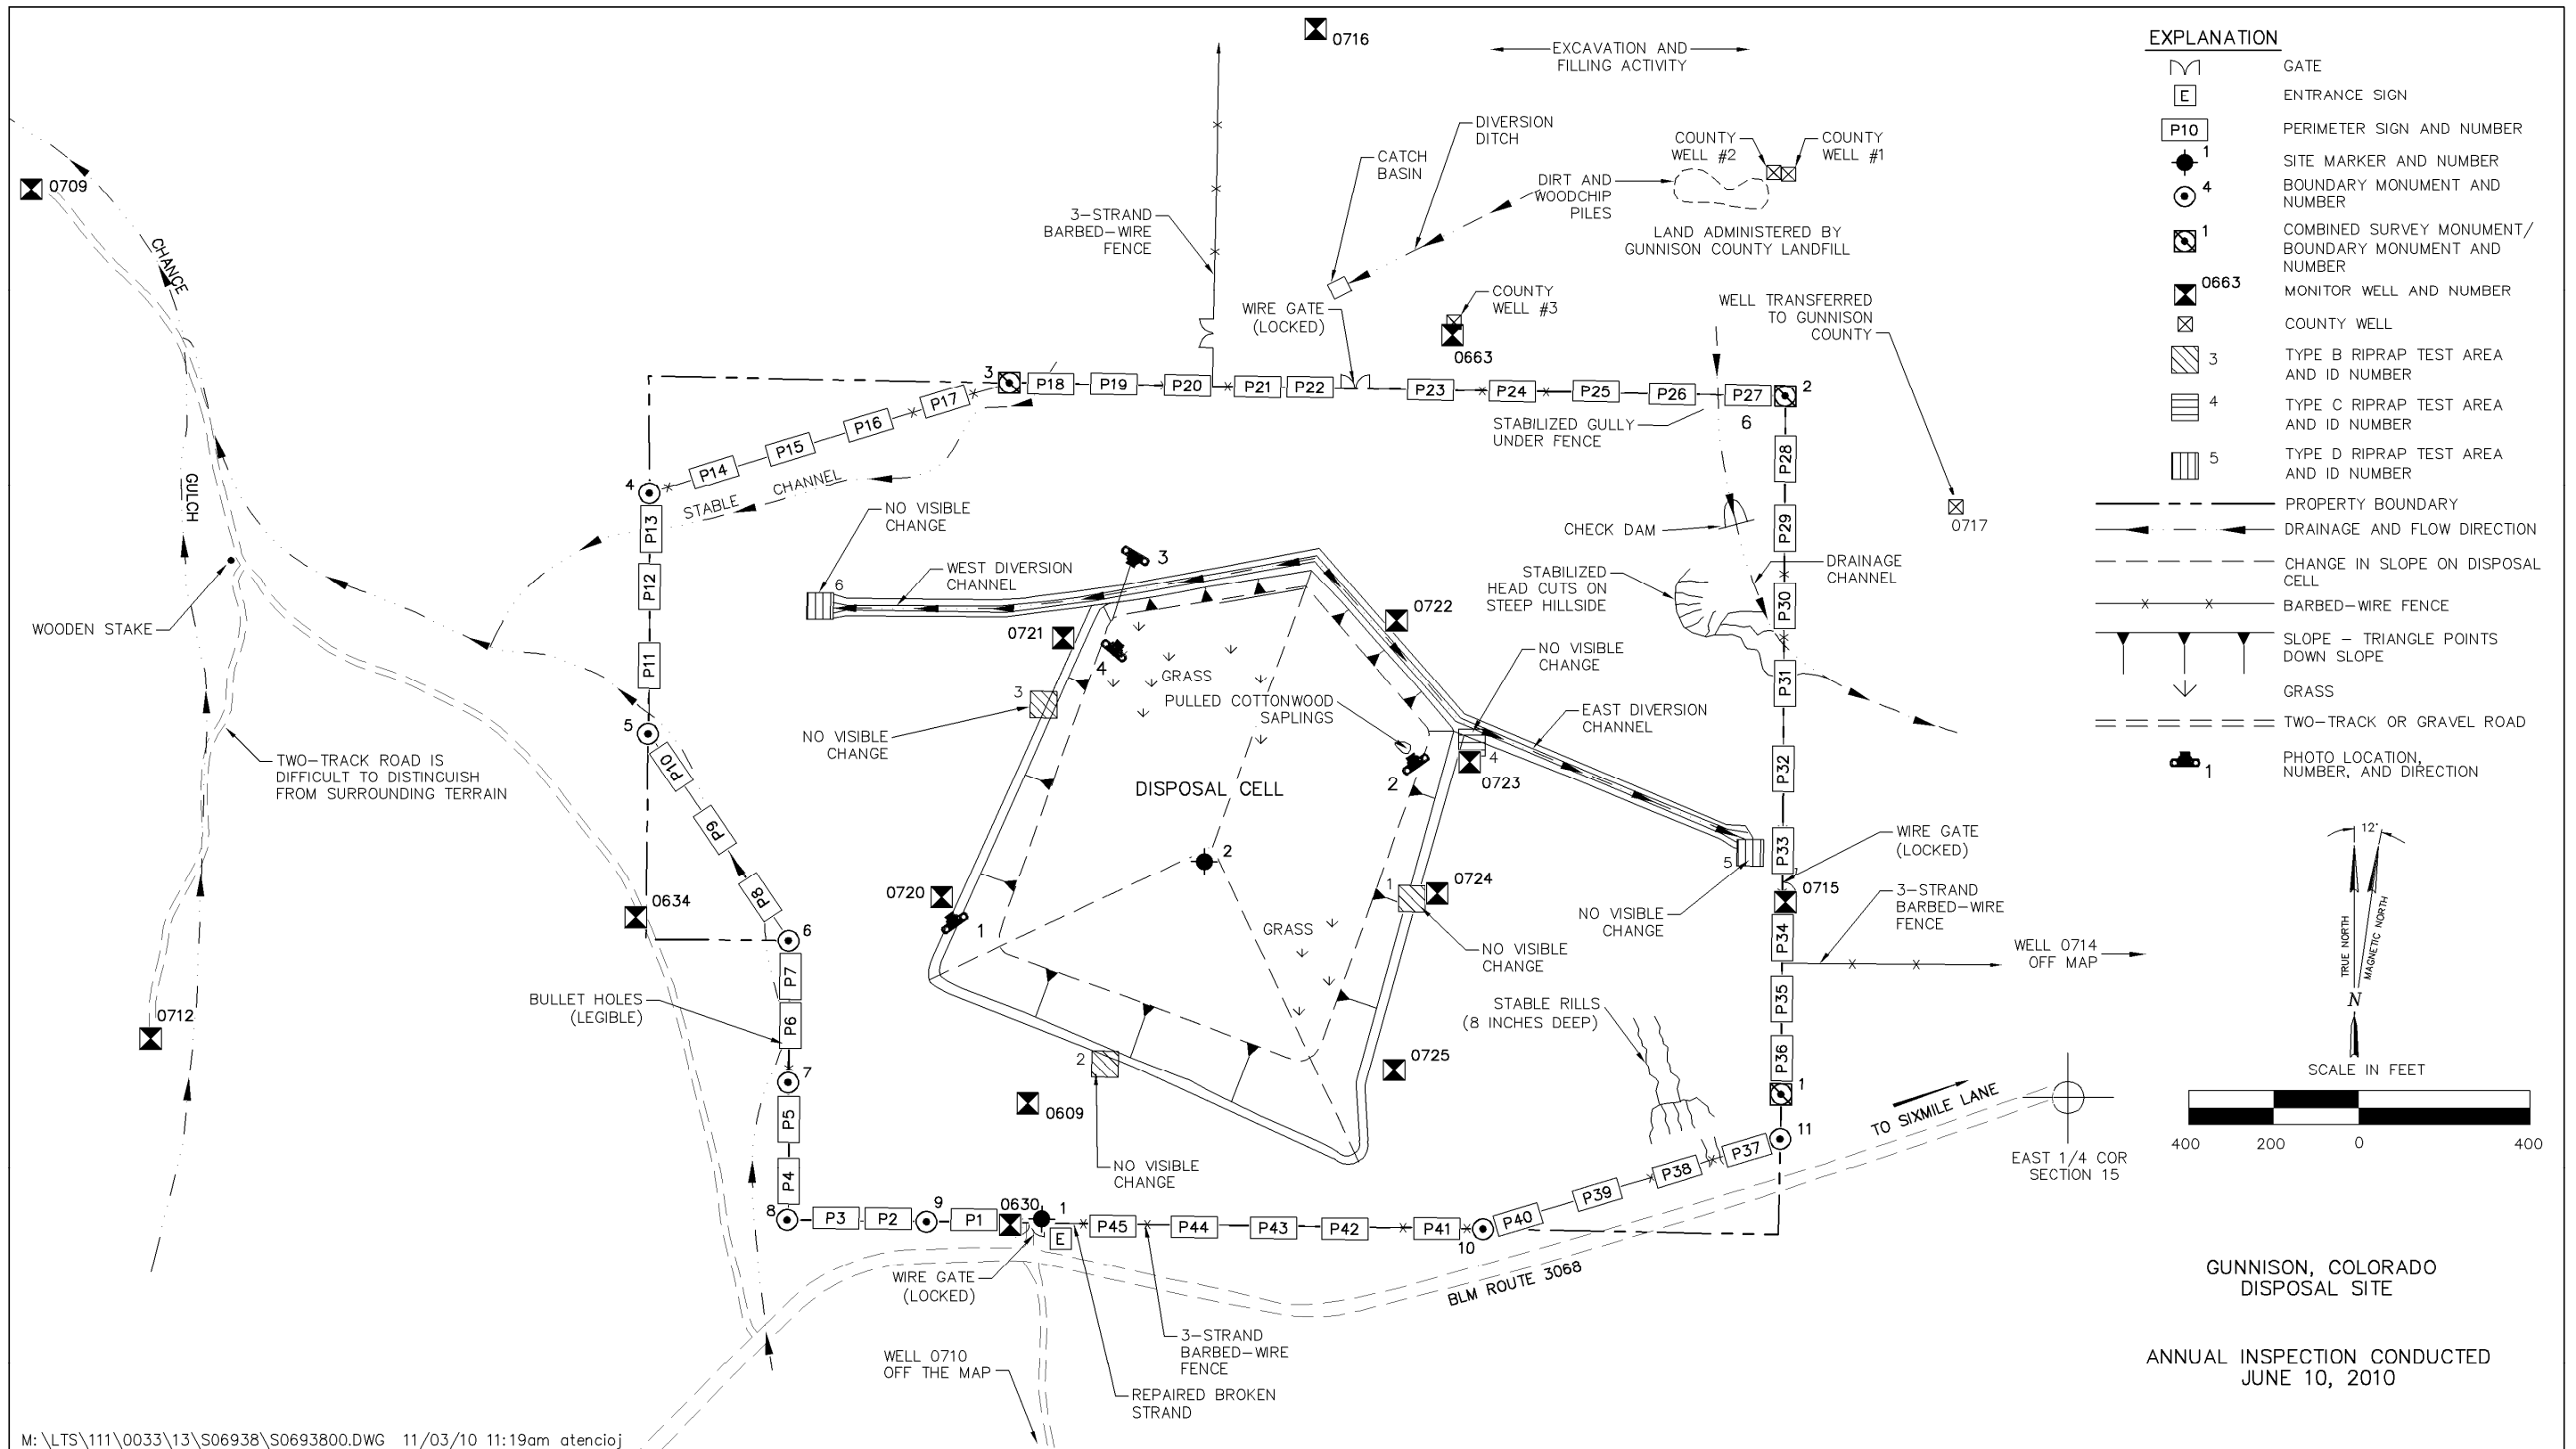
Figure 8-1. 2010 Annual Compliance Drawing for the Gunnison Disposal Site

The site, southeast of Gunnison, Colorado, was inspected on June 10, 2010. The results of the inspection are described below. Figure 8-1 shows features and photograph locations (PLs) mentioned in this report. Numbers in the left margin of this report refer to items summarized in the “Executive Summary” table.

**Outlying Area**—Gunnison County owns the land that adjoins the disposal site boundary to the north and east, and uses the land for a municipal landfill. In 2001, the County installed several fences and monitoring wells in these areas. The monitoring wells are identified as County Wells 1, 2, and 3 on Figure 8-1. DOE transferred monitoring well MW-0717 to the County in 2001. Gates installed in the County fence for access to the wells remain unlocked.
