8.0 Gunnison, Colorado, Disposal Site

8.1 Compliance Summary

Figure 8-1. 2014 Annual Inspection Drawing for the Gunnison Disposal Site

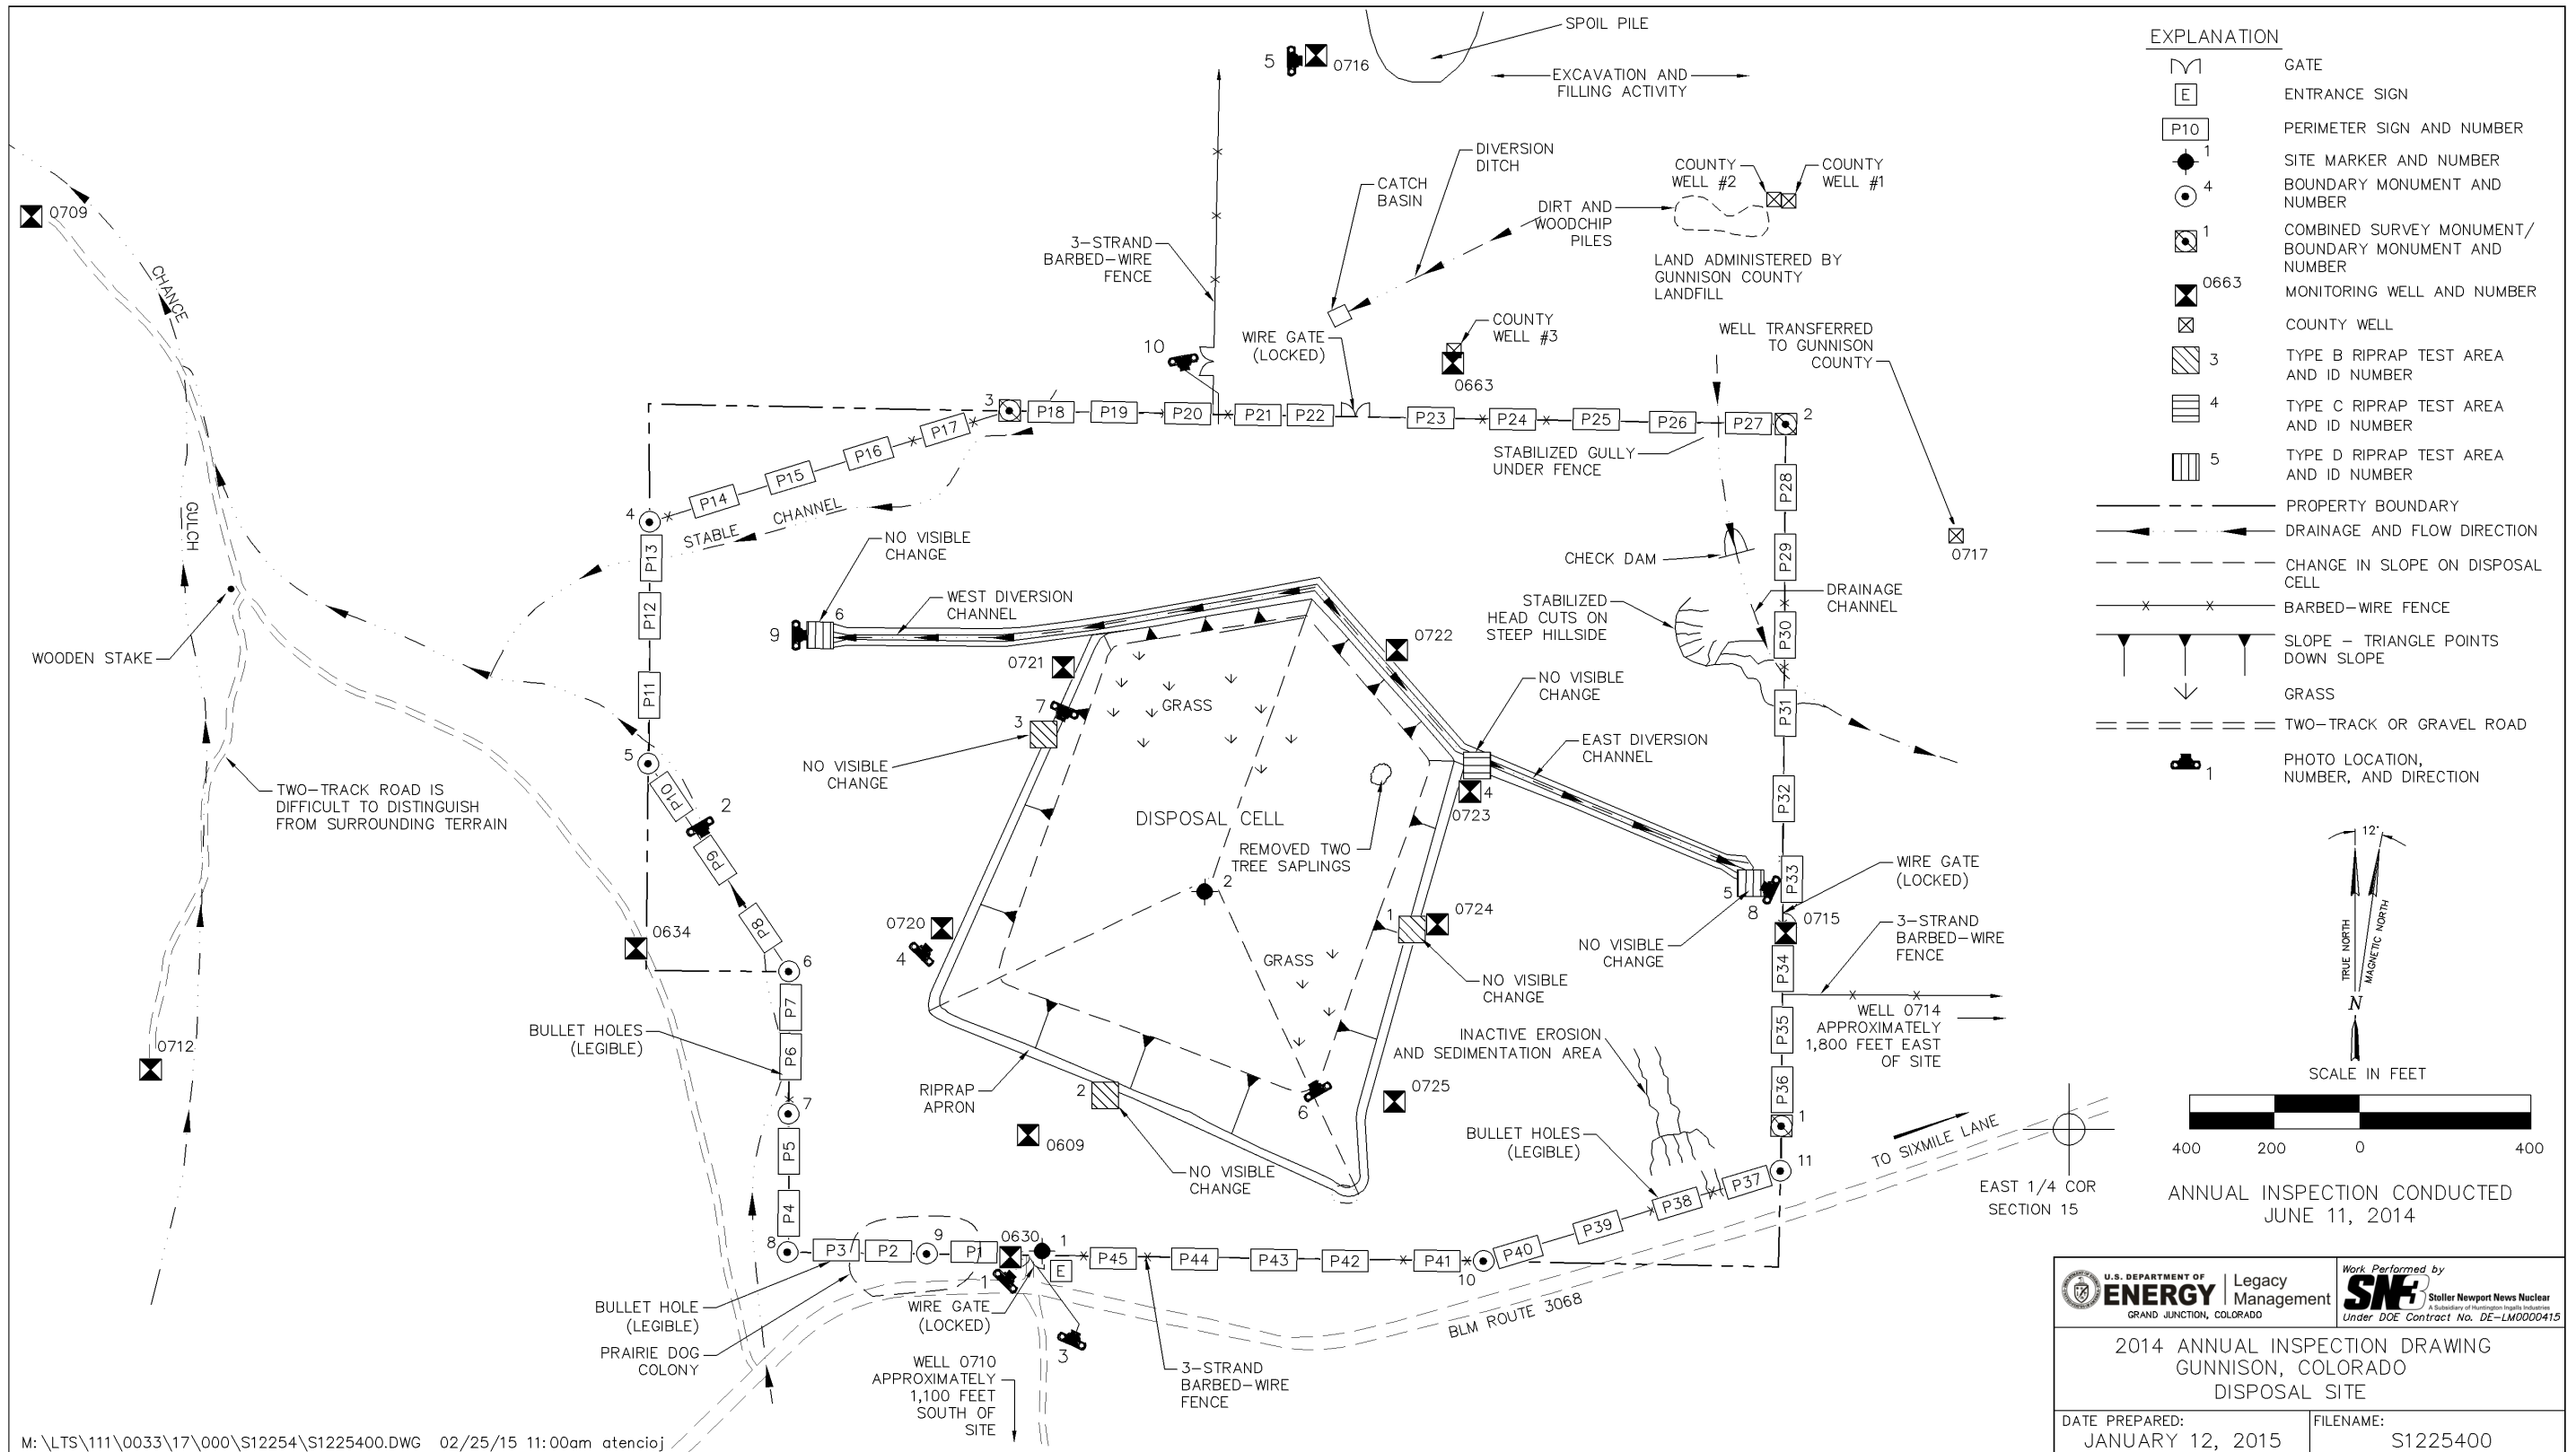
Figure 8-1 shows the locations of site surveillance features. Inspection results and recommended maintenance activities associated with site surveillance features are included in the following subsections. Photographs to support specific observations are identified in the text and on Figure 8-1 by photograph location (PL) numbers.
