8.0 Gunnison, Colorado, Disposal Site

8.1 Compliance Summary

The Gunnison, Colorado, Uranium Mill Tailings Radiation Control Act (UMTRCA) Title I Disposal Site was inspected on July 1, 2015. The disposal cell and all associated surface water diversion and drainage structures were in excellent condition and functioning as designed. Six riprap test areas on the cell apron and diversion ditches were visually inspected; no rock degradation was noted when compared to 2012 photos. Inspectors identified no maintenance needs or cause for a follow-up inspection.

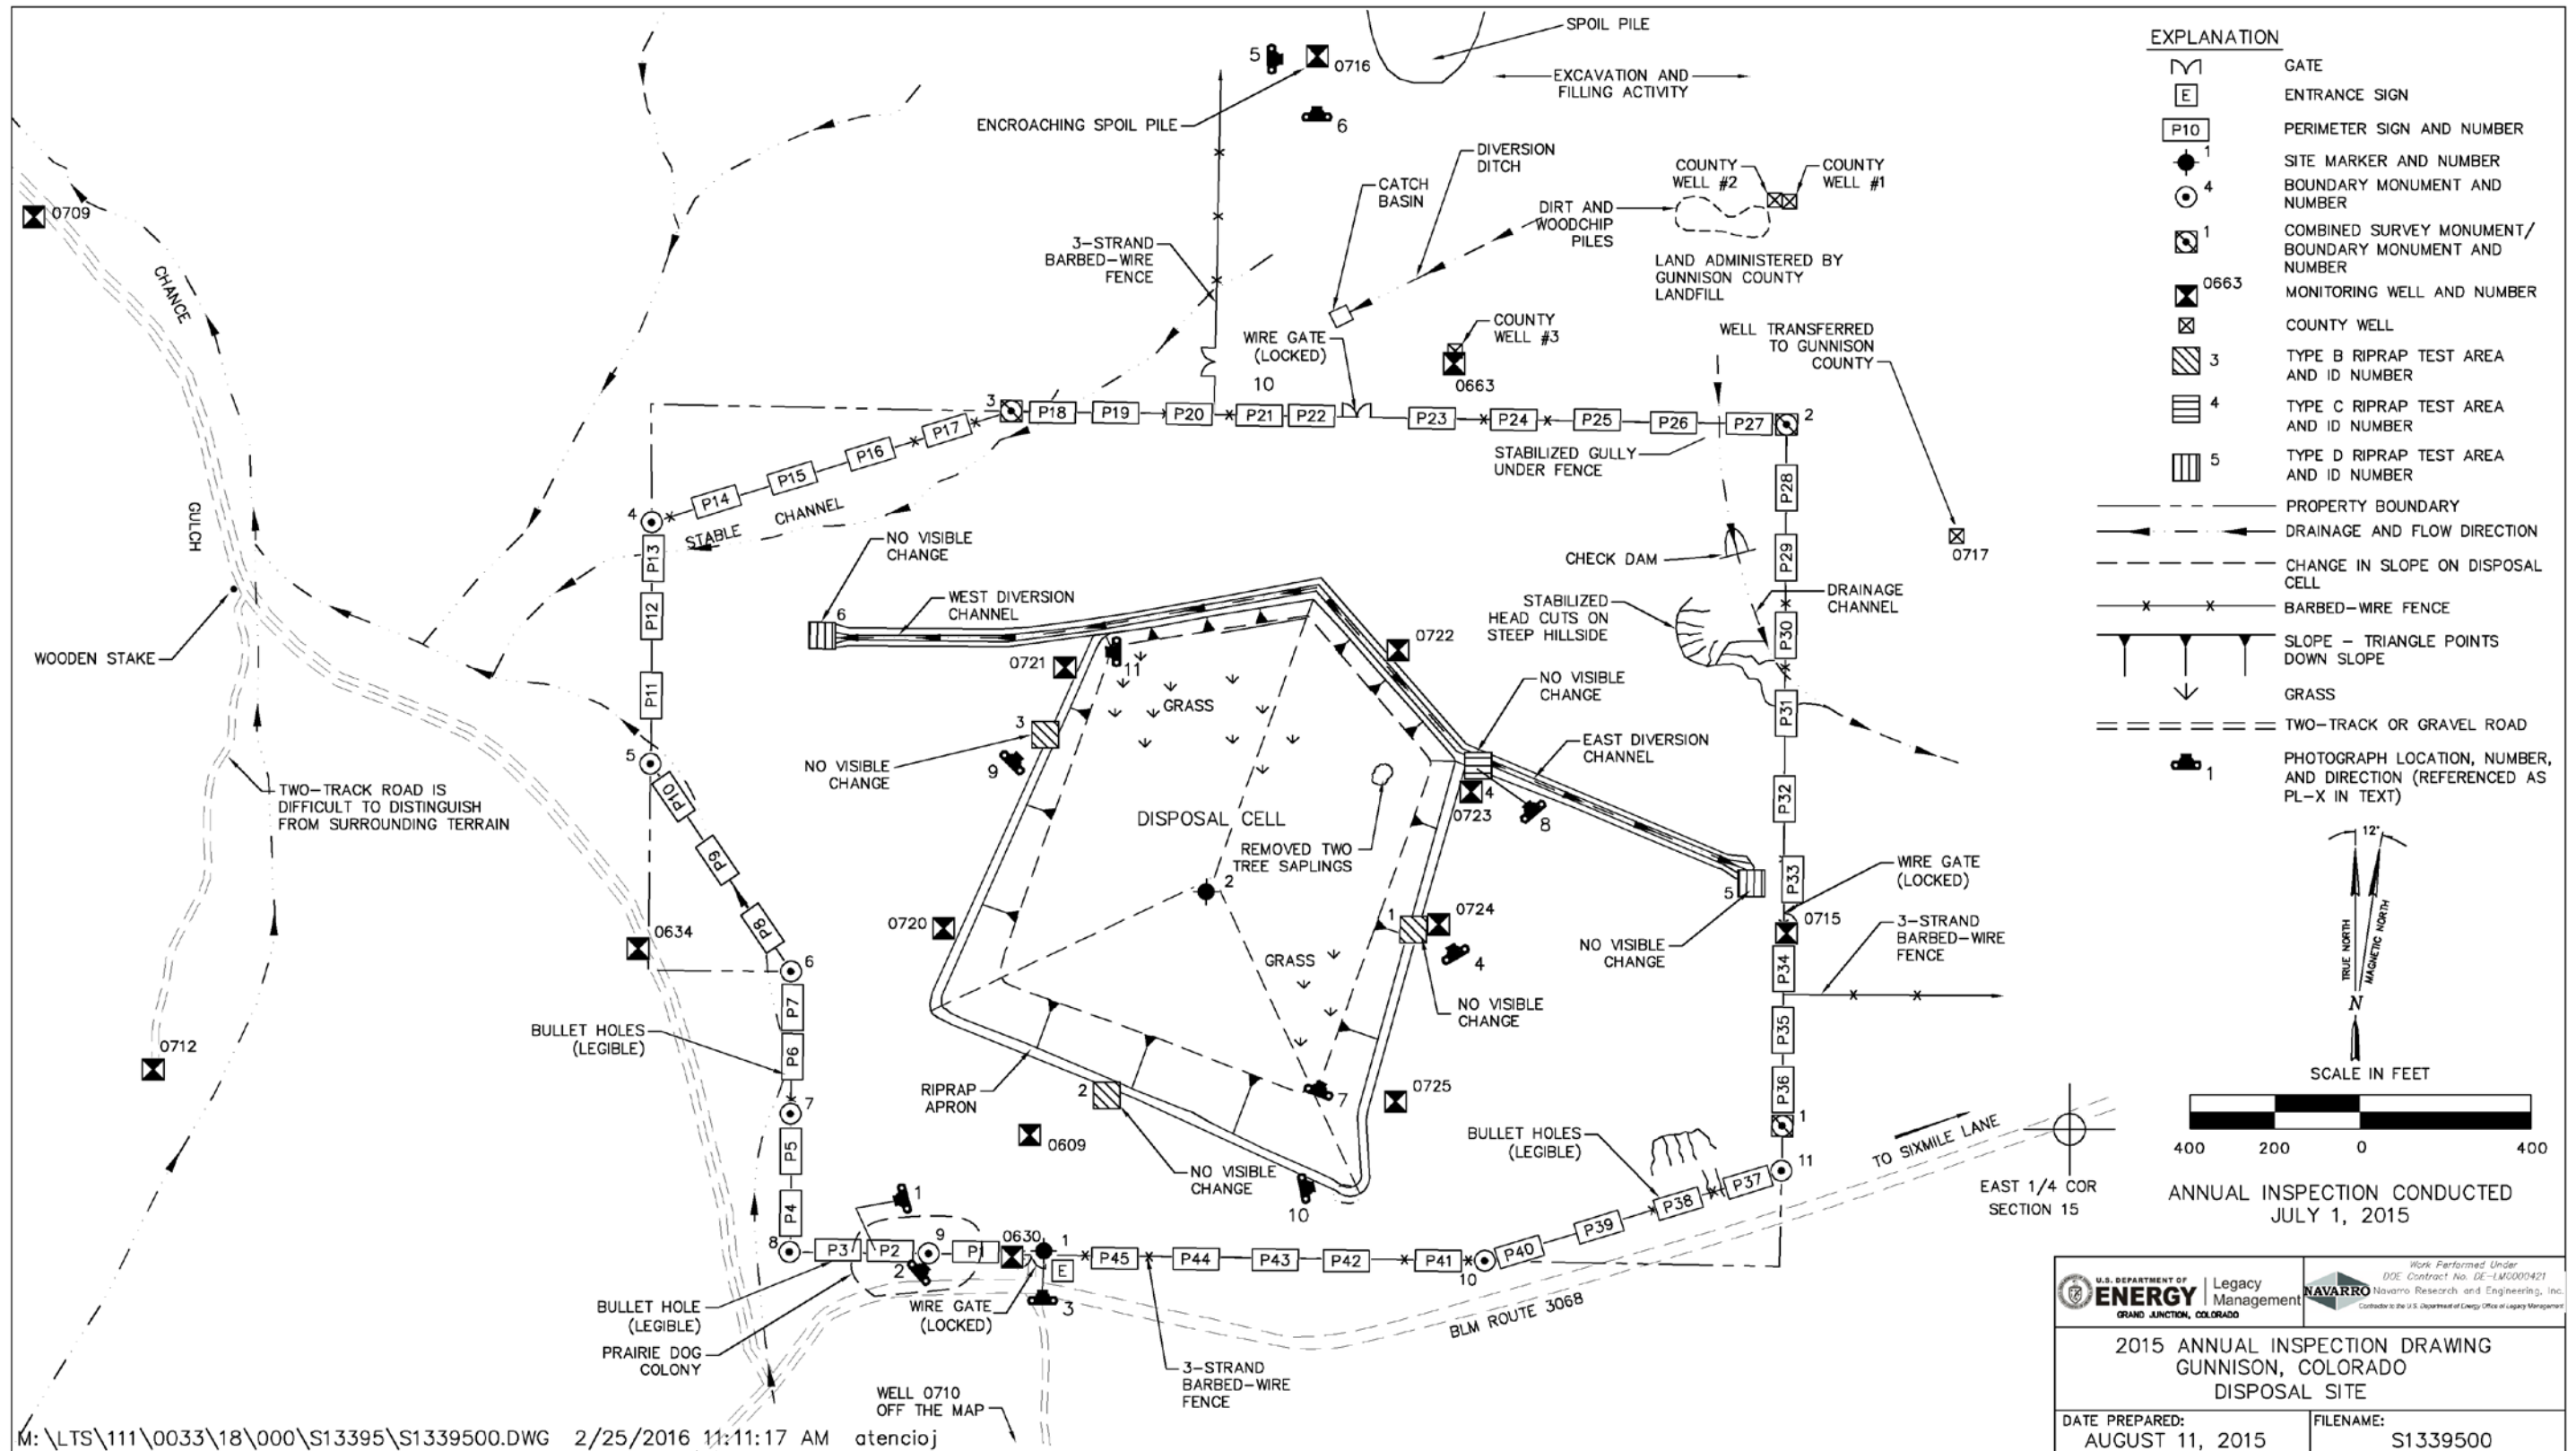
Figure 8-1. 2015 Annual Inspection Drawing for the Gunnison Disposal Site

Figure 8-1 shows the locations of site surveillance features. Inspection results and recommended maintenance activities associated with site surveillance features are included in the following subsections. Photographs to support specific observations are identified in the text and on Figure 8-1 by photograph location (PL) numbers.
