8.0 Gunnison, Colorado, Disposal Site

The U.S. Department of Energy (DOE) Office of Legacy Management (LM) conducted the Gunnison, Colorado, Uranium Mill Tailings Radiation Control Act (UMTRCA) Title I Disposal Site (site) inspection on September 4, 2019. No cause for a follow-up inspection was identified.

The site, 6 miles southeast of Gunnison, Colorado, was inspected on September 4, 2019. The inspection was conducted by J. Lobato and D. Atkinson of the Legacy Management Support

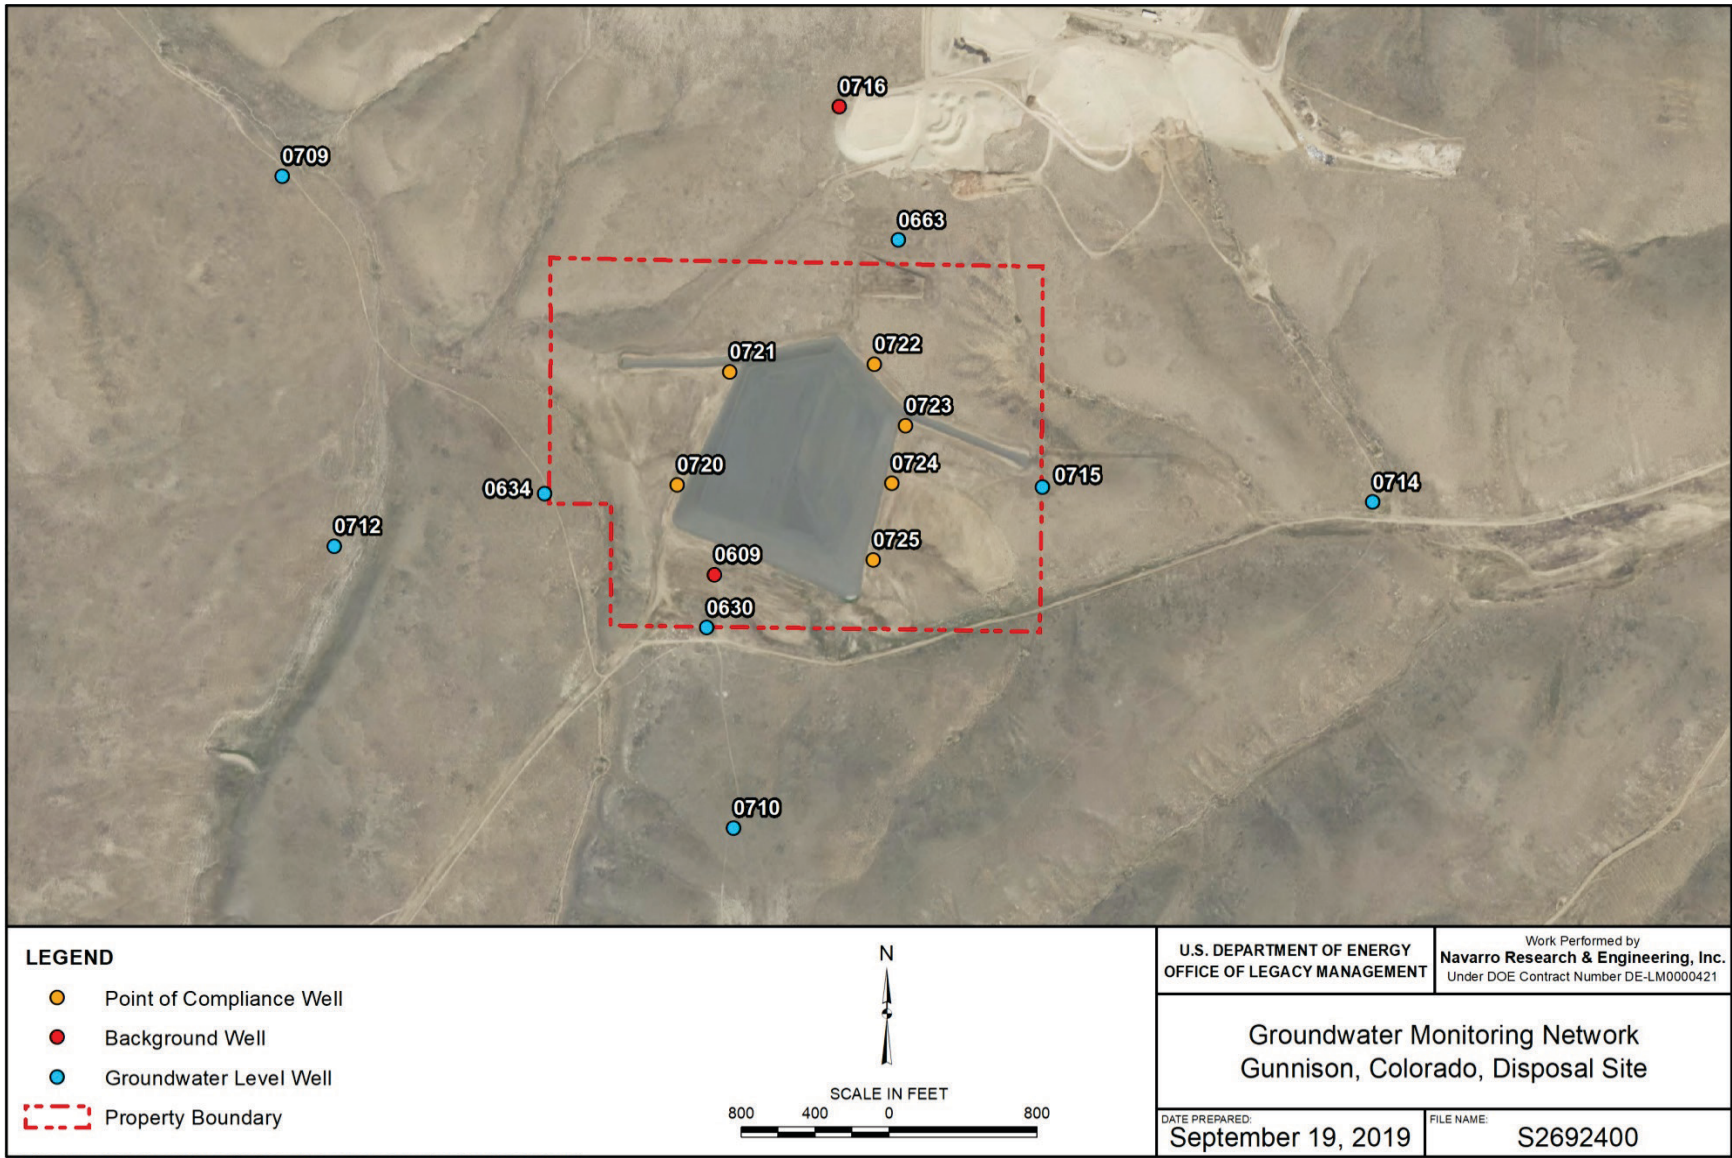
Figure 8-2. Groundwater Monitoring Network at the Gunnison, Colorado, Disposal Site

The groundwater monitoring network consists of 16 monitoring wells. That total includes six POC wells, two monitoring wells to monitor background groundwater quality, and eight wells to monitor groundwater levels (Table 8-2 and Figure 8-2). The indicator analyte for disposal cell performance is uranium, which was selected because of its presence in tailings pore fluid, its relatively high mobility in groundwater, and its low concentration in upgradient (background) groundwater. The site-specific screening monitoring action level (action level) concentration for uranium is 0.013 milligram per liter (mg/L). The basis for this action level is the maximum observed concentration of uranium in background samples before long-term surveillance and maintenance activities began. The U.S. Environmental Protection Agency established a maximum concentration limit for uranium of 0.044 mg/L in groundwater (40 CFR 192 Subpart A Table 1).

All groundwater monitoring results for the site are reported and published on the LM Geospatial Environmental Mapping System website (<http://gems.lm.doe.gov/#site=GUD>). The *2016 Annual Site Inspection and Monitoring Report for Uranium Mill Tailings Radiation Control Act Title I Disposal Sites* (DOE 2016) shows the most recent monitoring results. The report shows uranium concentration was below the action level (0.013 mg/L) in all POC wells and indicates continued groundwater compliance at the Gunnison disposal site.
