11.0 Maybell, Colorado, Disposal Site

11.1 Compliance Summary

The Maybell, Colorado, Uranium Mill Tailings Radiation Control Act (UMTRCA) Title I Disposal Site was inspected on July 31, 2008. The disposal cell and all associated surface water diversion and drainage structures were in excellent condition and functioning as designed. The Long-Term Surveillance Plan (LTSP) was revised and submitted to NRC to reflect a correction made to the property boundary along the north and northwest portion of the site; relocation of boundary monuments is planned for 2009. Several breaks were found in the perimeter fence, and cattle were grazing on site; the local rancher was contacted, the cattle were removed, and repairs to the fence were made. Additional fence damage caused by wildlife will be repaired in 2009. A mining claim stake found at the base of the disposal cell is considered a “nuisance claim” because protection of the disposal cell is provided through the NRC general license. Groundwater monitoring is not required at this site. Deep-rooted plants on the disposal cell top will be cut and treated in 2009. Noxious weeds found growing on the disposal cell were treated with herbicide. I

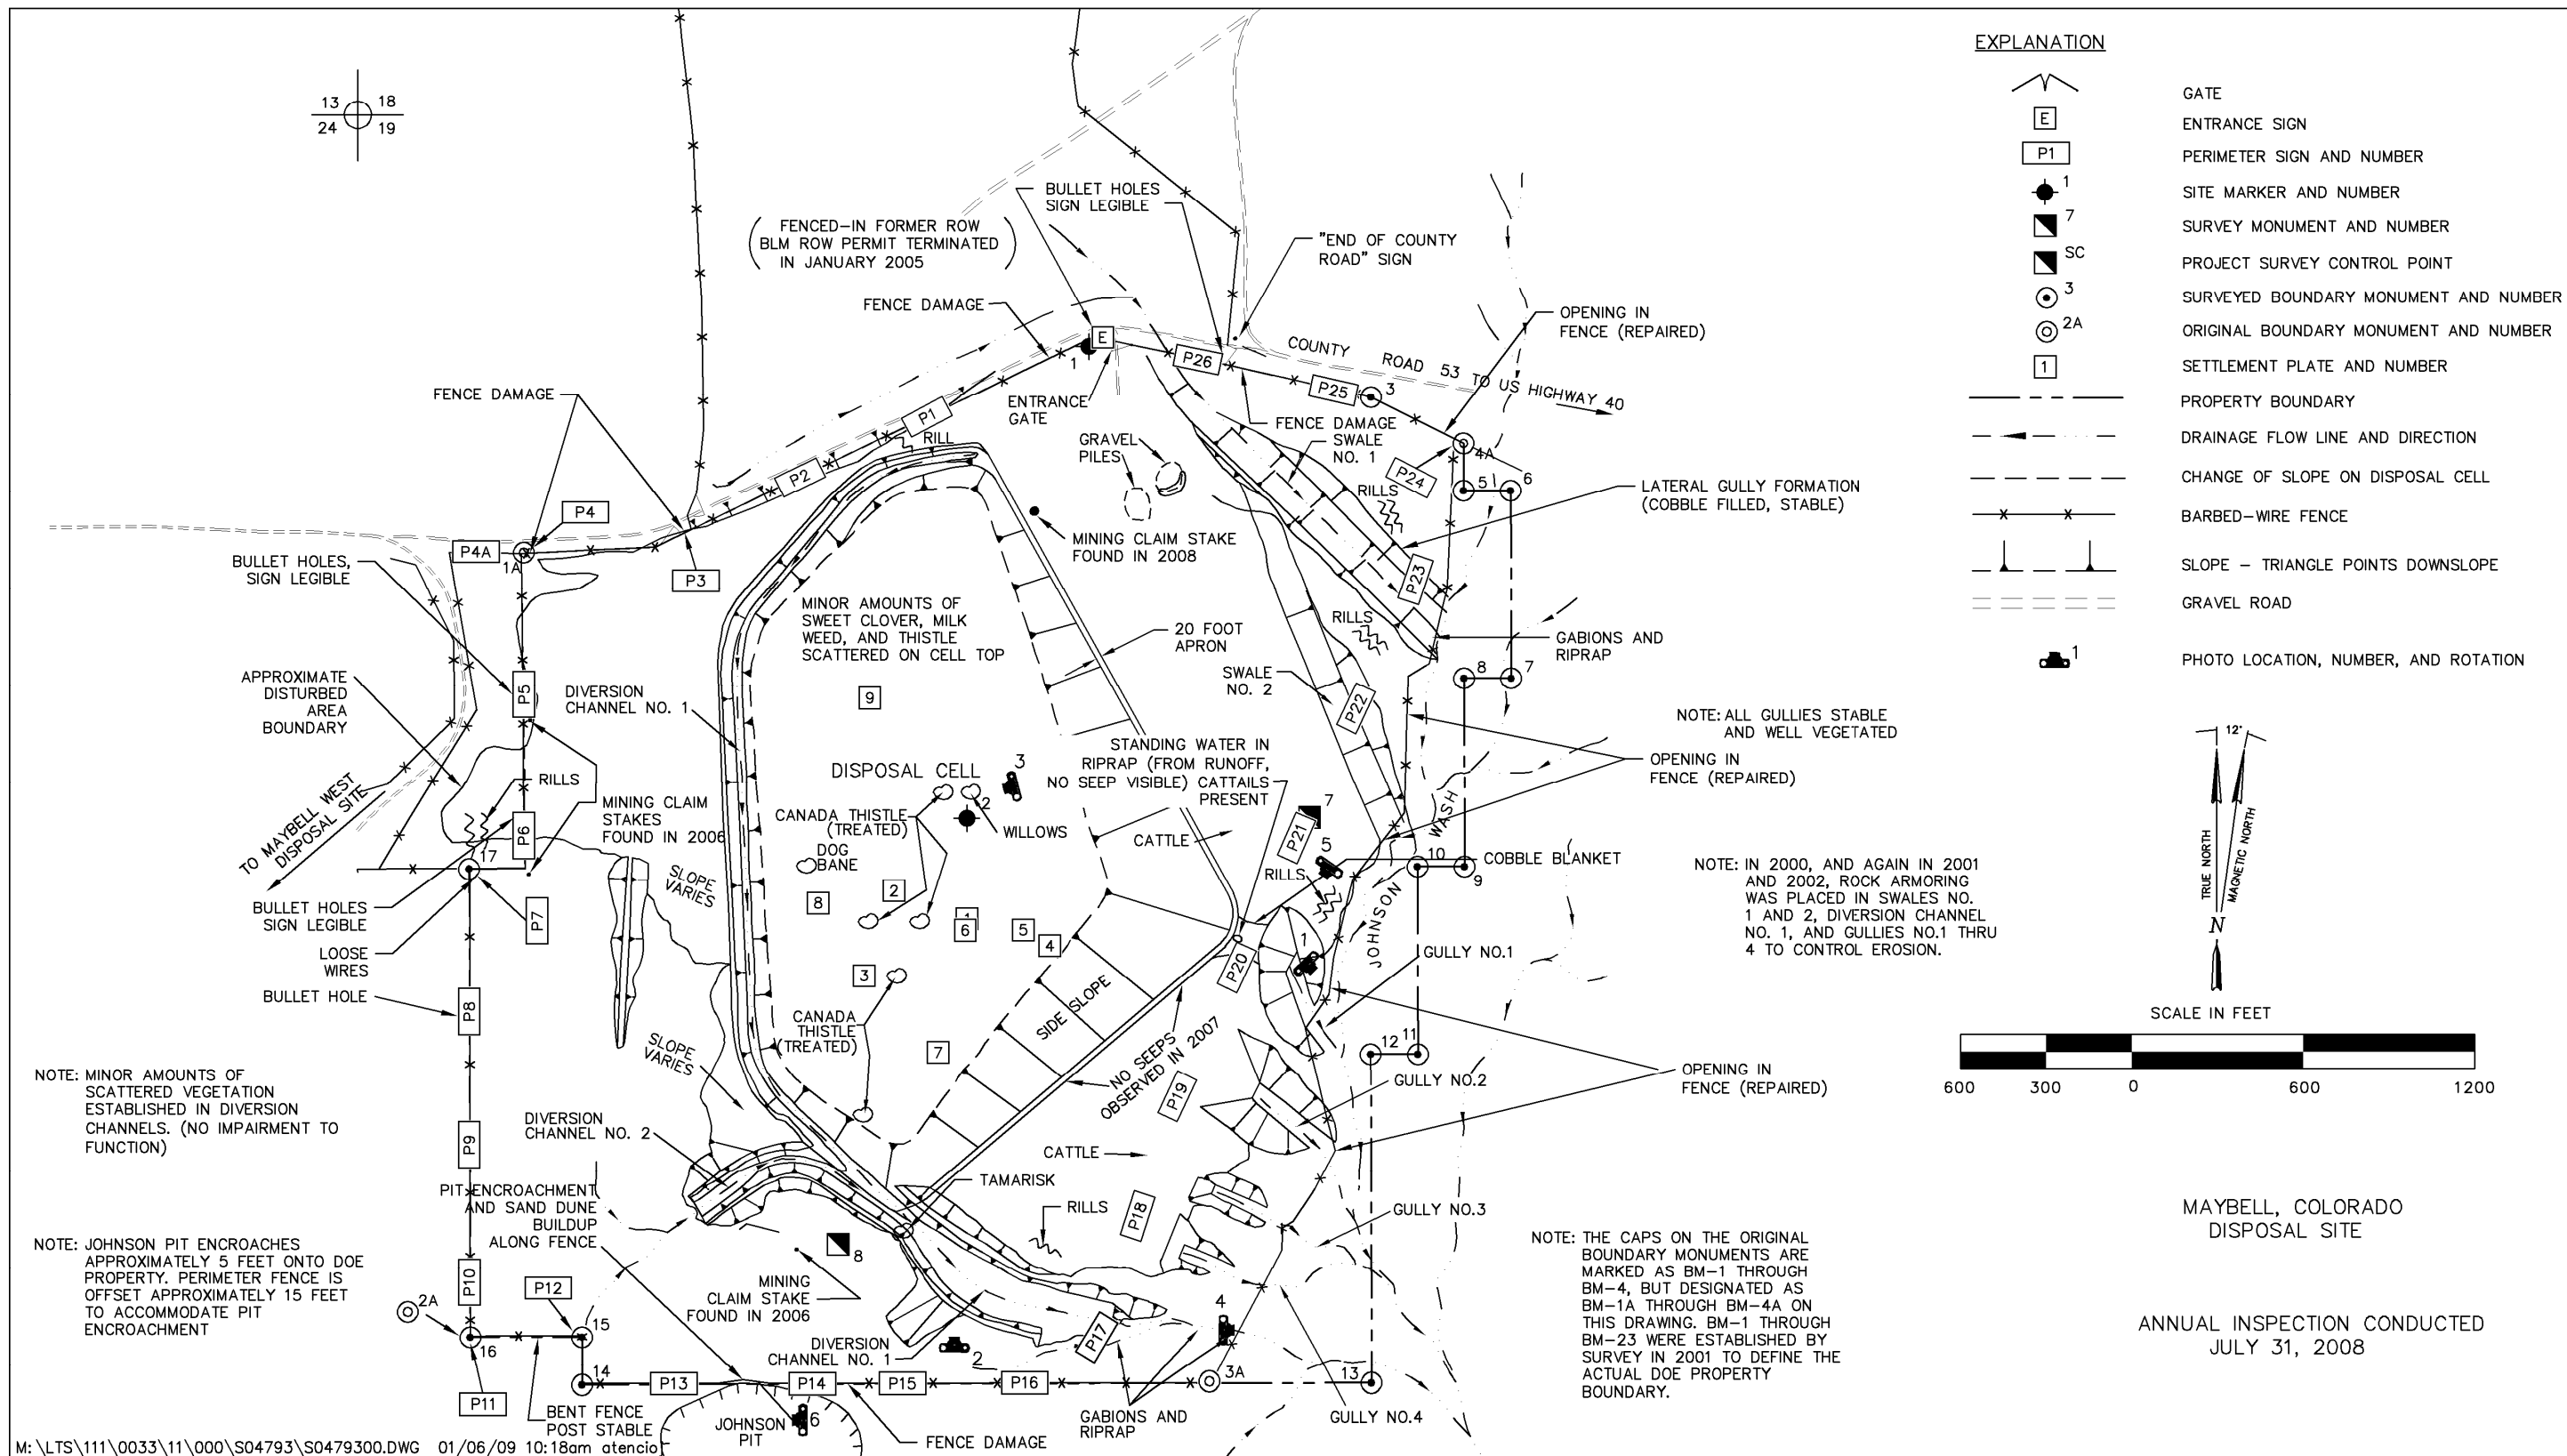
Figure 11-1. 2008 Annual Compliance Drawing for the Maybell Disposal Site

11A A standard four-strand barbed-wire stock fence surrounds the disposal cell and drainage structures. Several breaks were found in the perimeter fence (PL–1), and cattle were observed grazing on site. The local rancher was contacted, the cattle were removed, and the fence was repaired. Reinforcement of the perimeter fence will be made in 2009 (before the cattle return to the area) in an effort to ensure that cattle do not access the site in the future. Loose wires and bent posts were also noted at several other locations along the perimeter fence. This damage was likely caused by wildlife (e.g., deer, elk, antelope) crossing back and forth across the fence, and snowpack. The Maybell Disposal Site is located in wintering grounds frequented by big game animals, and damage to the perimeter stock fence is to be expected. Repairs to the fence will be made in 2009.

11B In 2008, during a real property assessment, an error was discovered in the property boundary along the north and northwest portion of the site as it was depicted following a 2002 land survey. It was found that the property boundary did not match the legal description included in the permanent withdrawal posted in the *Federal Register* (April 13, 1995, Vol. 60, No. 71, Page 18778). The correct property boundary along the north and northwest portion of the site was determined to follow the perimeter fence line, as shown in Figure 11-1. As a result, in 2008, the site base map was corrected, and the LTSP was revised and submitted to NRC. In 2009, nine boundary monuments (numbers 1, 2, 4, 18, 19, 20, 21, 22, and 23) will be removed, and three new monuments will be installed along the correct property boundary (i.e., the north perimeter fence line).
