13.0 Naturita, Colorado, Disposal Site

13.1 Compliance Summary

13.3.1 Annual Inspection and Report

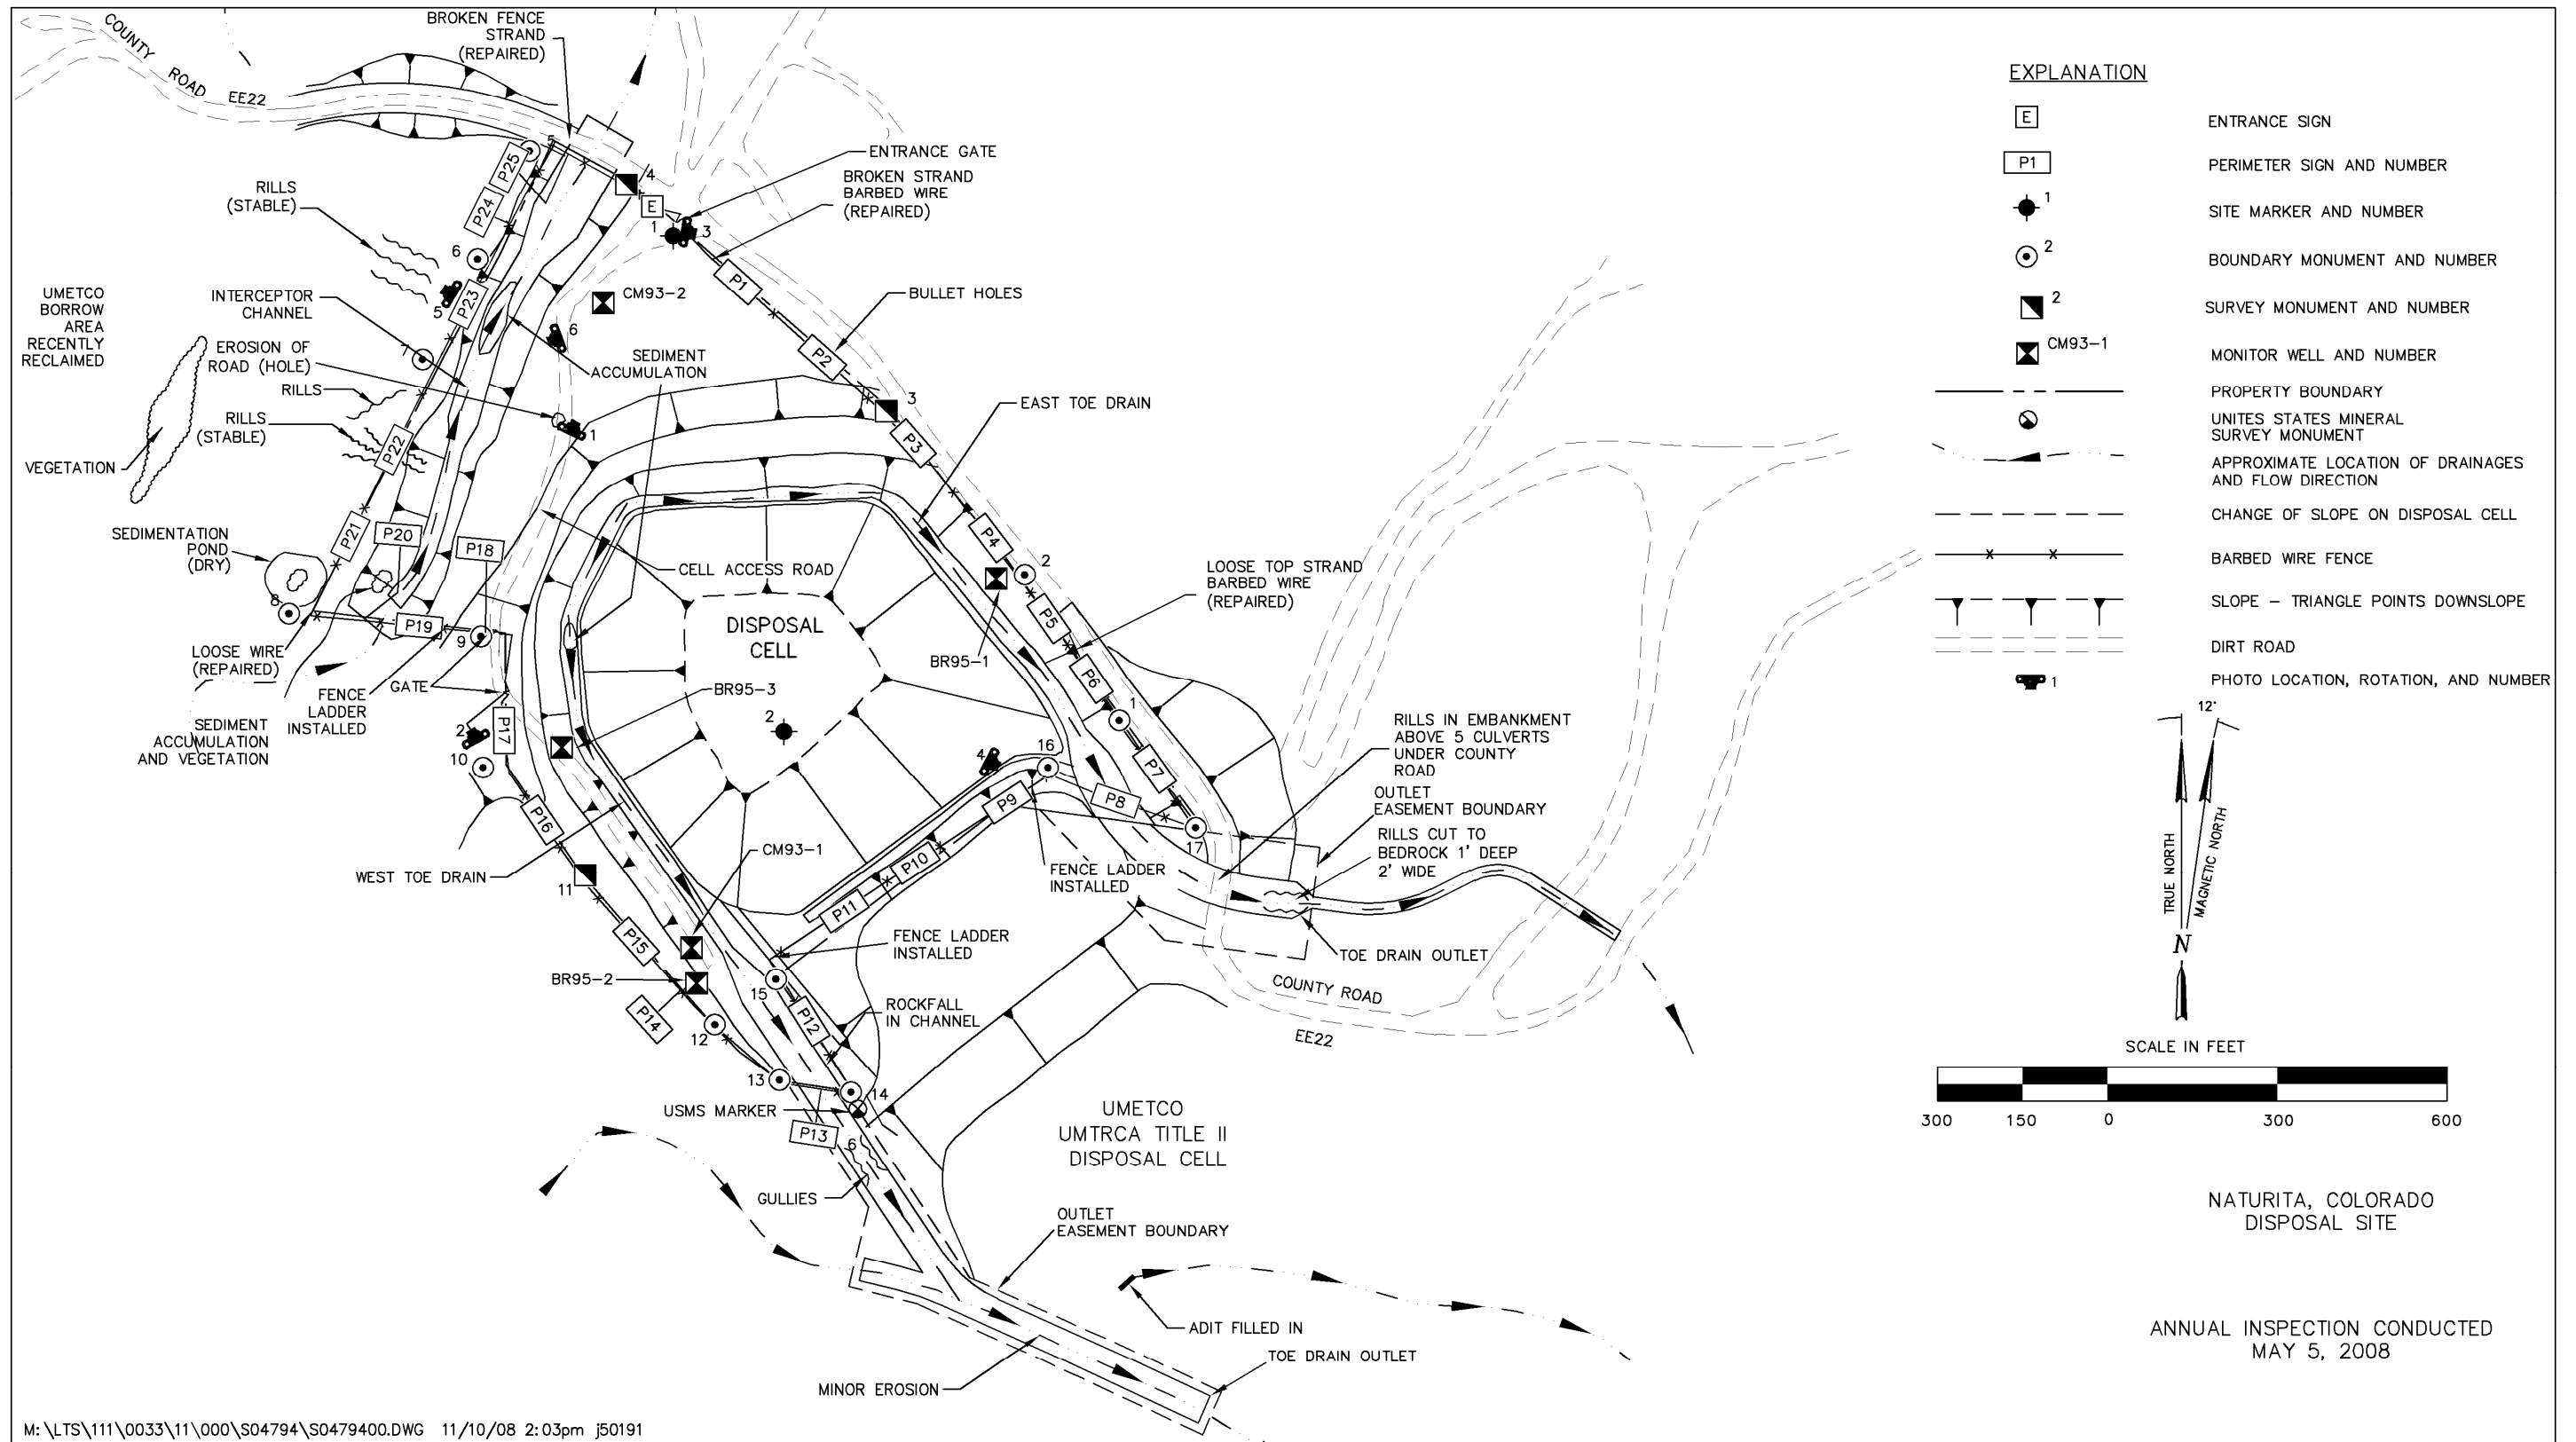
Figure 13-1. 2008 Annual Compliance Drawing for the Naturita Disposal Site

13A The access road, which was regraded after the 2005 inspection, was generally in good condition. However, a small hole has begun to erode along the west side of the road (PL–1). This eroded roadside area was identified in 2007 and will be repaired before the next inspection. In September 2005, fallen rocks were removed from the road, the road was regraded, and several loads of gravel were used to fill gullies. No significant erosion of these gullies was evident in 2008. However, boulders have fallen onto the road again (PL–2); these boulders will be removed from the access road before the next annual site inspection.

13B A barbed-wire stock fence encloses the site. Except for several small sections with broken or loose wire strands, the fence was in good condition. Broken strands were observed near perimeter signs P1 (PL–3) and P25. Two other fence sections have loose strands; the first located between perimeter signs P5 and P6, and the second south of perimeter sign P21. These broken and loose strands were repaired in September 2008.

13C In August 2008, as a safety precaution, pedestrian fence ladders were installed at three locations around the perimeter of the site near boundary monuments BM–9, BM–15, and BM–16 (PL–4). These structures will allow inspectors to safely cross barbed-wire fences to access the site.
