13.0 Naturita, Colorado, Disposal Site

13.1 Compliance Summary

The Naturita, Colorado, Uranium Mill Tailings Radiation Control Act (UMTRCA) Title I Disposal Site was inspected on June 8, 2021. No changes were observed on the disposal cell or in the associated drainage features. Inspectors identified several minor maintenance needs but found no cause for a follow-up inspection.

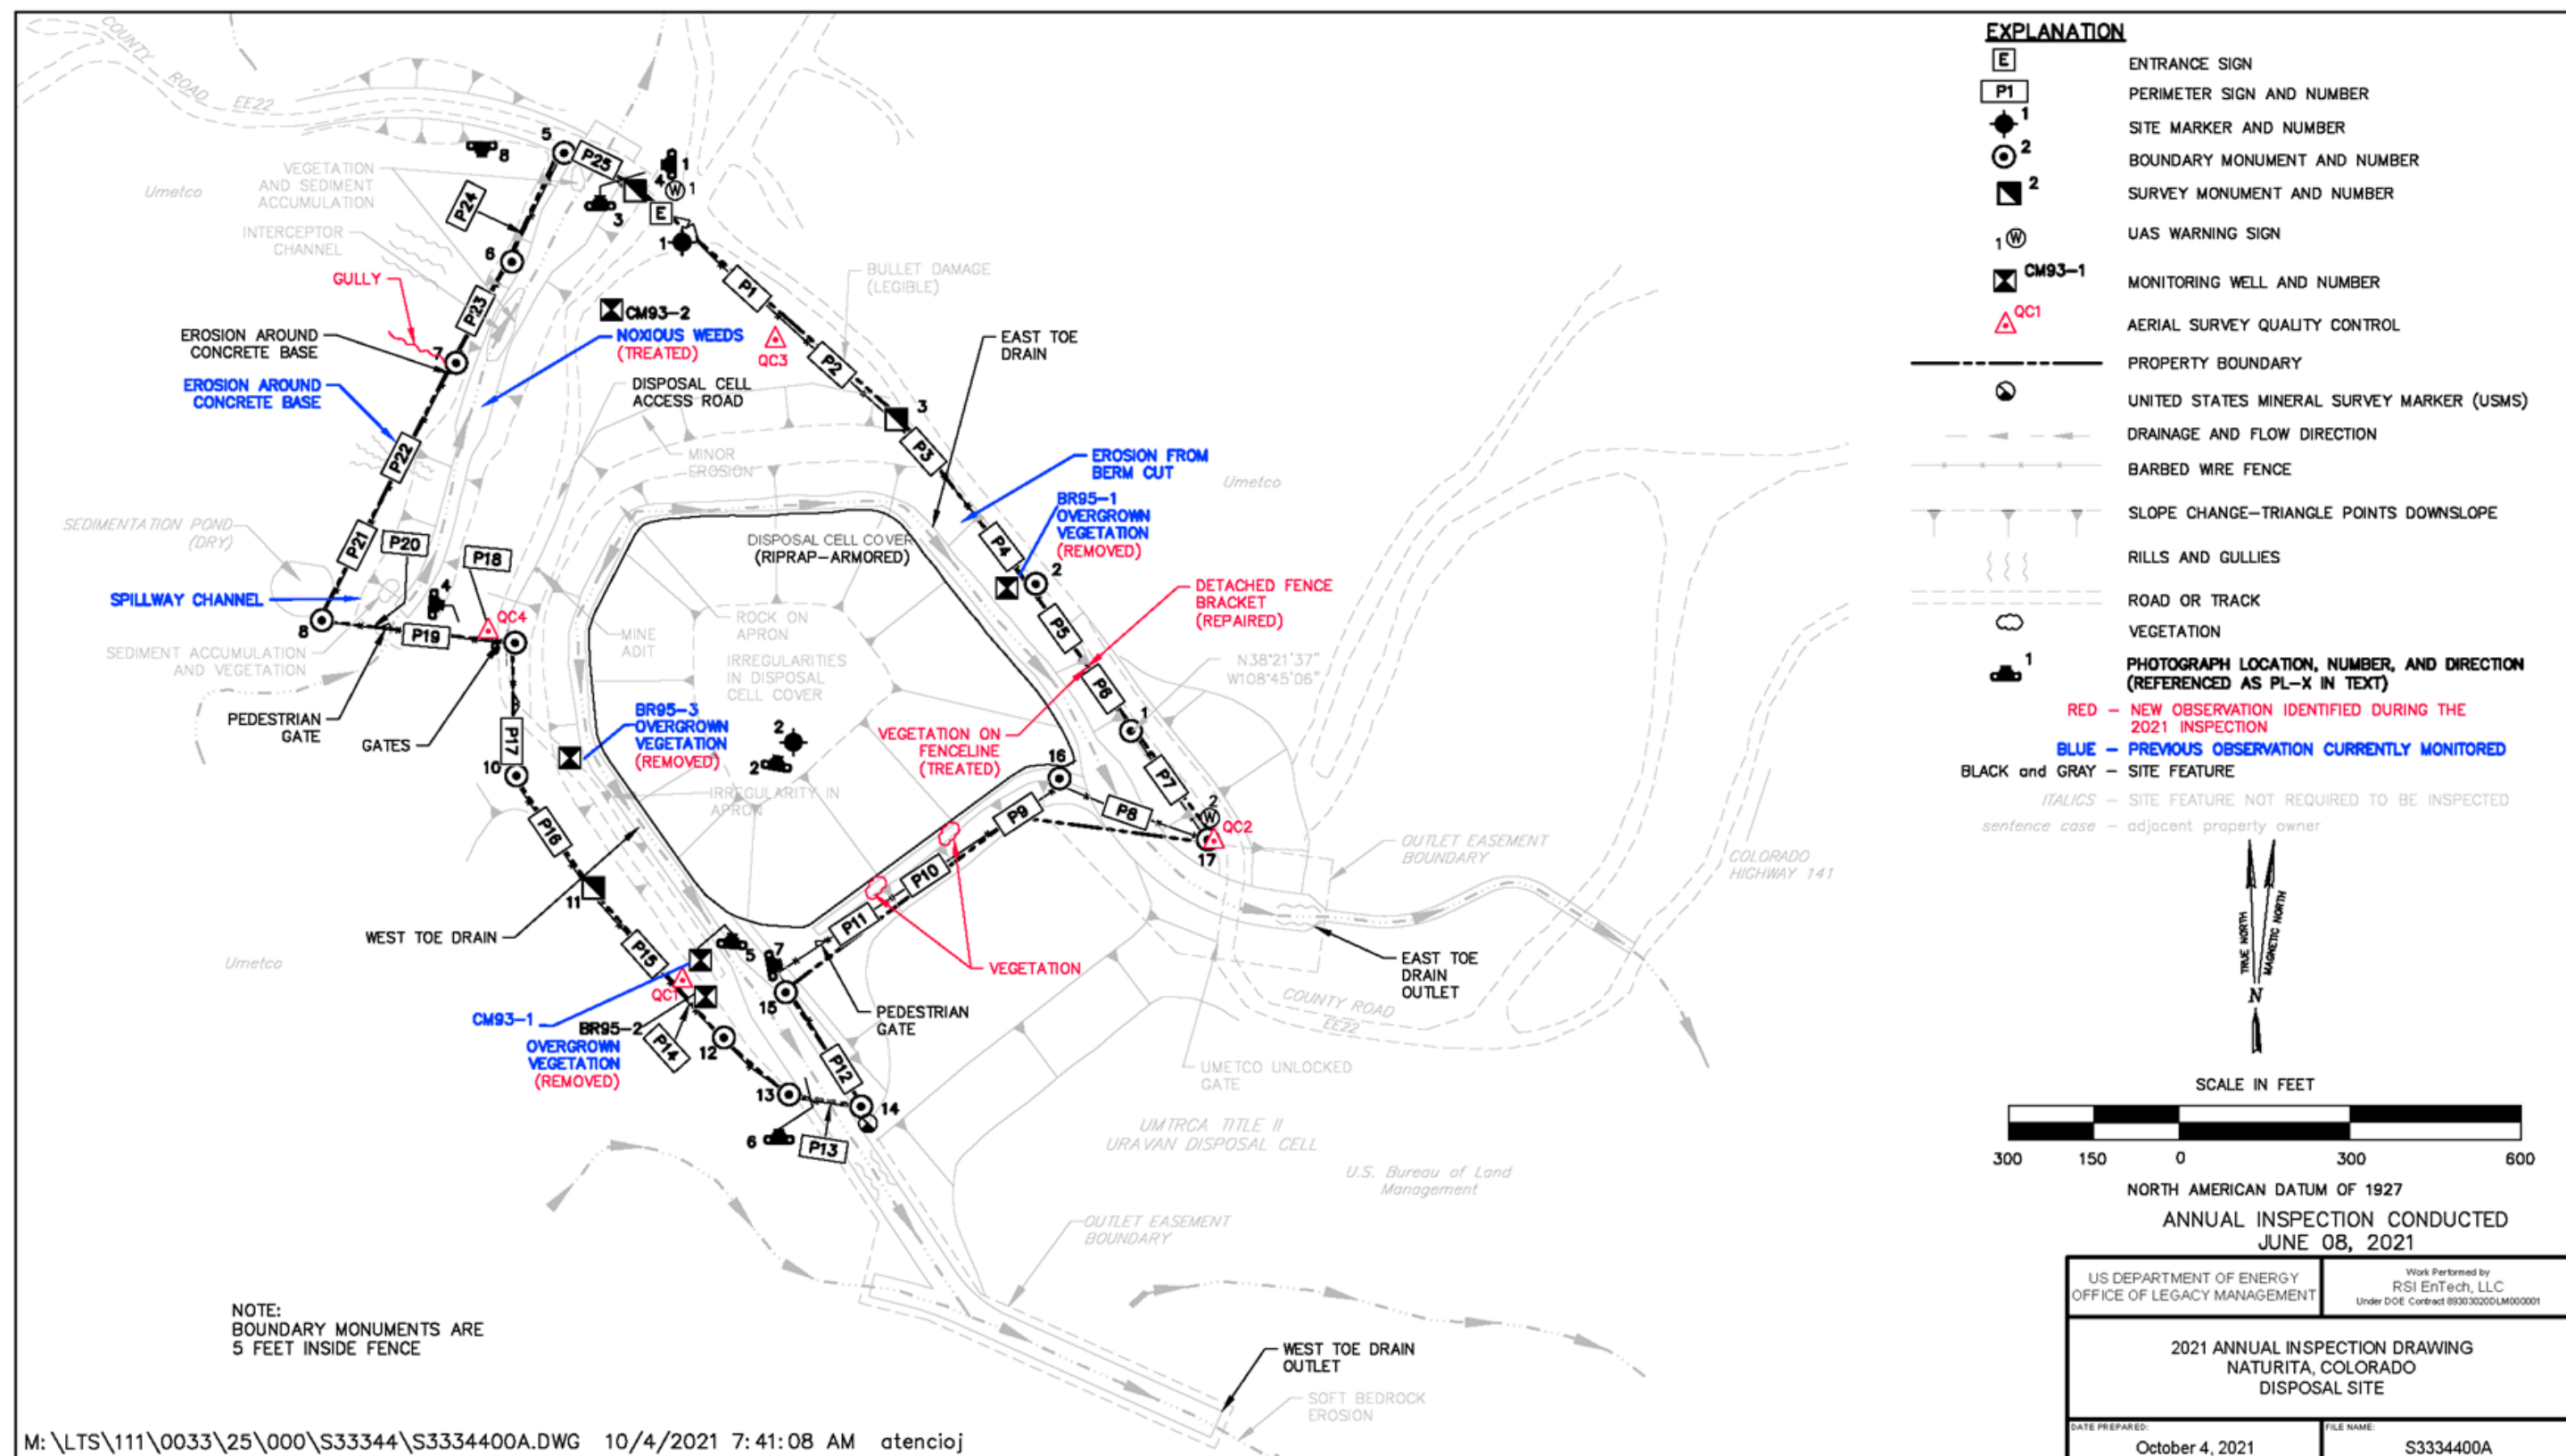
Figure 13-1. 2021 Annual Inspection Drawing for the Naturita, Colorado, Disposal Site

Figure 13-1 shows the locations of site features, including site surveillance features and inspection areas, in black and gray font. Site features that are present but not required to be inspected are shown in italic font. Observations from previous inspections that are currently monitored are shown in blue text, and new observations identified during the 2021 annual inspection are shown in red font. Inspection results and recommended maintenance activities associated with site surveillance features are described in the following subsections. Photographs to support specific observations are identified in the text and in Figure 13-1 by photograph location (PL) numbers. The photographs and photograph log are presented in Section 13.10.
