13.0 Naturita, Colorado, Disposal Site

13.1 Compliance Summary

Figure 13-1. 2024 Annual Inspection Drawing for the Naturita, Colorado, Disposal Site

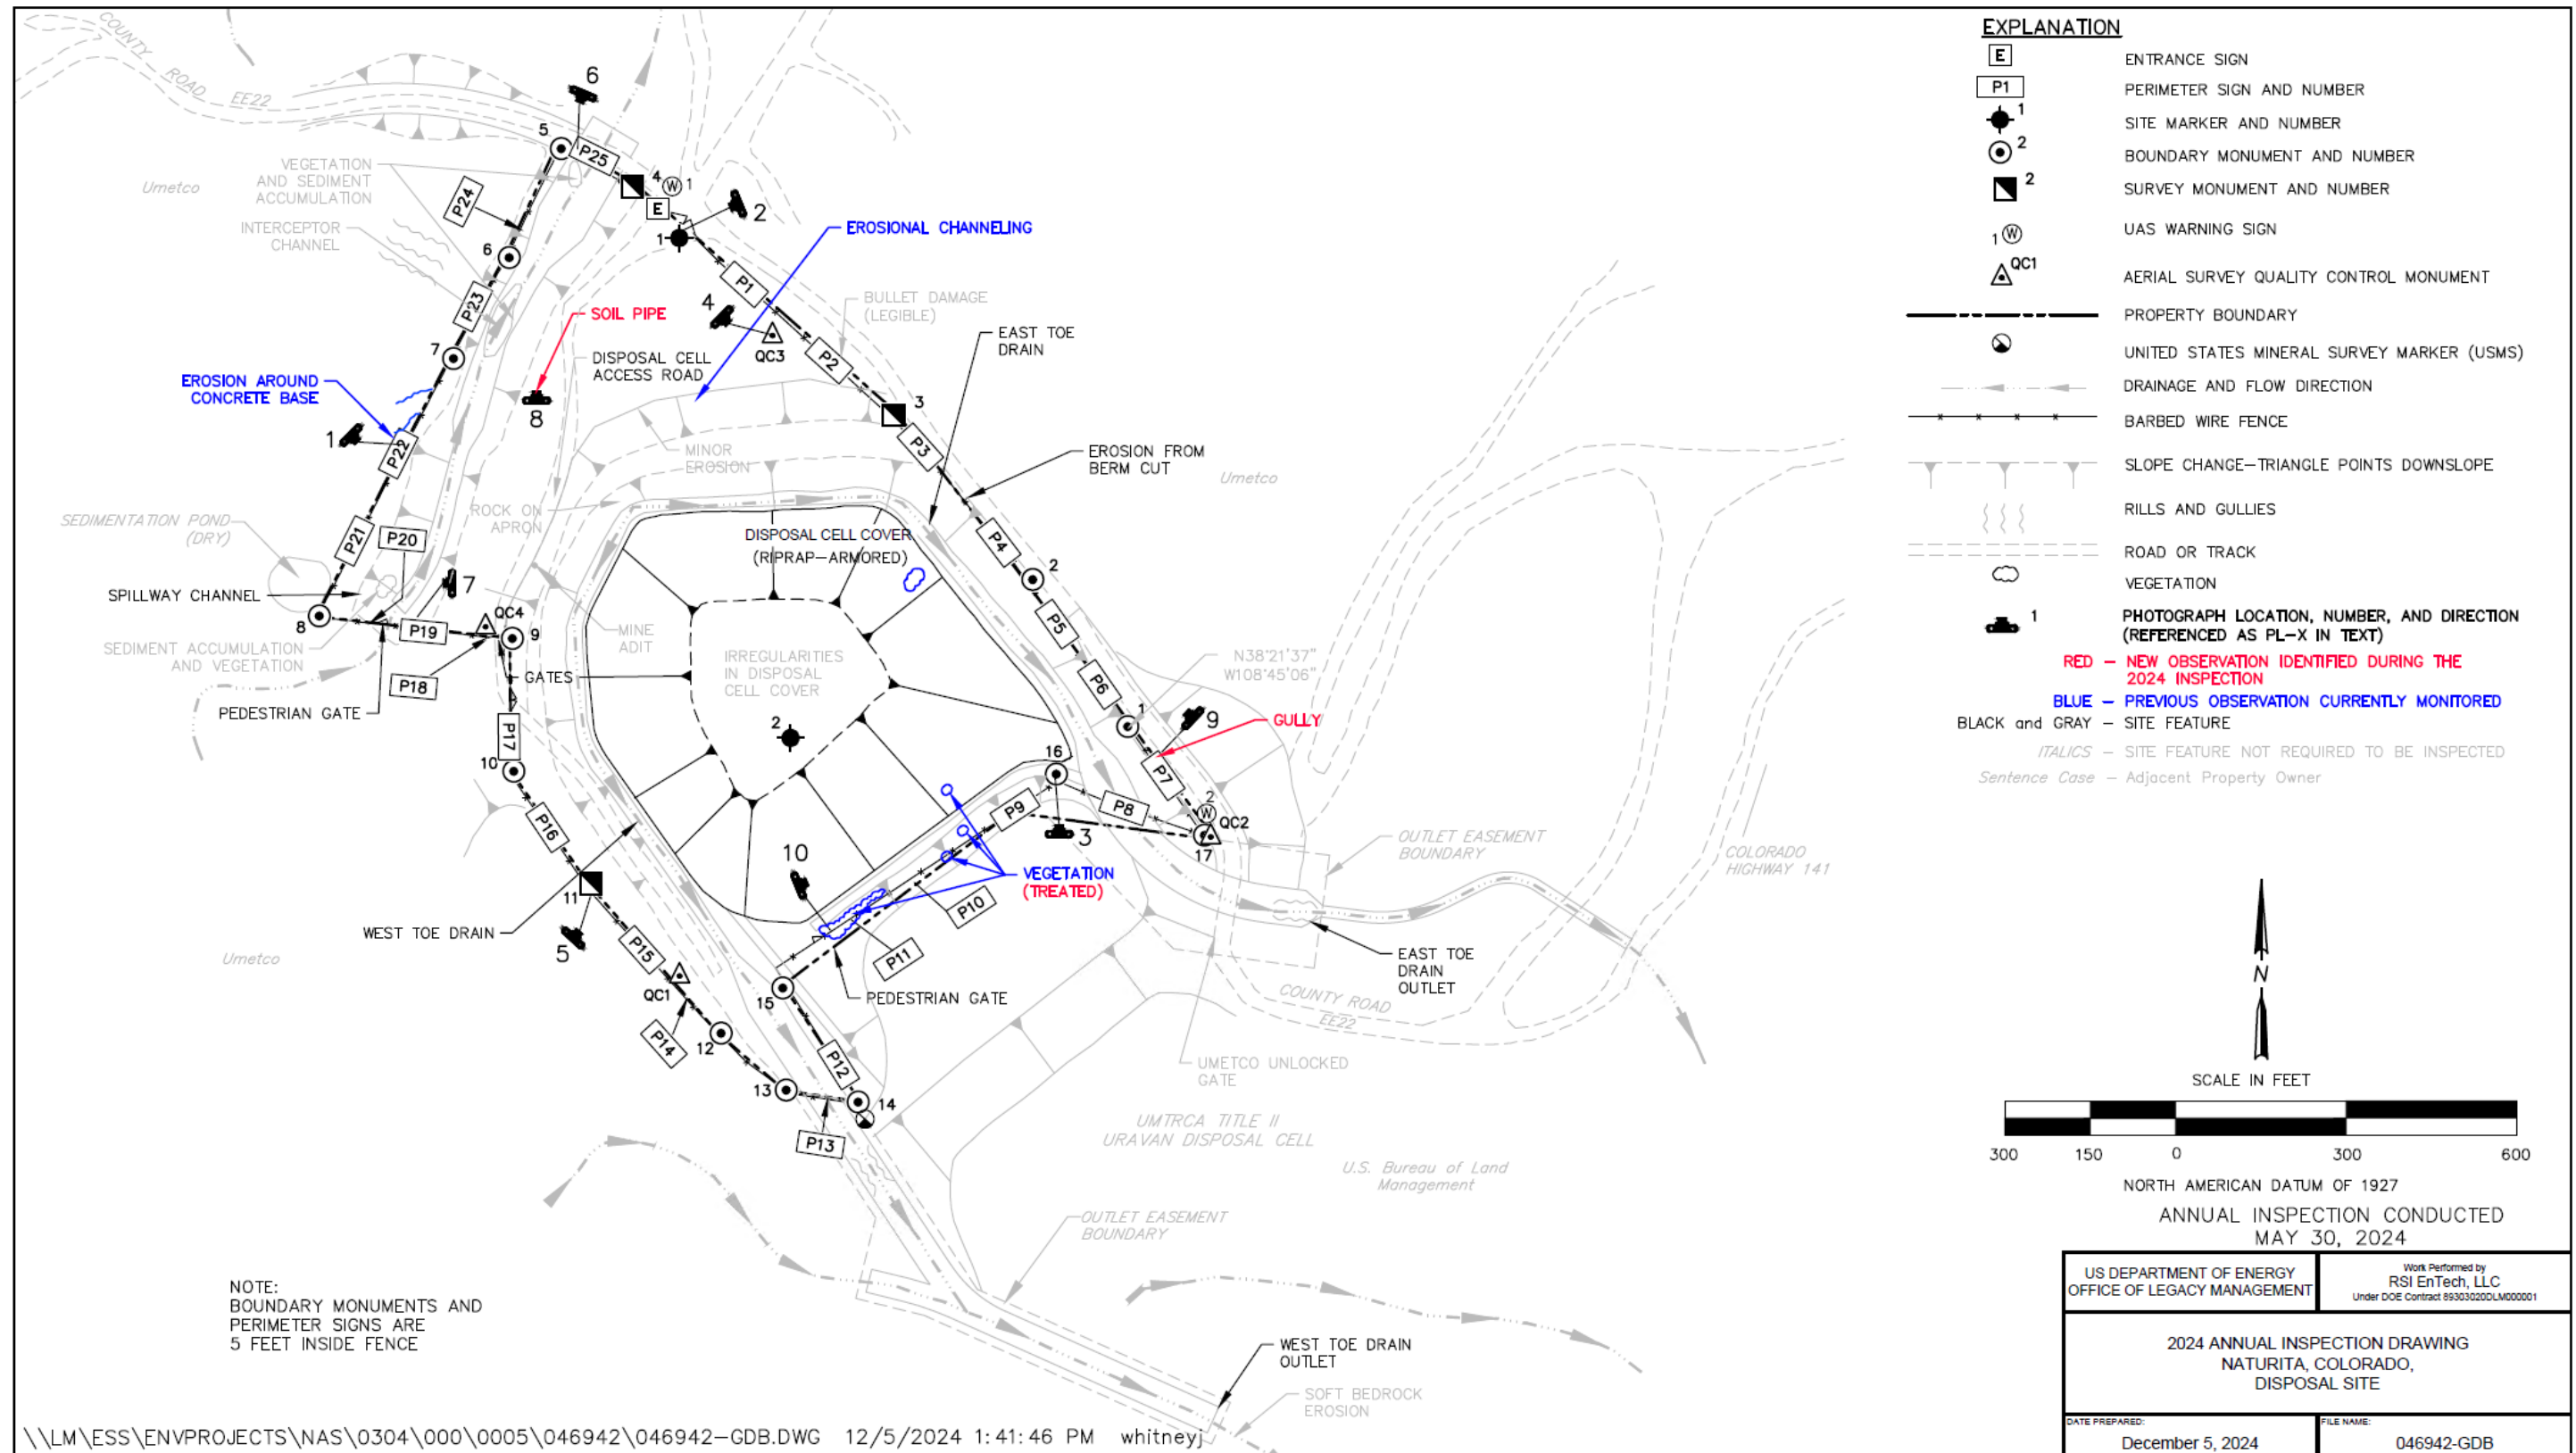
Figure 13-1 shows the locations of site features, including site surveillance features and inspection areas, in black and gray font. Some site features that are present but not required to be inspected are shown in italic font. Observations from previous inspections that are currently monitored are shown in blue, and new observations identified during the 2024 annual inspection are shown in red. Inspection results and recommended maintenance activities associated with site surveillance features are described in the following subsections. Photographs to support specific observations are noted in the text and in Figure 13-1 by photograph location (PL) numbers. The photographs and photograph log are presented in Section 13.10.
