## 14.0 Rifle, Colorado, Disposal Site

### 14.1 Compliance Summary

Figure 14-1. 2021 Annual Inspection Drawing for the Rifle, Colorado, Disposal Site

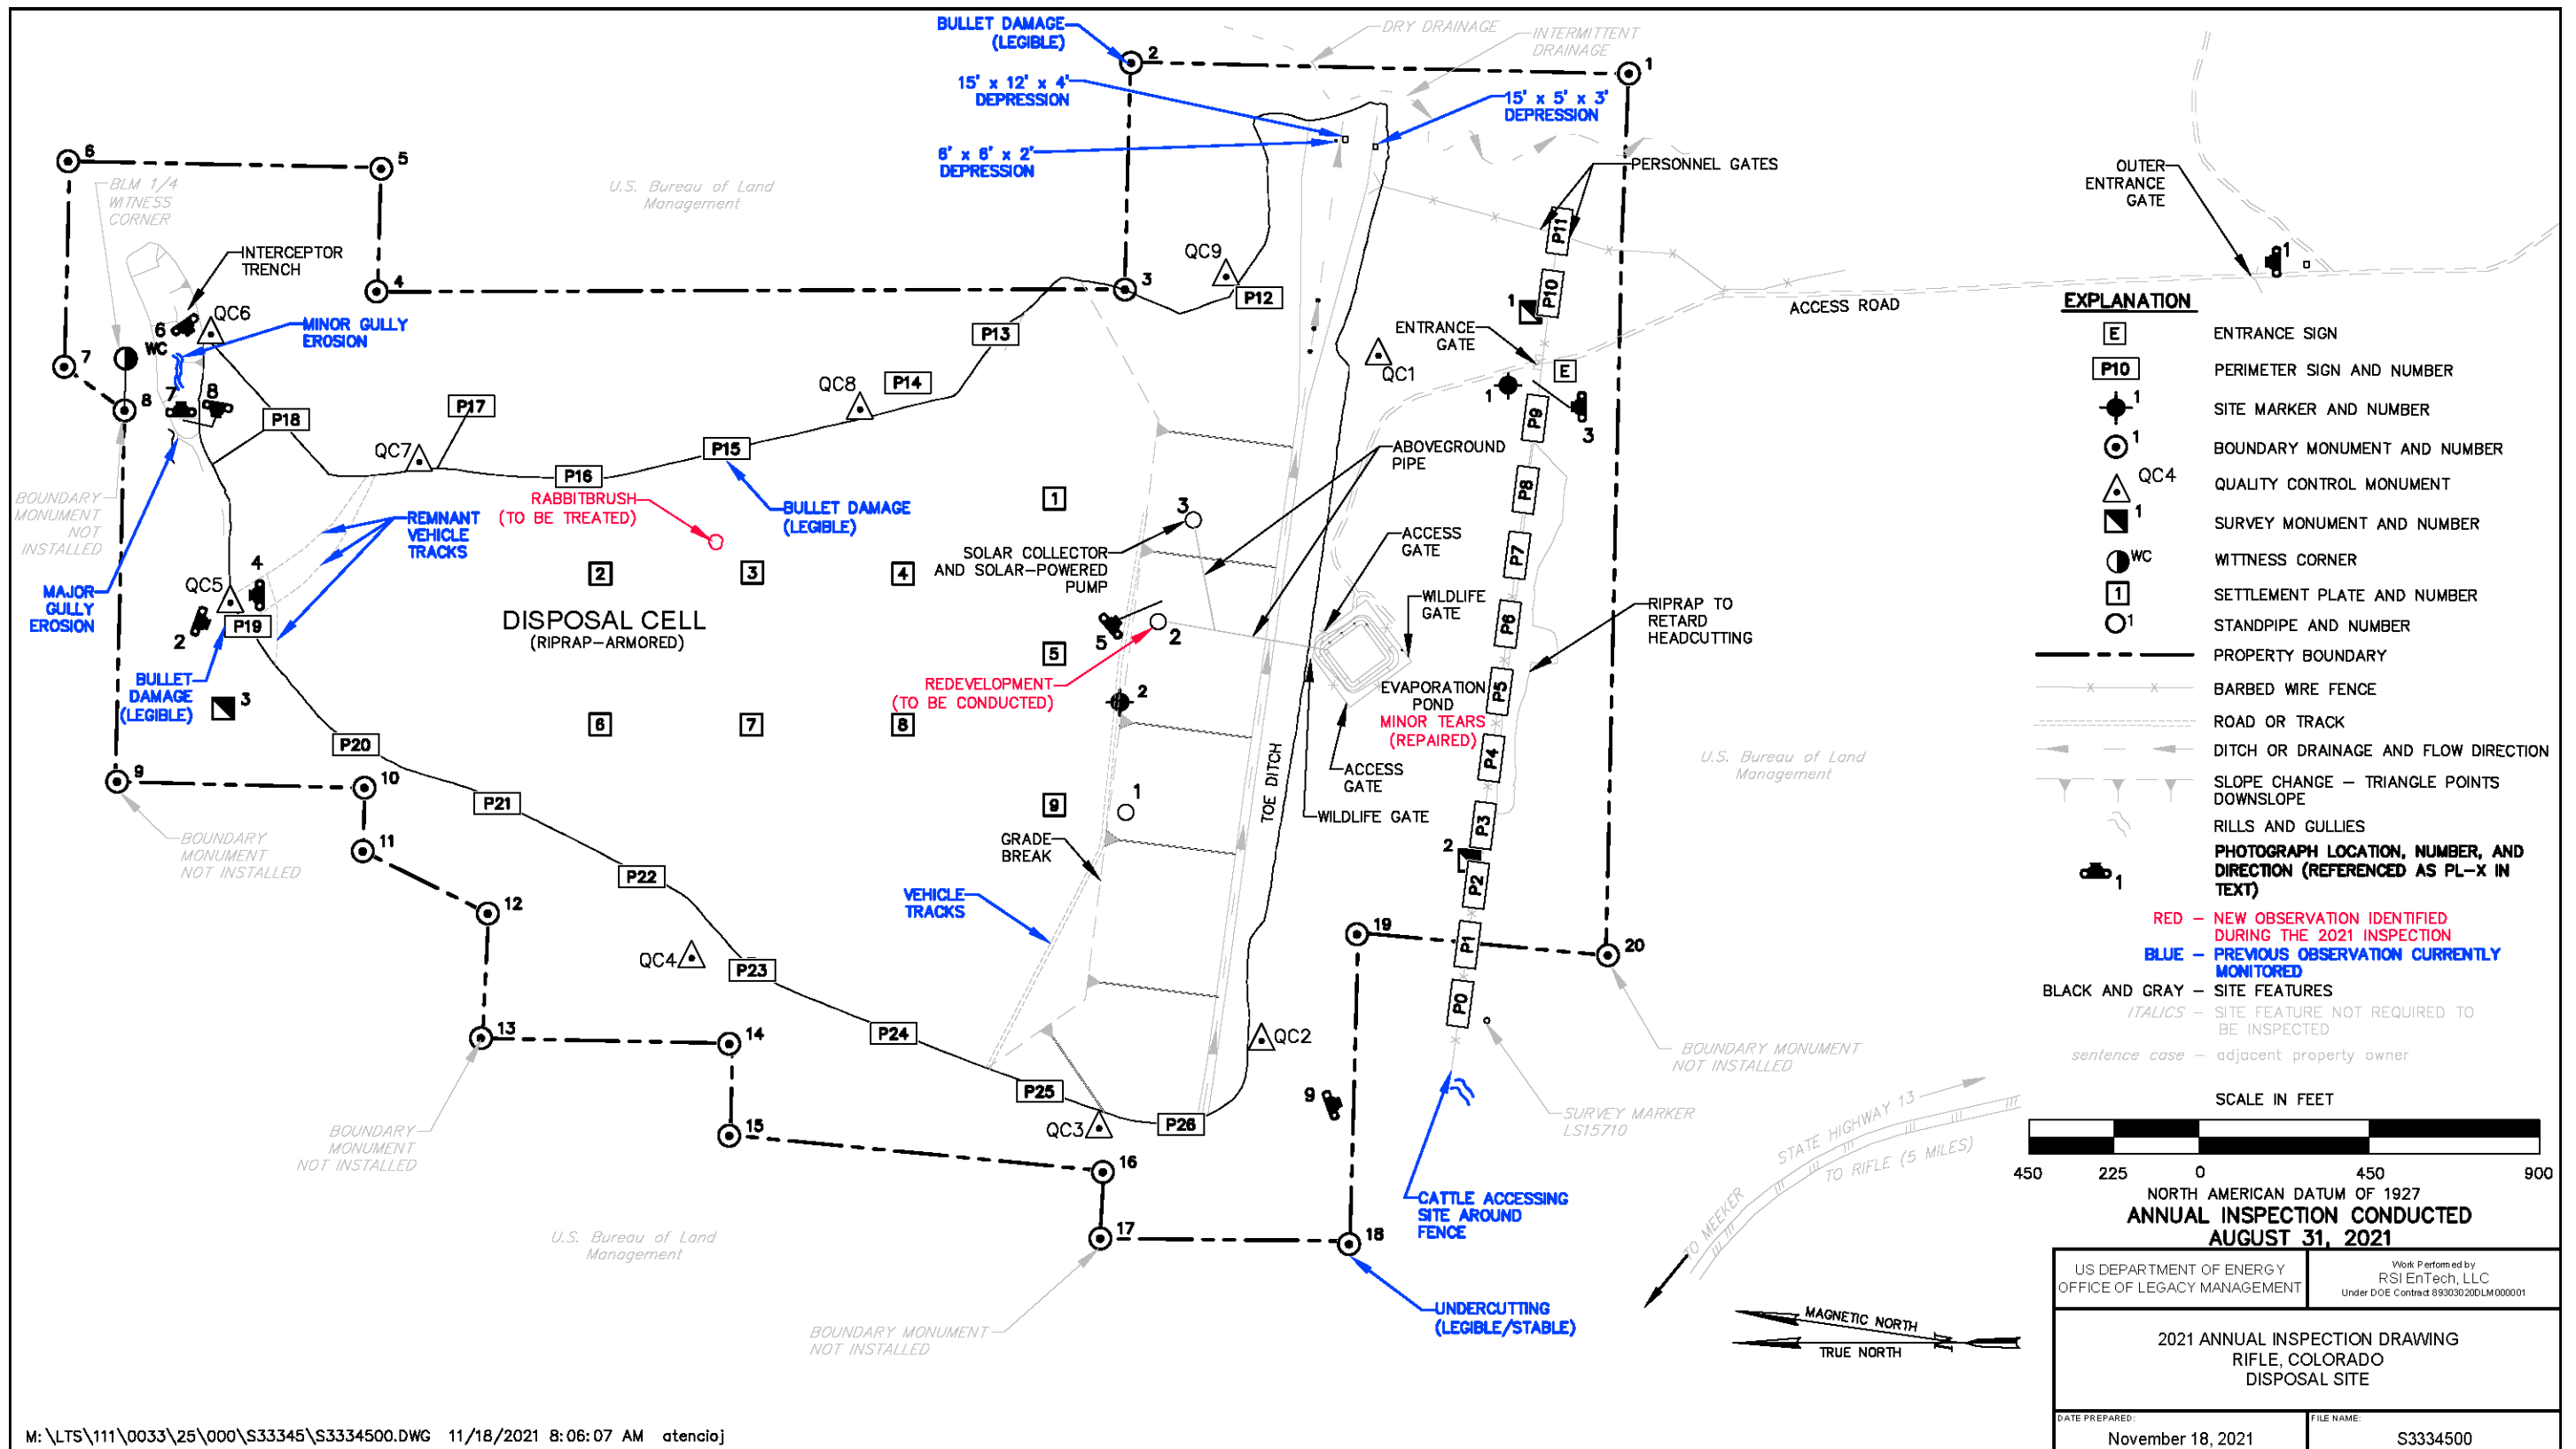
Figure 14-1 shows the locations of site features, including site surveillance features and inspection areas, in black and gray font. Site features that are present but not required to be inspected are shown in italic font. Observations from previous inspections that are currently monitored are shown in blue text, and new observations identified during the 2021 annual inspection are shown in red. Inspection results and recommended maintenance activities associated with site surveillance features are identified in the following subsections. Photographs to support specific observations are identified in the text and in Figure 14-1 by photograph location (PL) numbers. The photographs and photograph log are presented in Section 14.11.
