14.0 Rifle, Colorado, Disposal Site

14.1 Compliance Summary

The Rifle, Colorado, Uranium Mill Tailings Radiation Control Act (UMTRCA) Title I Disposal Site was inspected on August 11, 2022. Minor depressions or undulations were noted on the disposal cell cover, particularly on the western edge of the cell. These features will be verified with the light detection and ranging (lidar) data from the baseline aerial survey. No other changes were observed on the disposal cell. No changes were observed in the associated drainage features. Inspectors identified one minor maintenance need but found no cause for a follow-up inspection.

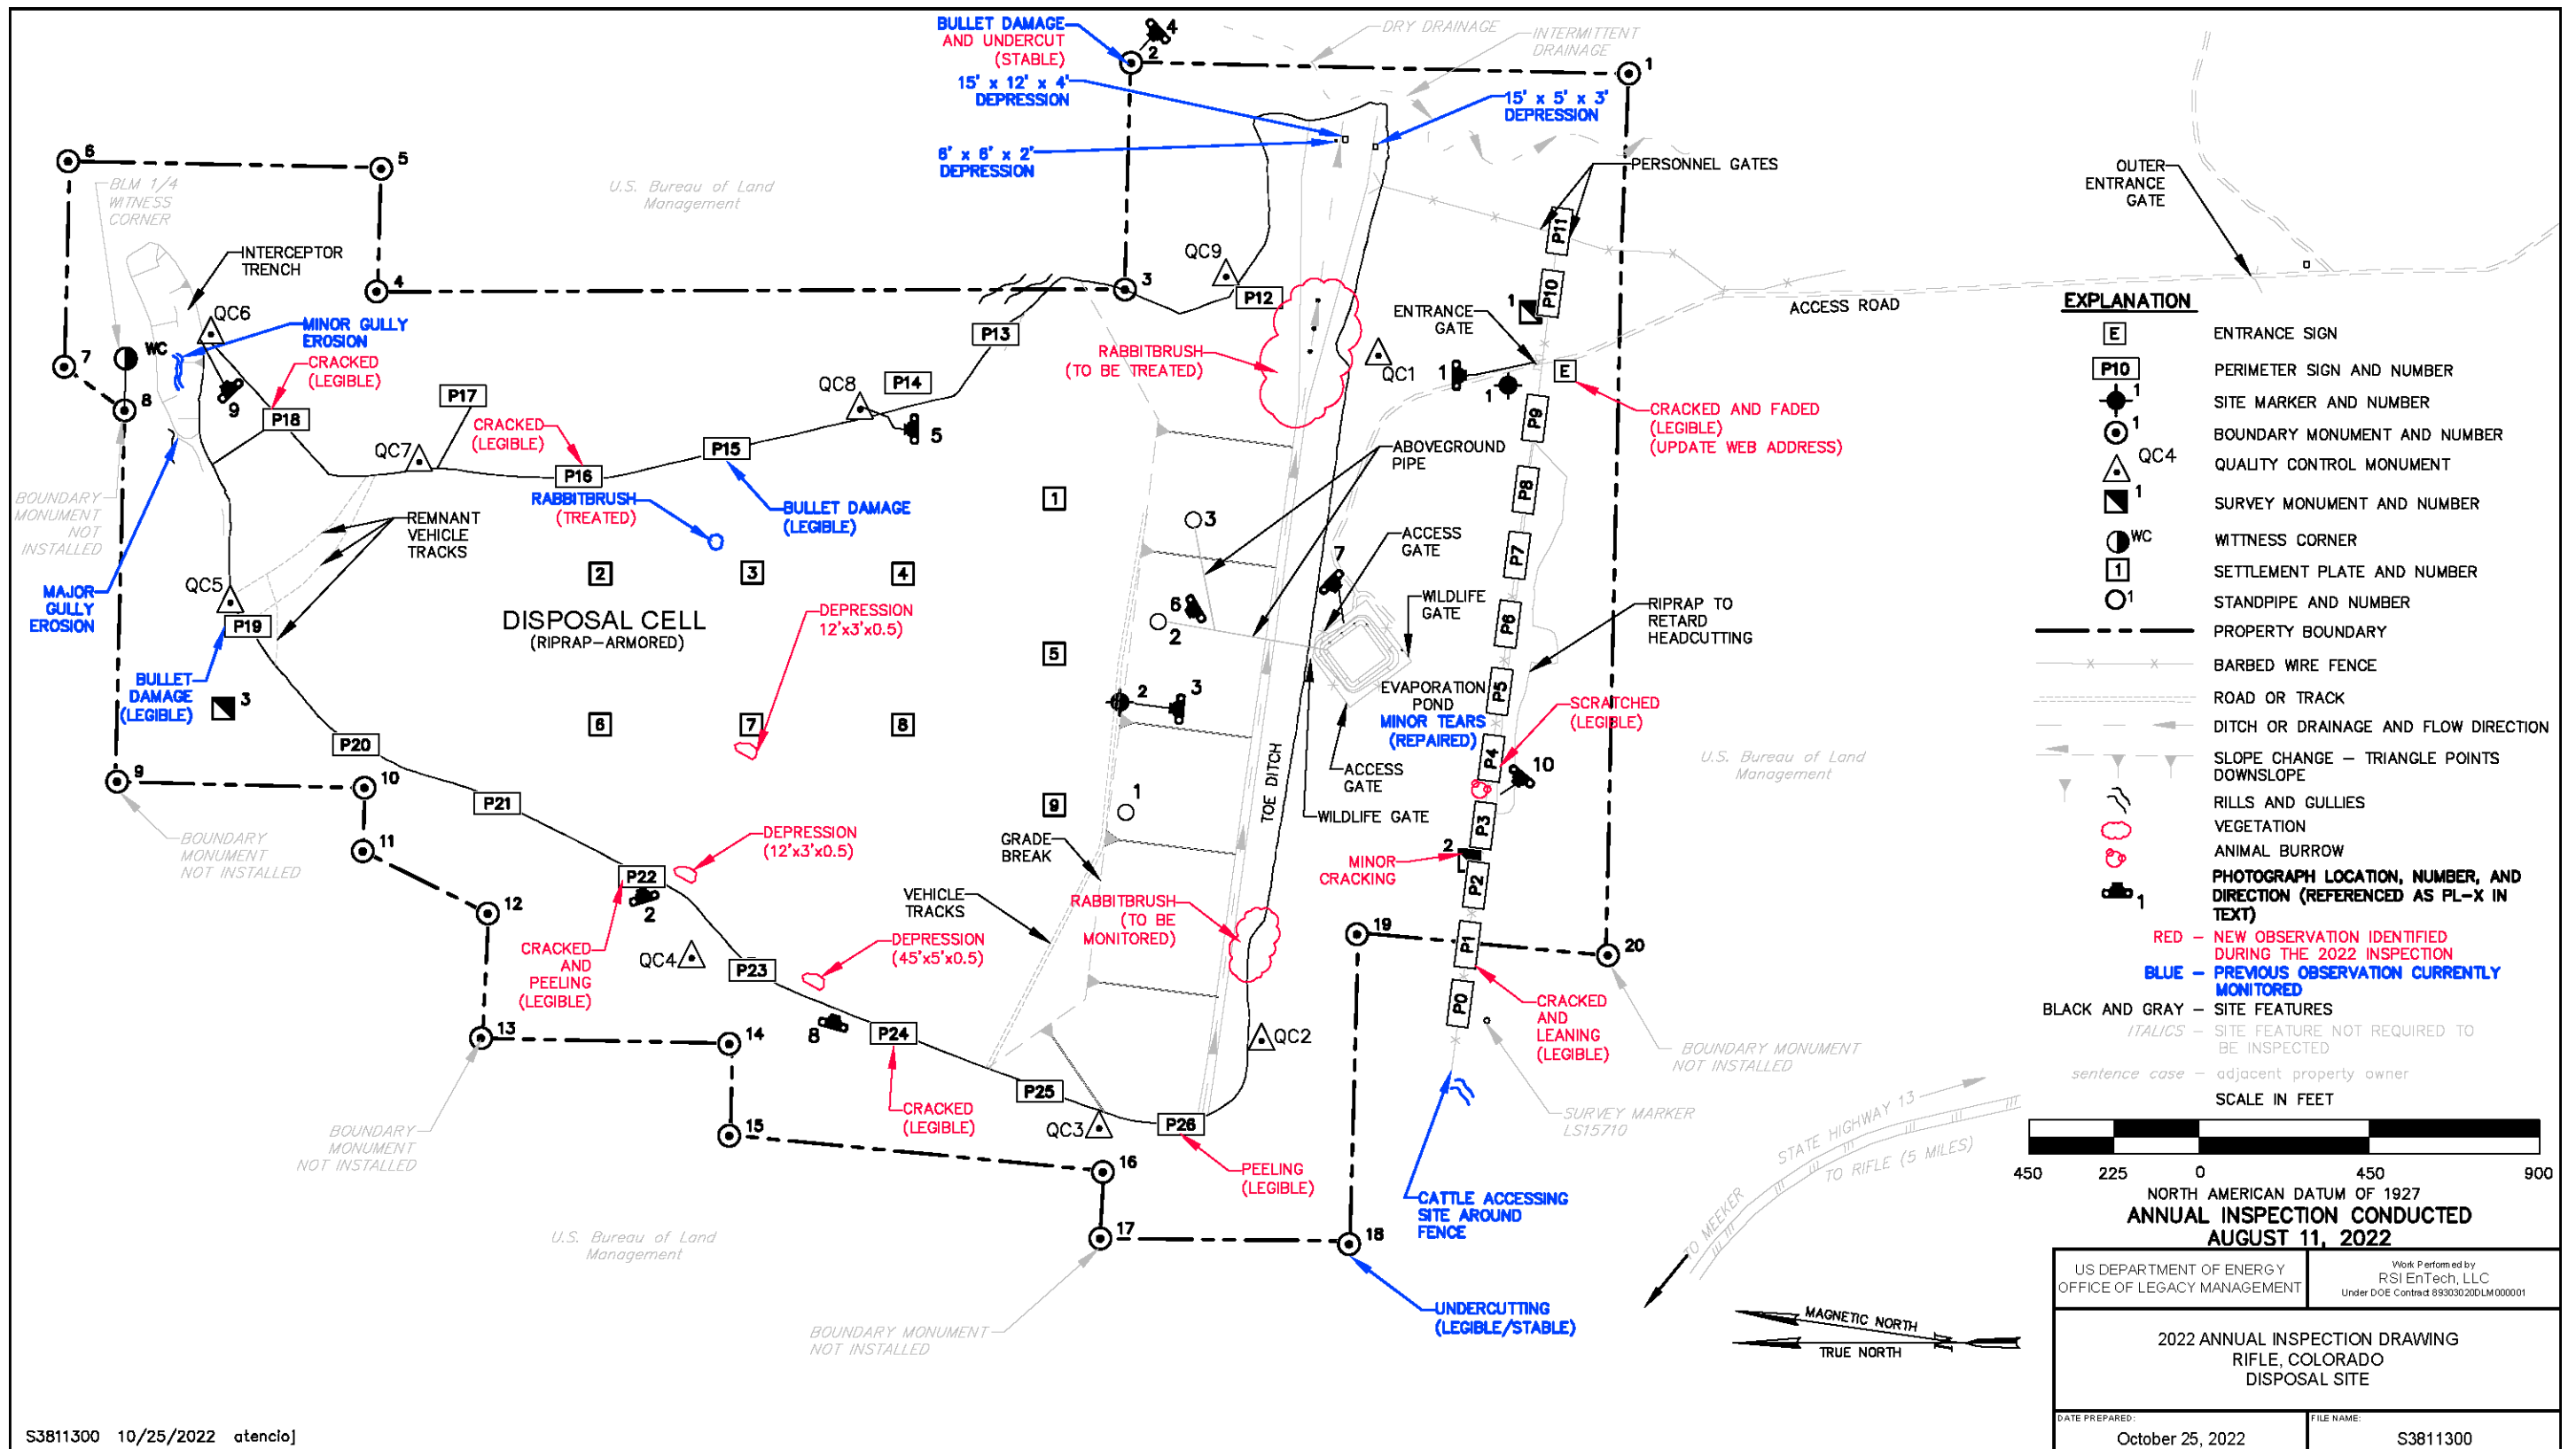
Figure 14-1. 2022 Annual Inspection Drawing for the Rifle, Colorado, Disposal Site

Figure 14-1 shows the locations of site features, including site surveillance features and inspection areas, in black and gray font. Some site features that are present but not required to be inspected are shown in italic font. Observations from previous inspections that are currently monitored are shown in blue, and new observations identified during the 2022 annual inspection are shown in red. Inspection results and recommended maintenance activities associated with site surveillance features are described in the following subsections. Photographs to support specific observations are noted in the text and in Figure 14-1 by photograph location (PL) numbers. The photographs and photograph log are presented in Section 14.11.

In accordance with the LTSP, LM monitors pore-water levels in the disposal cell at standpipes SP-02 and SP-03, which are installed at the downgradient end of the disposal cell on the south side slope (Figure 14-1). The pore-water levels were monitored during monthly pump shutdown periods, which allowed the water level to equilibrate. This monitoring is conducted in conjunction with extraction to maintain water levels below the high-density polyethylene (HDPE) liner that was installed in the toe of the disposal cell at an elevation of 6022.50 ft during original construction. In 2022, monthly recovery tests have been paused for maintenance efforts and will resume in 2023. The bottom of standpipe SP-01 is at an elevation of 6023.95 ft; as such, it continues to be dry and does not require continuous monitoring.
