14.0 Rifle, Colorado, Disposal Site

14.1 Compliance Summary

Figure 14-1. 2023 Annual Inspection Drawing for the Rifle, Colorado, Disposal Site

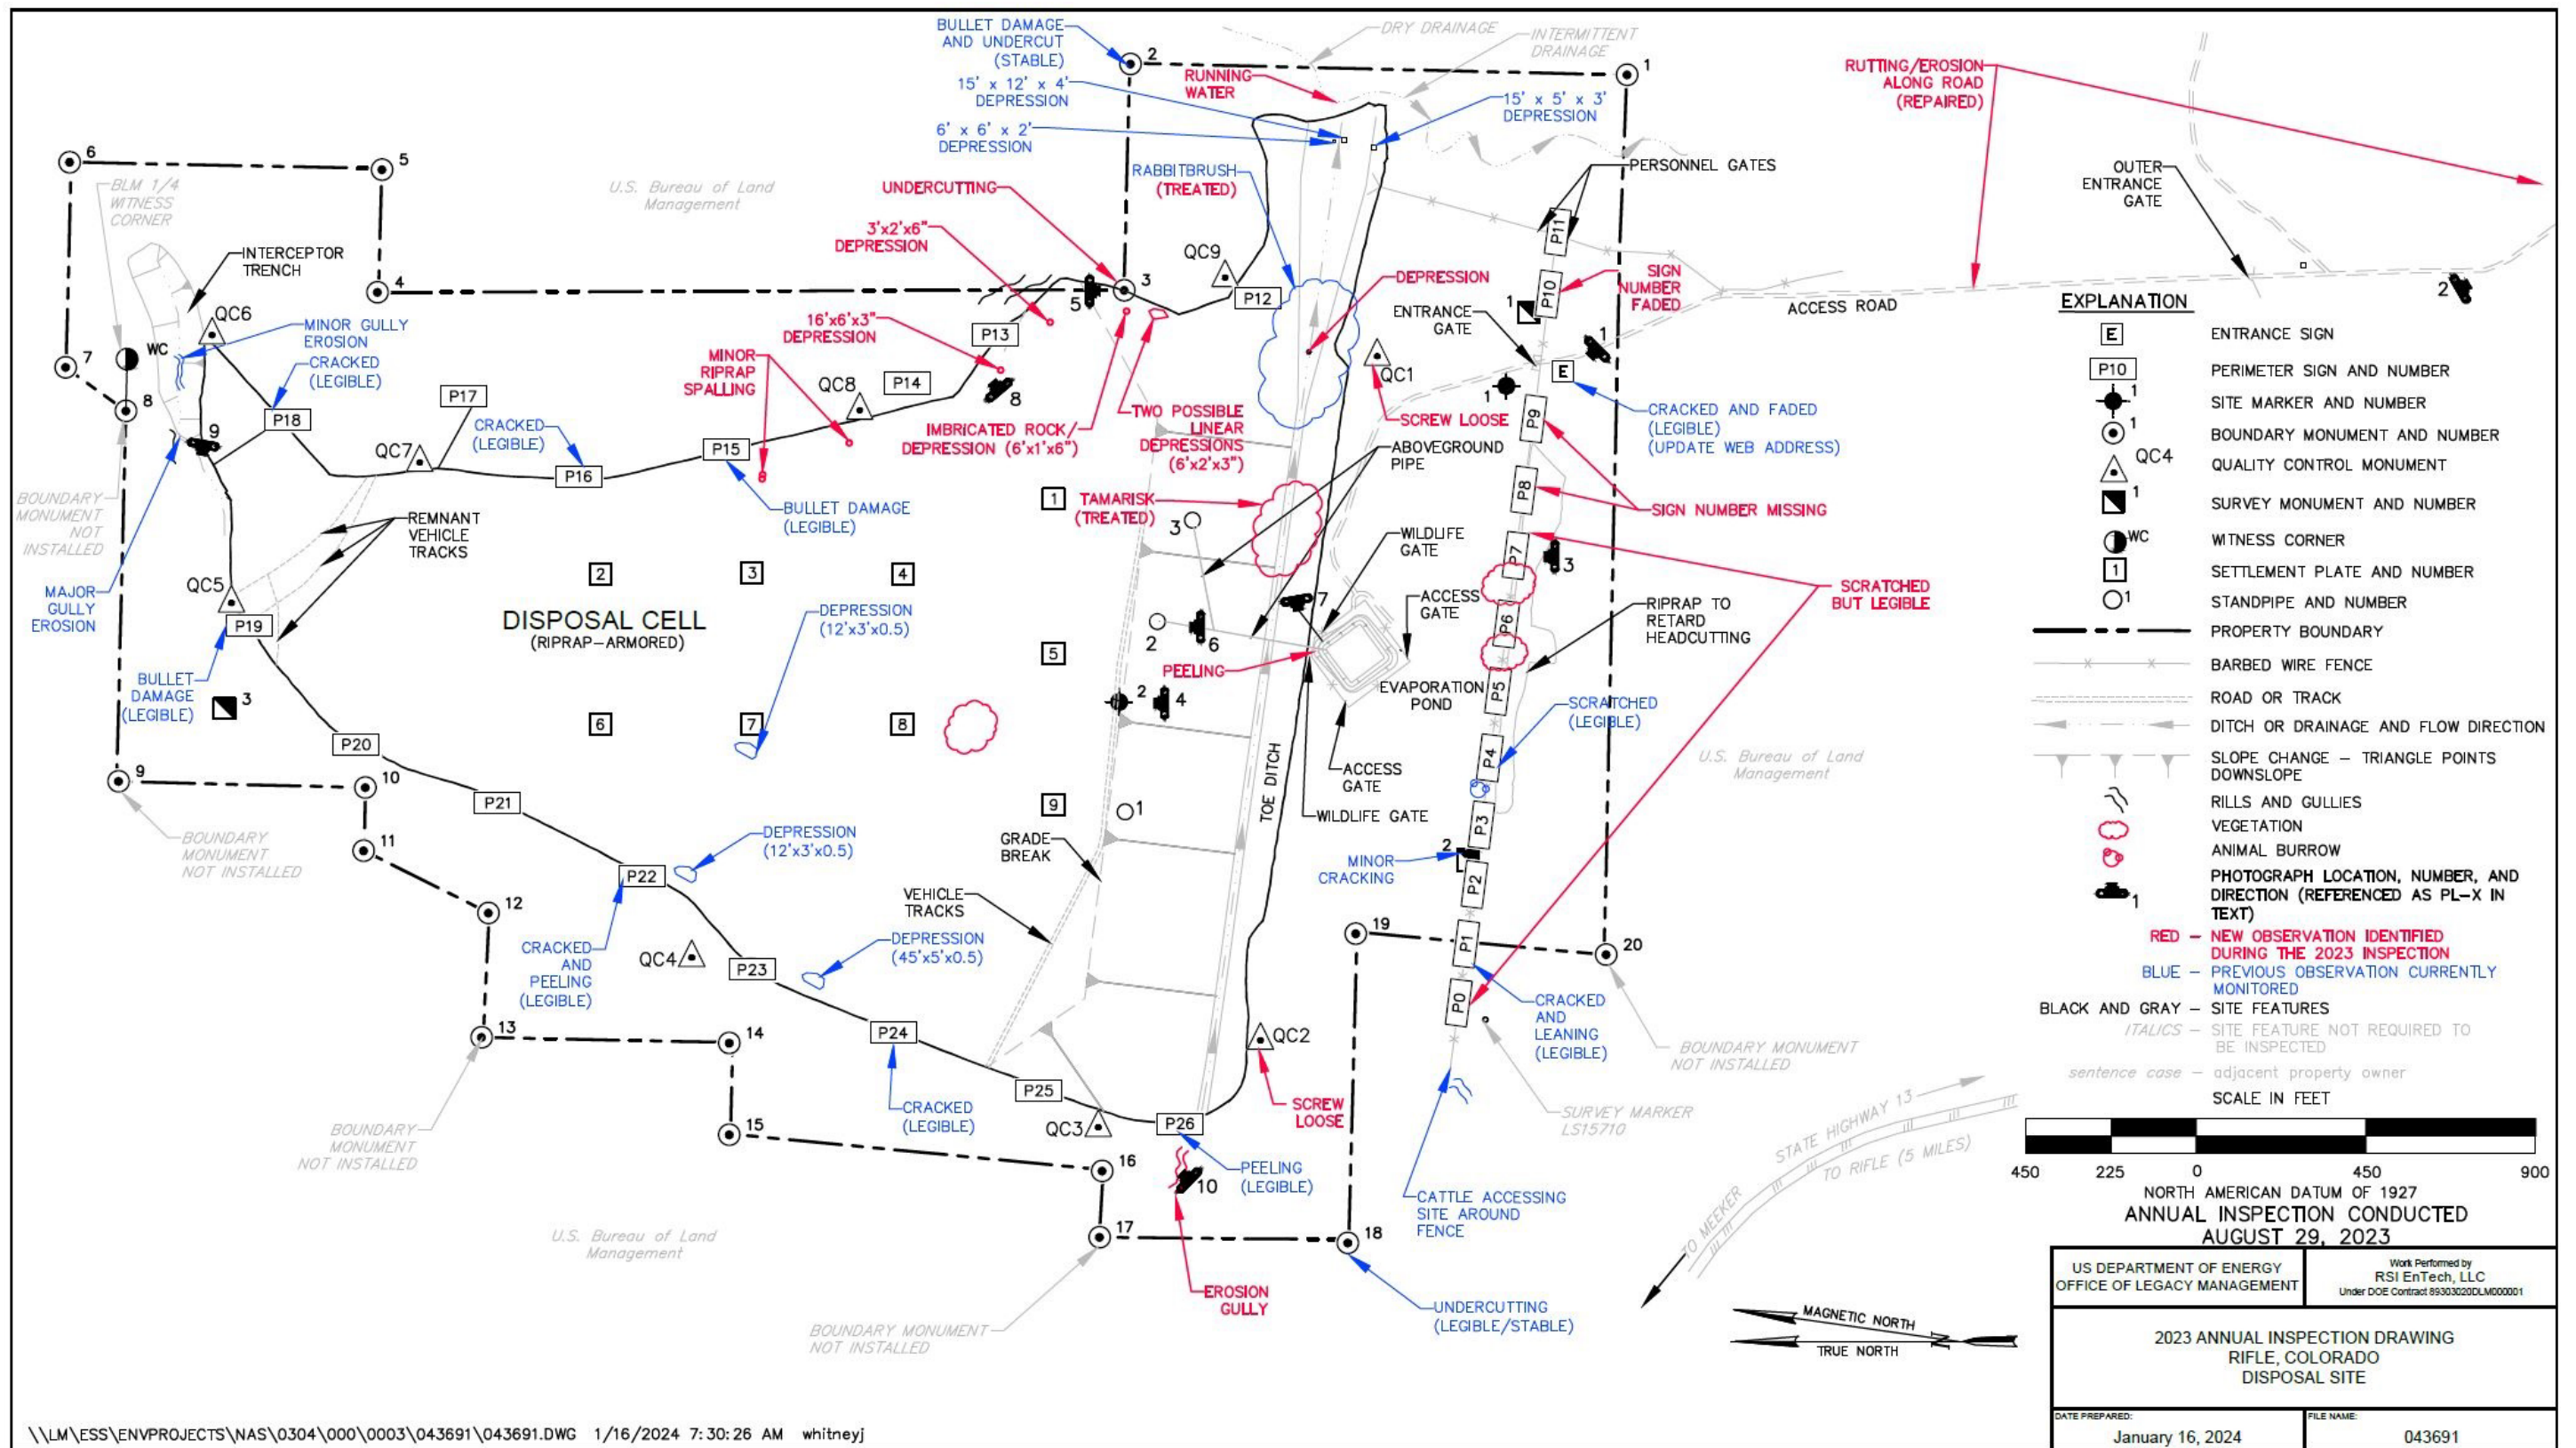
Figure 14-1 shows the locations of site features, including site surveillance features and inspection areas, in black and gray font. Some site features that are present but not required to be inspected are shown in italic font. Observations from previous inspections that are currently monitored are shown in blue, and new observations identified during the 2023 annual inspection are shown in red. Inspection results and recommended maintenance activities associated with site surveillance features are described in the following subsections. Photographs to support specific observations are noted in the text and in Figure 14-1 by photograph location (PL) numbers. The photographs and photograph log are presented in Section 14.11.
