15.0 Salt Lake City, Utah, Disposal Site

15.4 Inspection Results

Figure 15-1. 2021 Annual Inspection Drawing for the Salt Lake City, Utah, Disposal Site

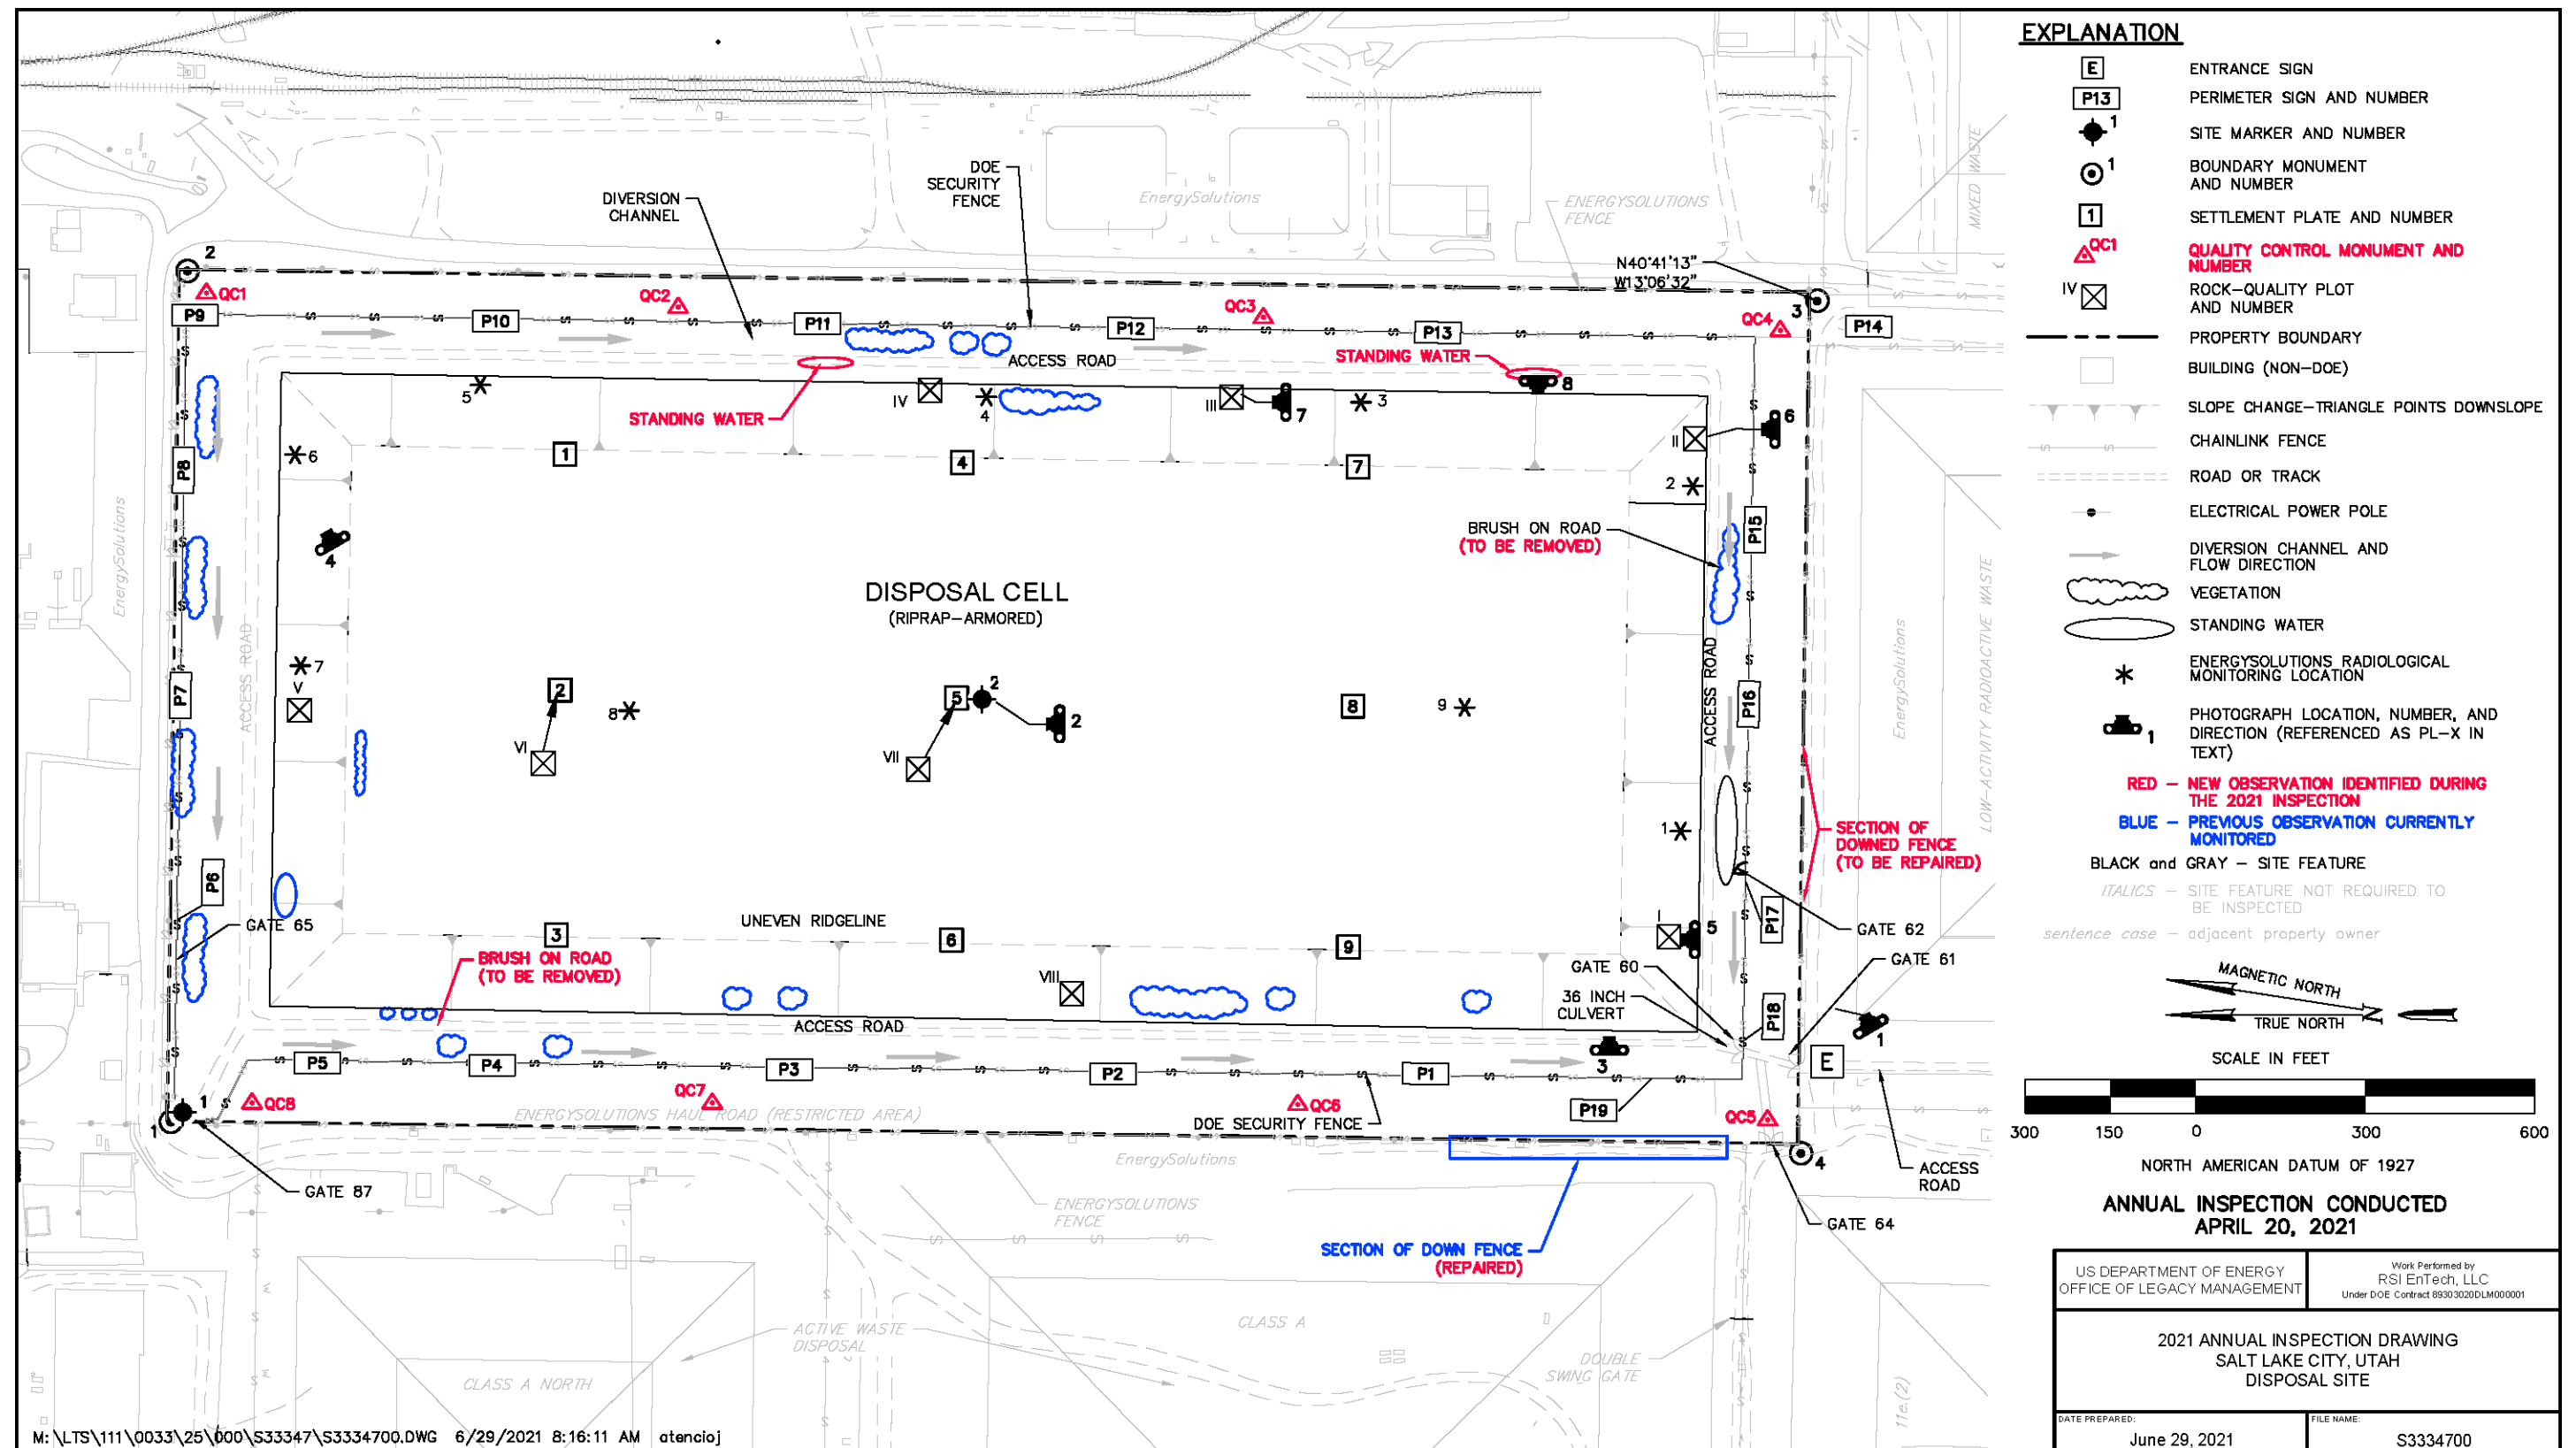
Figure 15-1 shows the locations of site features, including site surveillance features and inspection areas, in black and gray font. Site features that are present but not required to be inspected are shown in italic font. Observations from previous inspections that are currently monitored are shown in blue text, and new observations identified during the 2021 annual inspection are shown in red. Inspection results and recommended maintenance activities associated with site surveillance features are described in the following subsections. Photographs to support specific observations are identified in the text and in Figure 15-1 by photograph location (PL) numbers. The photographs and photograph log are presented in Section 15.10.
