## 15.0 Salt Lake City, Utah, Disposal Site

### 15.1 Compliance Summary

The Salt Lake City, Utah, Uranium Mill Tailings Radiation Control Act (UMTRCA) Title I Disposal Site was inspected on April 19, 2022. No changes were observed on the disposal cell or in associated drainage features. Observations of rock-quality monitoring plots indicated no significant change from the previous year. Inspectors identified one routine maintenance need but found no cause for a follow-up inspection. Minor maintenance needs were identified and will be completed before the next inspection. Groundwater monitoring is not required.

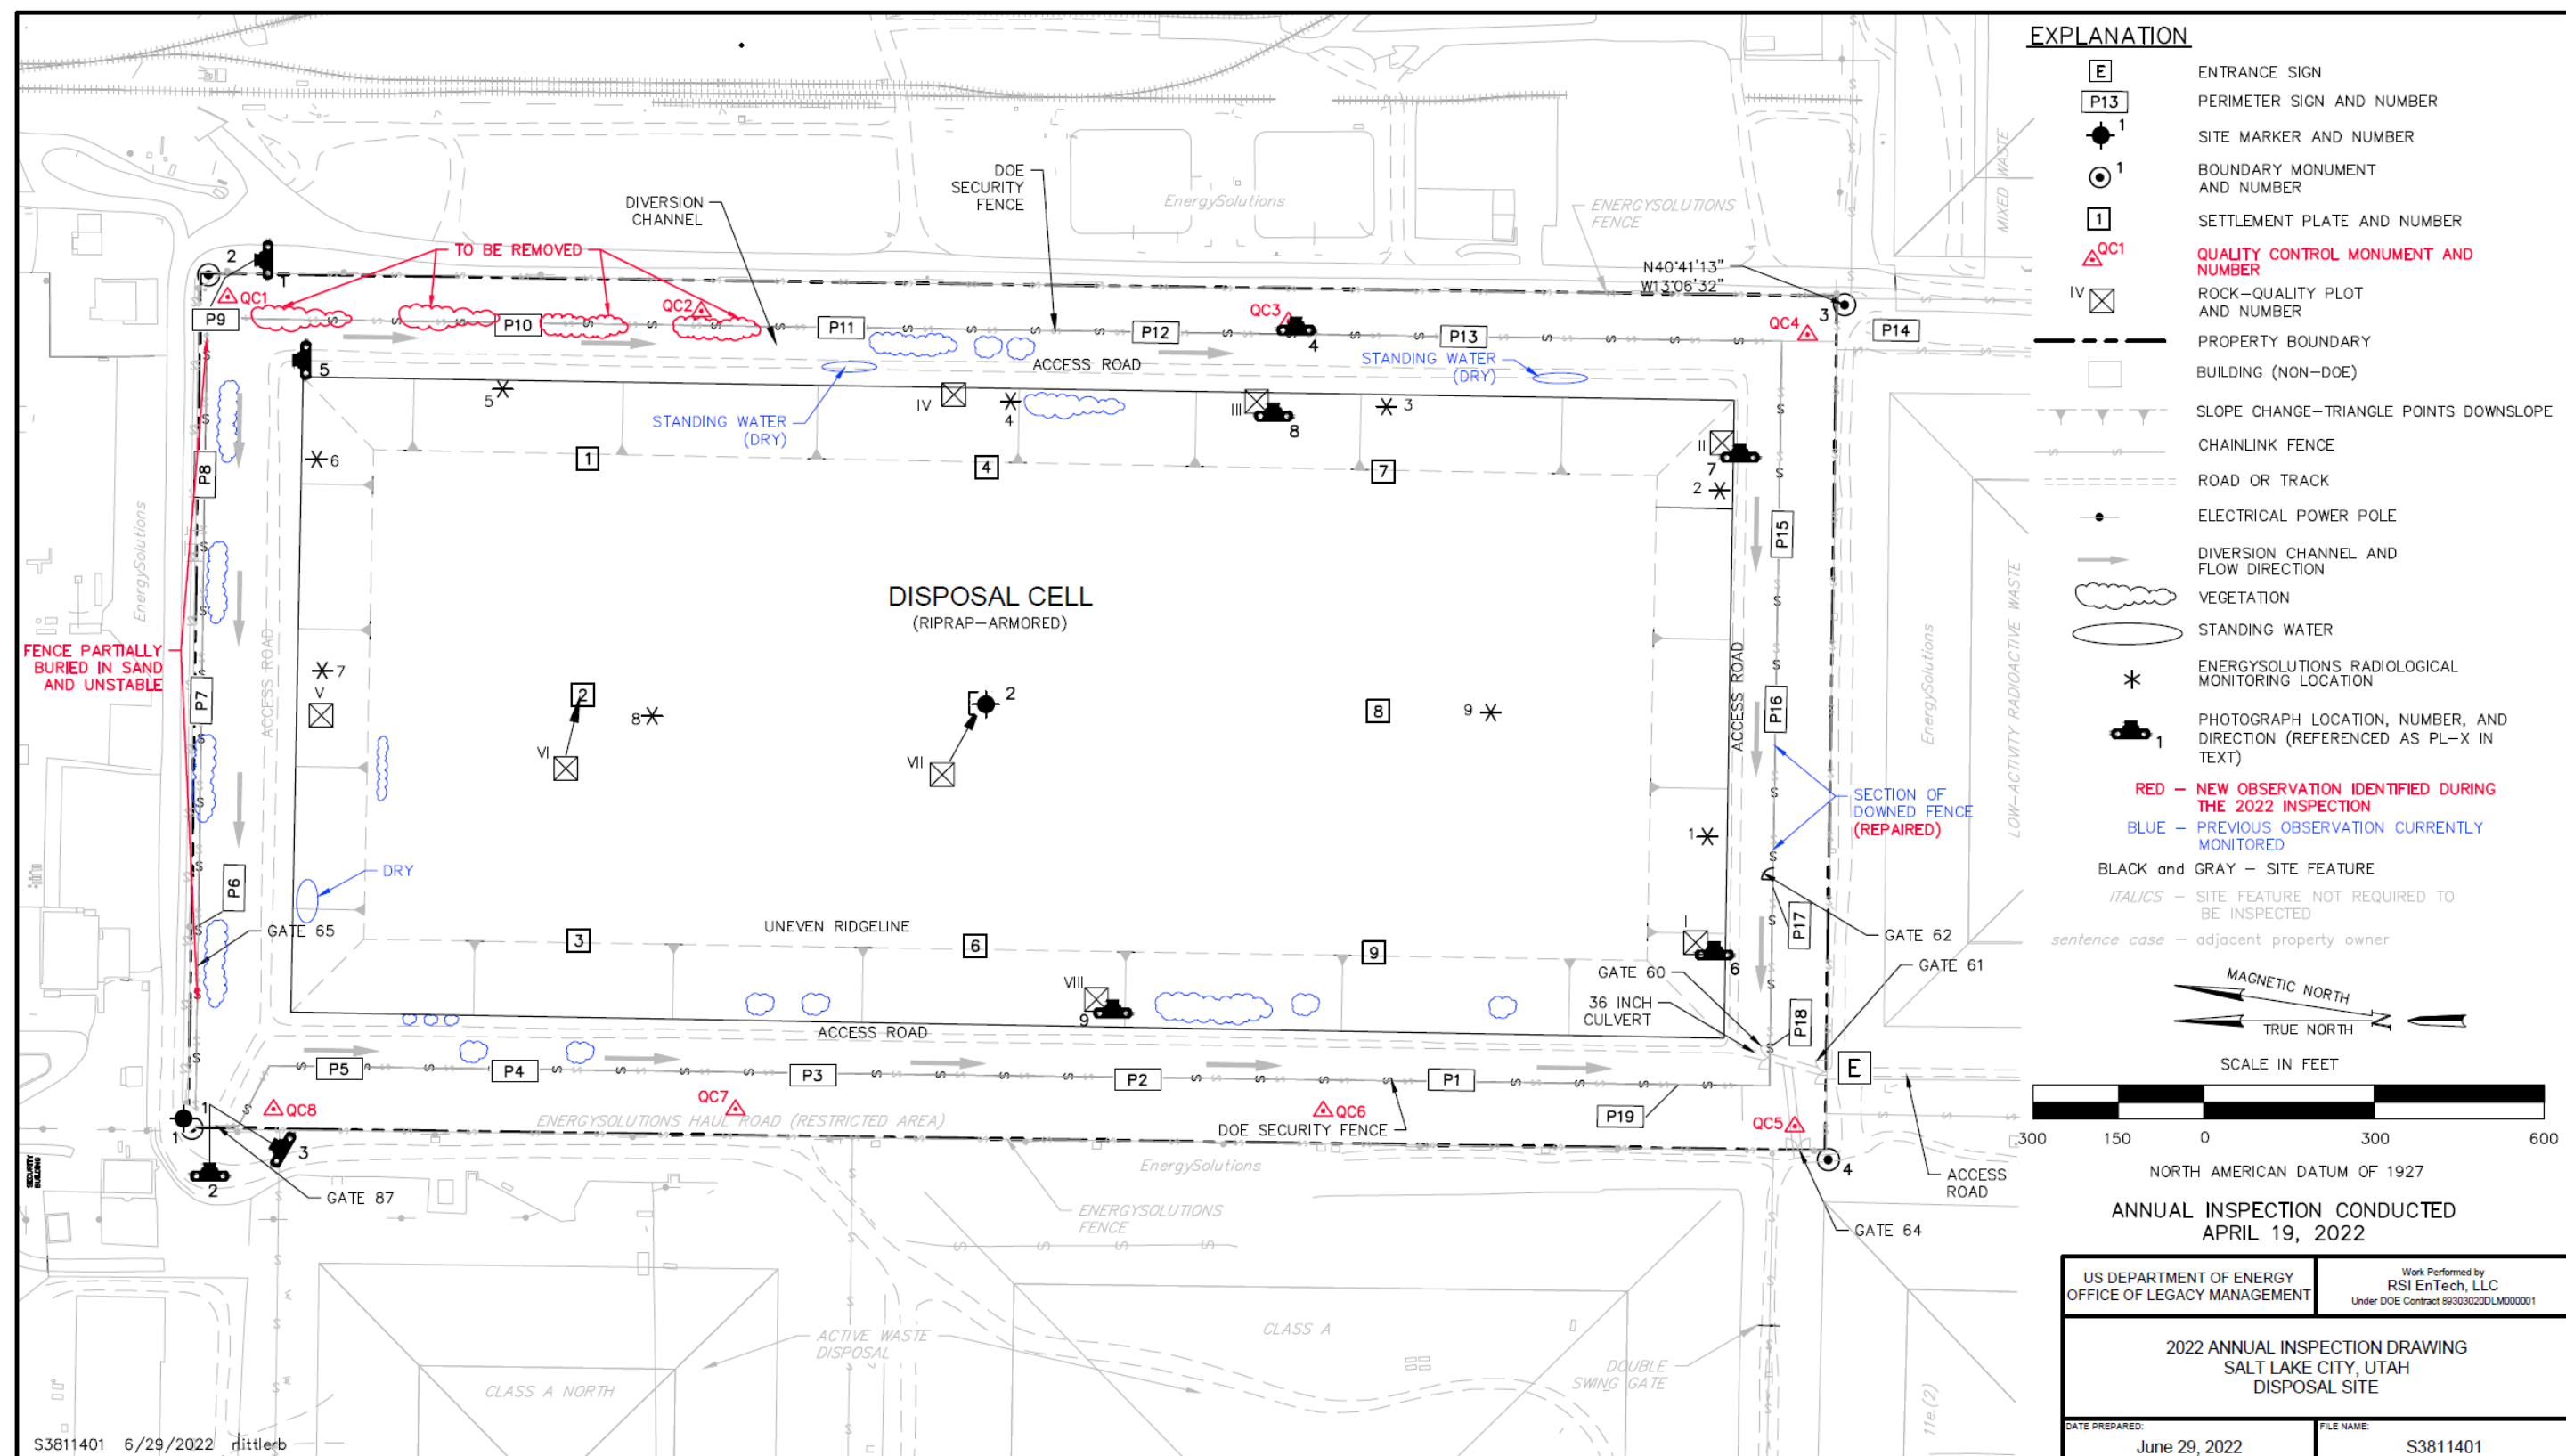
Figure 15-1. 2022 Annual Inspection Drawing for the Salt Lake City, Utah, Disposal Site

Figure 15-1 shows the locations of site features, including site surveillance features and inspection areas, in black and gray font. Some site features that are present but not required to be inspected are shown in italic font. Observations from previous inspections that are currently monitored are shown in blue, and new observations identified during the 2022 annual inspection are shown in red. Inspection results and recommended maintenance activities associated with site surveillance features are described in the following subsections. Photographs to support specific observations are noted in the text and in Figure 15-1 by photograph location (PL) numbers. The photographs and photograph log are presented in Section 15.10.

Eight rock-quality monitoring plots, each measuring 1 square meter (indicated by Roman numerals I–VIII in Figure 15-1), were established in 2010 to monitor for continued rock degradation.

Dose rate measurements and wipe samples were collected at various locations around the base of the disposal cell, including on the disposal cell top slope during the 2022 annual inspection. Nine wipe samples were collected by the EnergySolutions radiological control technician at the specific radiological monitoring locations depicted in Figure 15-1.
