## 16.0 Shiprock, New Mexico, Disposal Site

### 16.1 Compliance Summary

The Shiprock, New Mexico, Uranium Mill Tailings Radiation Control Act (UMTRCA) Title I Disposal Site was inspected on June 8, 2021. No changes were observed on the disposal cell or in the associated diversion channels. Inspectors identified several minor maintenance needs but found no cause for a follow-up inspection. Groundwater monitoring to evaluate disposal cell performance is not required.

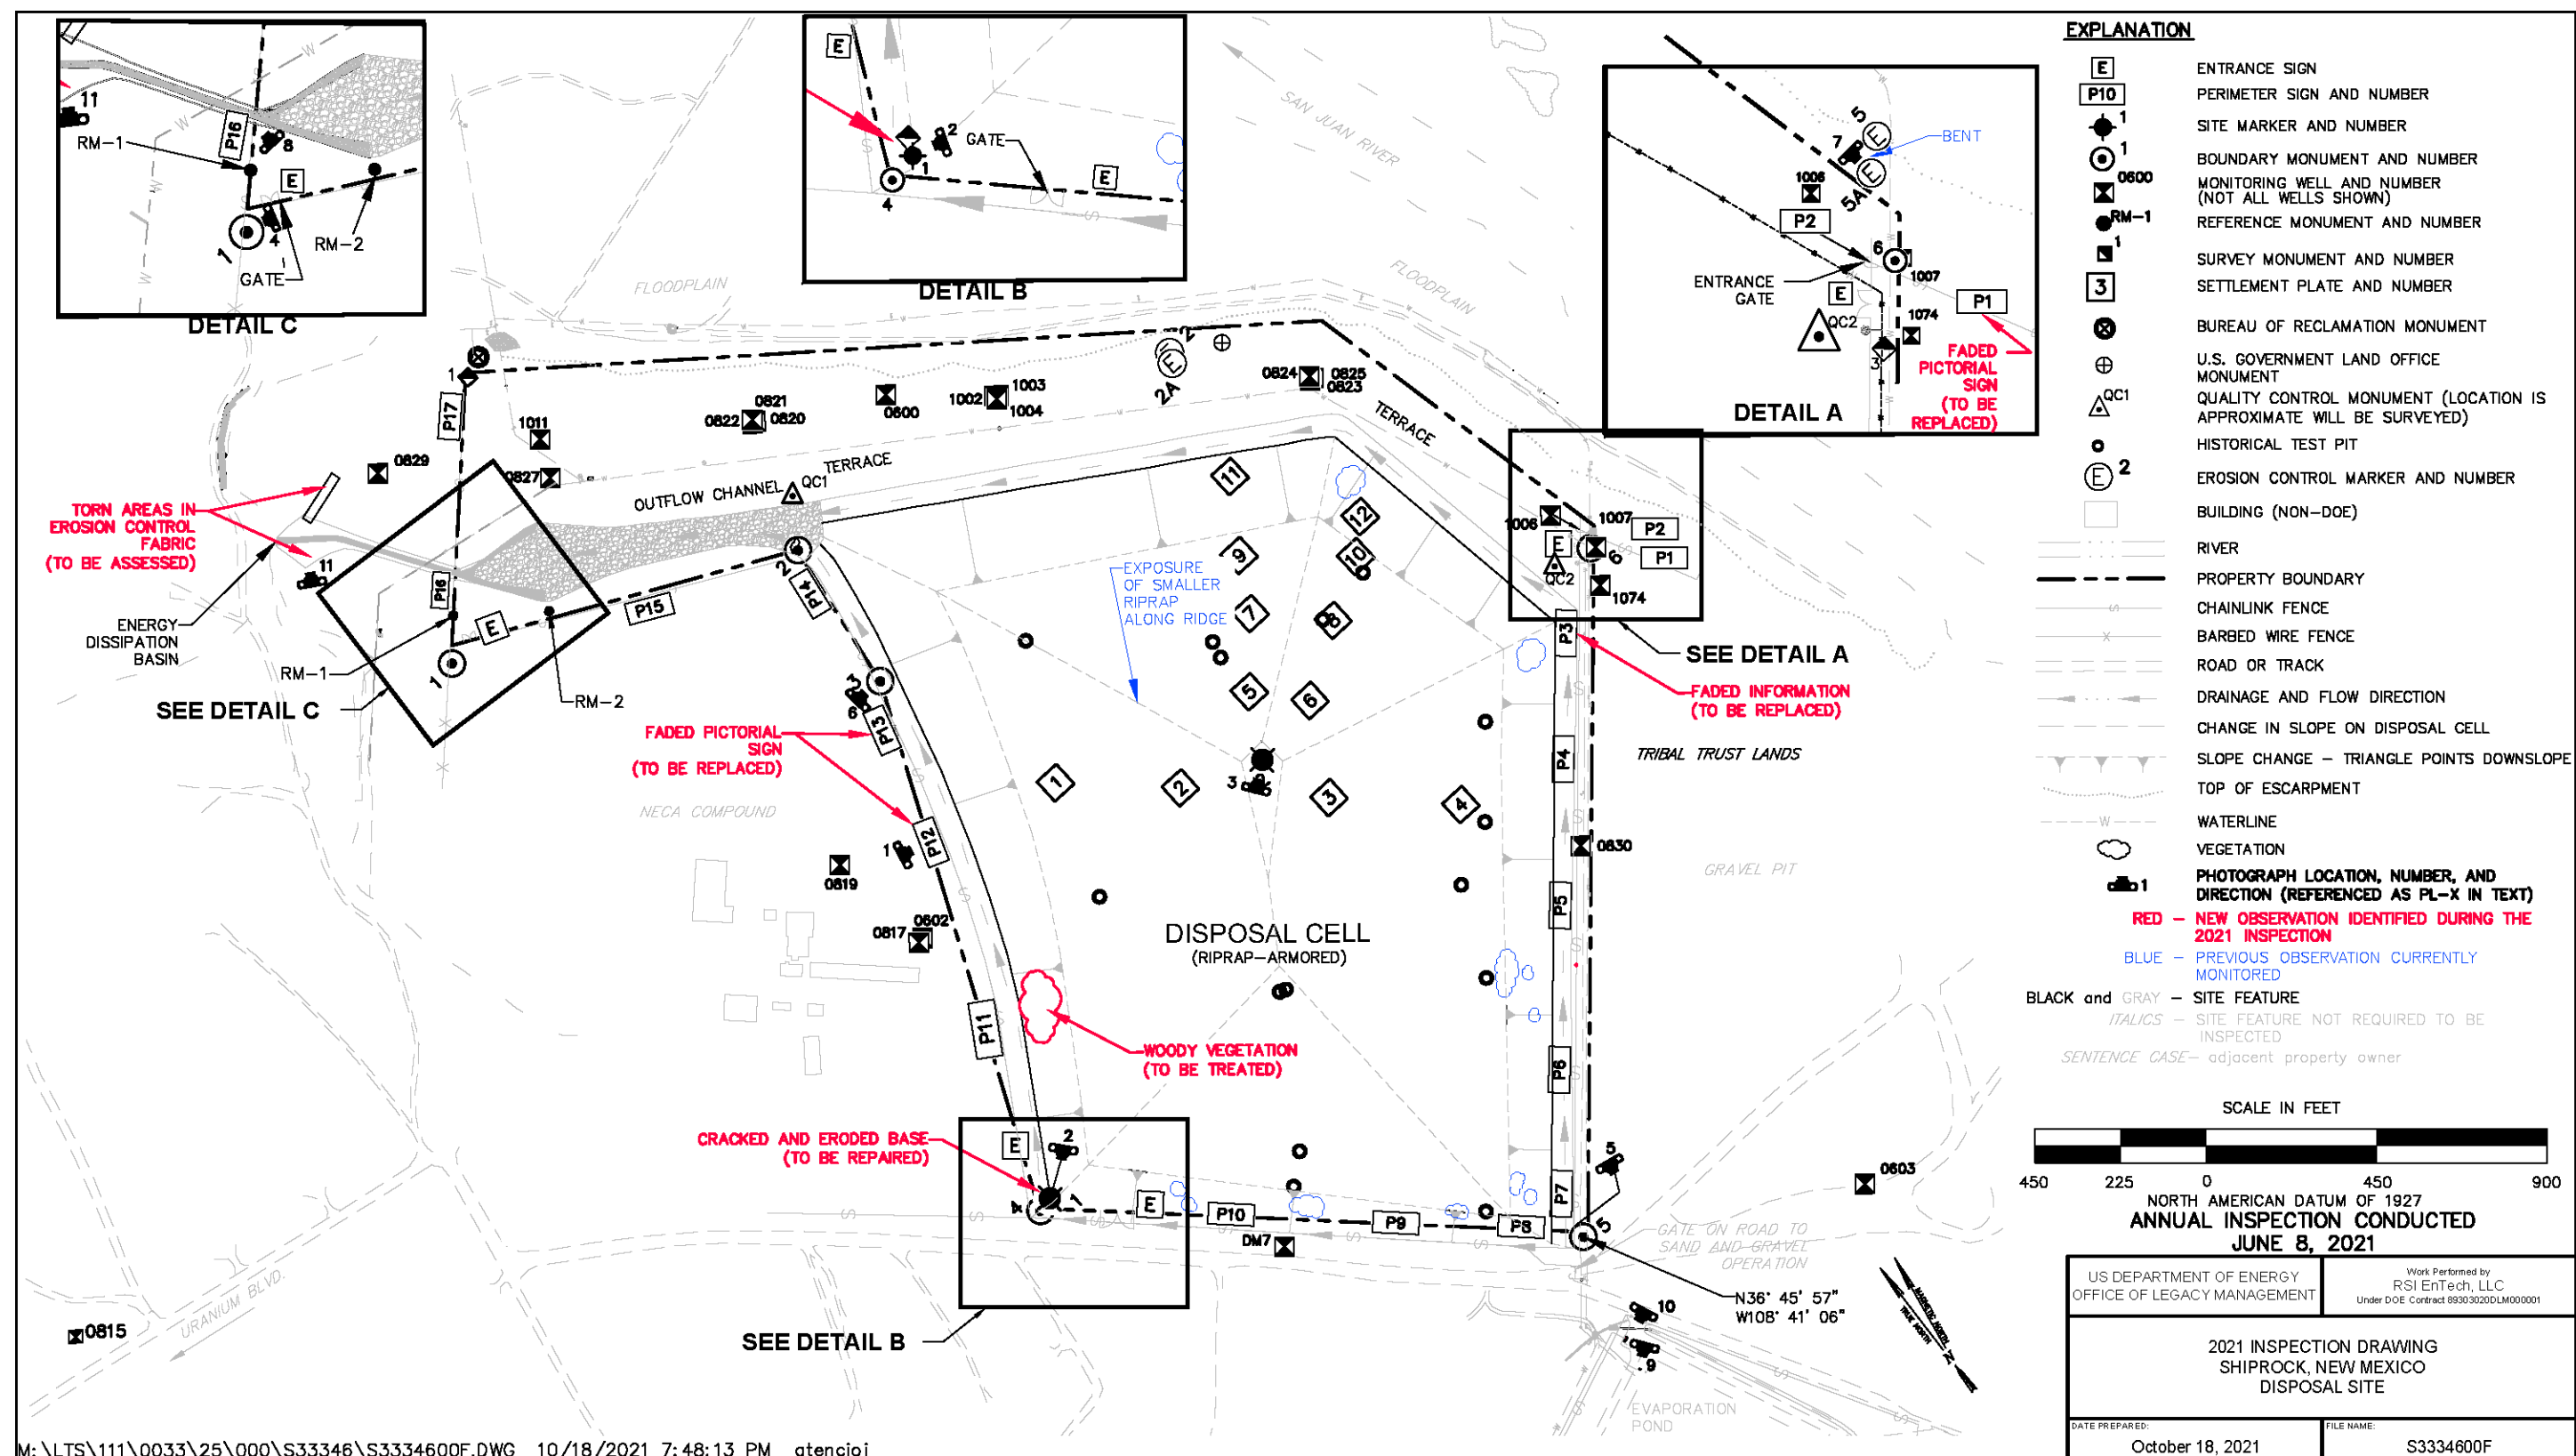
Figure 16-1 shows the locations of site features, including site surveillance features and inspection areas, in black and gray font. Site features that are present but not required to be inspected are shown in italic font. Observations from previous inspections that are currently monitored are shown in blue text, and new observations identified during the 2021 annual inspection are shown in red. Inspection results and recommended maintenance activities associated with site surveillance features are included in the following subsections. Photographs to support specific observations are identified in the text and in Figure 16-1 by photograph location (PL) numbers. The photographs and photograph log are presented in Section 16.10.
