16.0 Shiprock, New Mexico, Disposal Site

16.1 Compliance Summary

The Shiprock, New Mexico, Uranium Mill Tailings Radiation Control Act (UMTRCA) Title I Disposal Site was inspected on June 21, 2023. No changes were observed on the disposal cell or in the associated diversion channels. Inspectors identified several minor maintenance needs but found no cause for a follow-up inspection. Groundwater monitoring to evaluate disposal cell performance is not required.

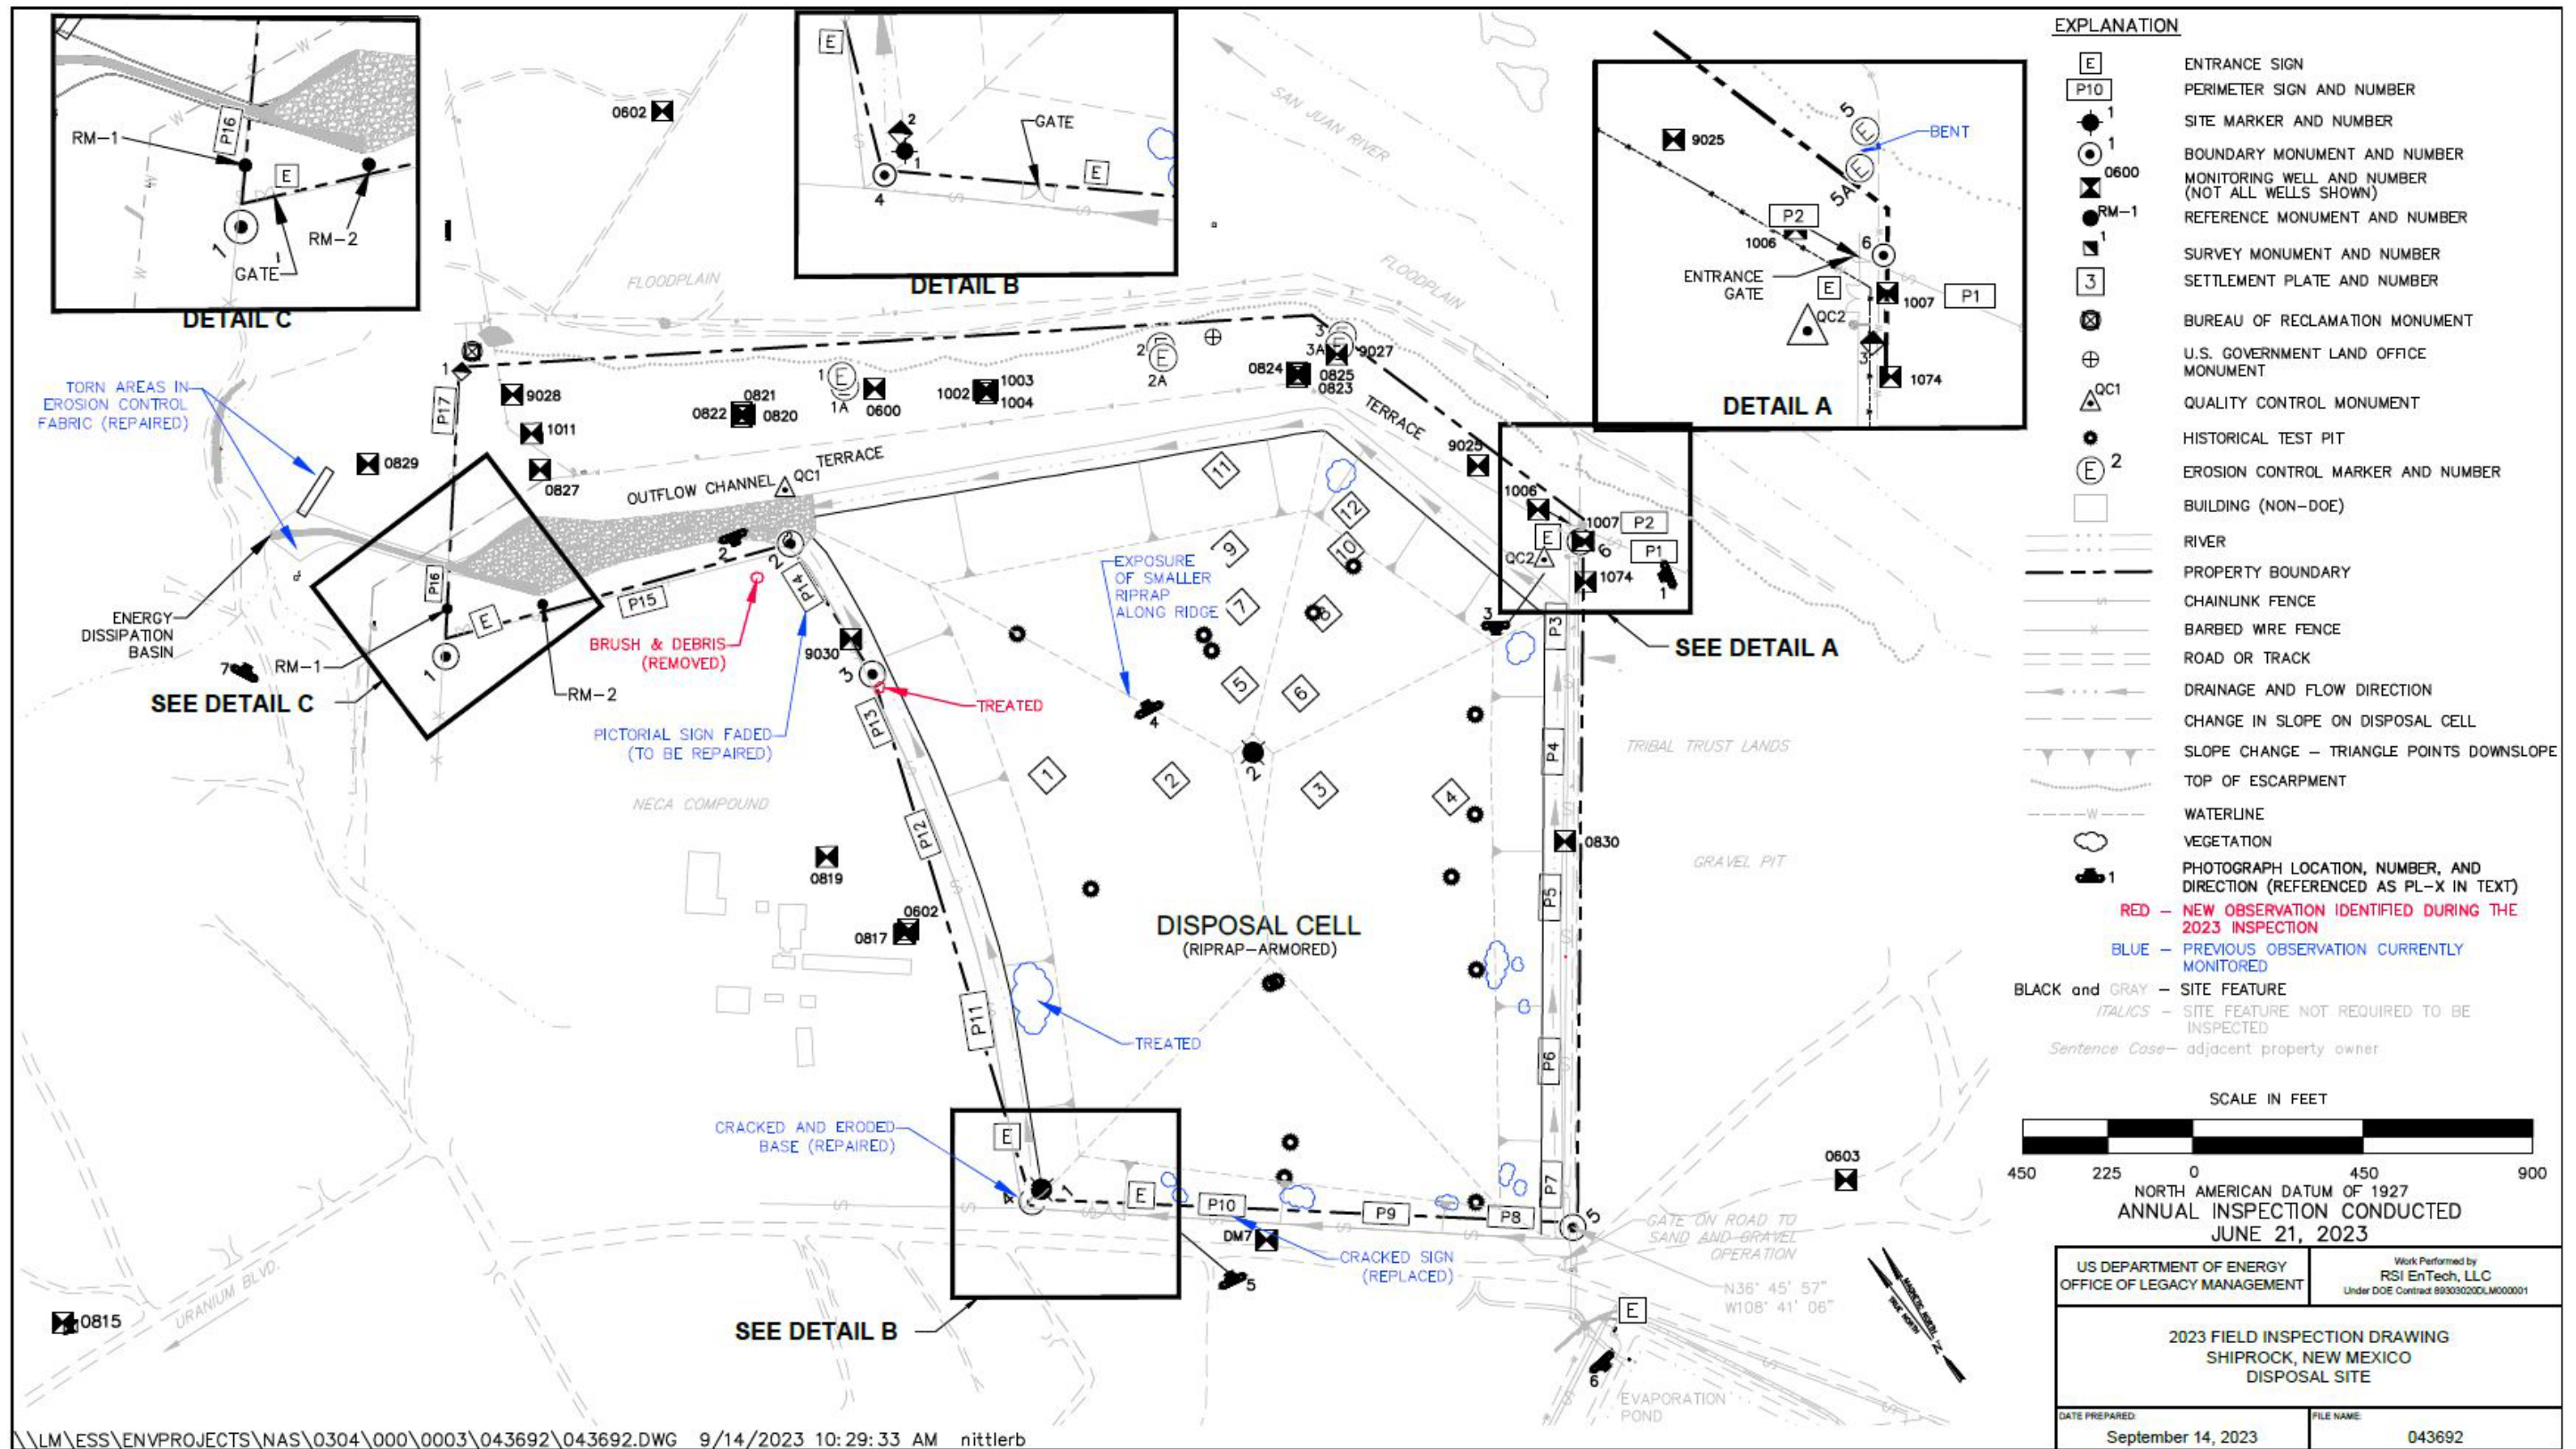
Figure 16-1. 2023 Annual Inspection Drawing for the Shiprock, New Mexico, Disposal Site

Figure 16-1 shows the locations of site features, including site surveillance features and inspection areas, in black and gray font. Some site features that are present but not required to be inspected are shown in italic font. Observations from previous inspections that are currently monitored are shown in blue, and new observations identified during the 2023 annual inspection are shown in red. Inspection results and recommended maintenance activities associated with site surveillance features are described in the following subsections. Photographs to support specific observations are noted in the text and in Figure 16-1 by photograph location (PL) numbers. The photographs and photograph log are presented in Section 16.10.
