## 16.0 Shiprock, New Mexico, Disposal Site

### 16.1 Compliance Summary

The Shiprock, New Mexico, Uranium Mill Tailings Radiation Control Act (UMTRCA) Title I Disposal Site was inspected on June 6, 2024. No changes were observed on the disposal cell or in the associated diversion channels. Inspectors identified several minor maintenance needs but found no cause for a follow-up inspection. Groundwater monitoring to evaluate the disposal cell performance is not required.

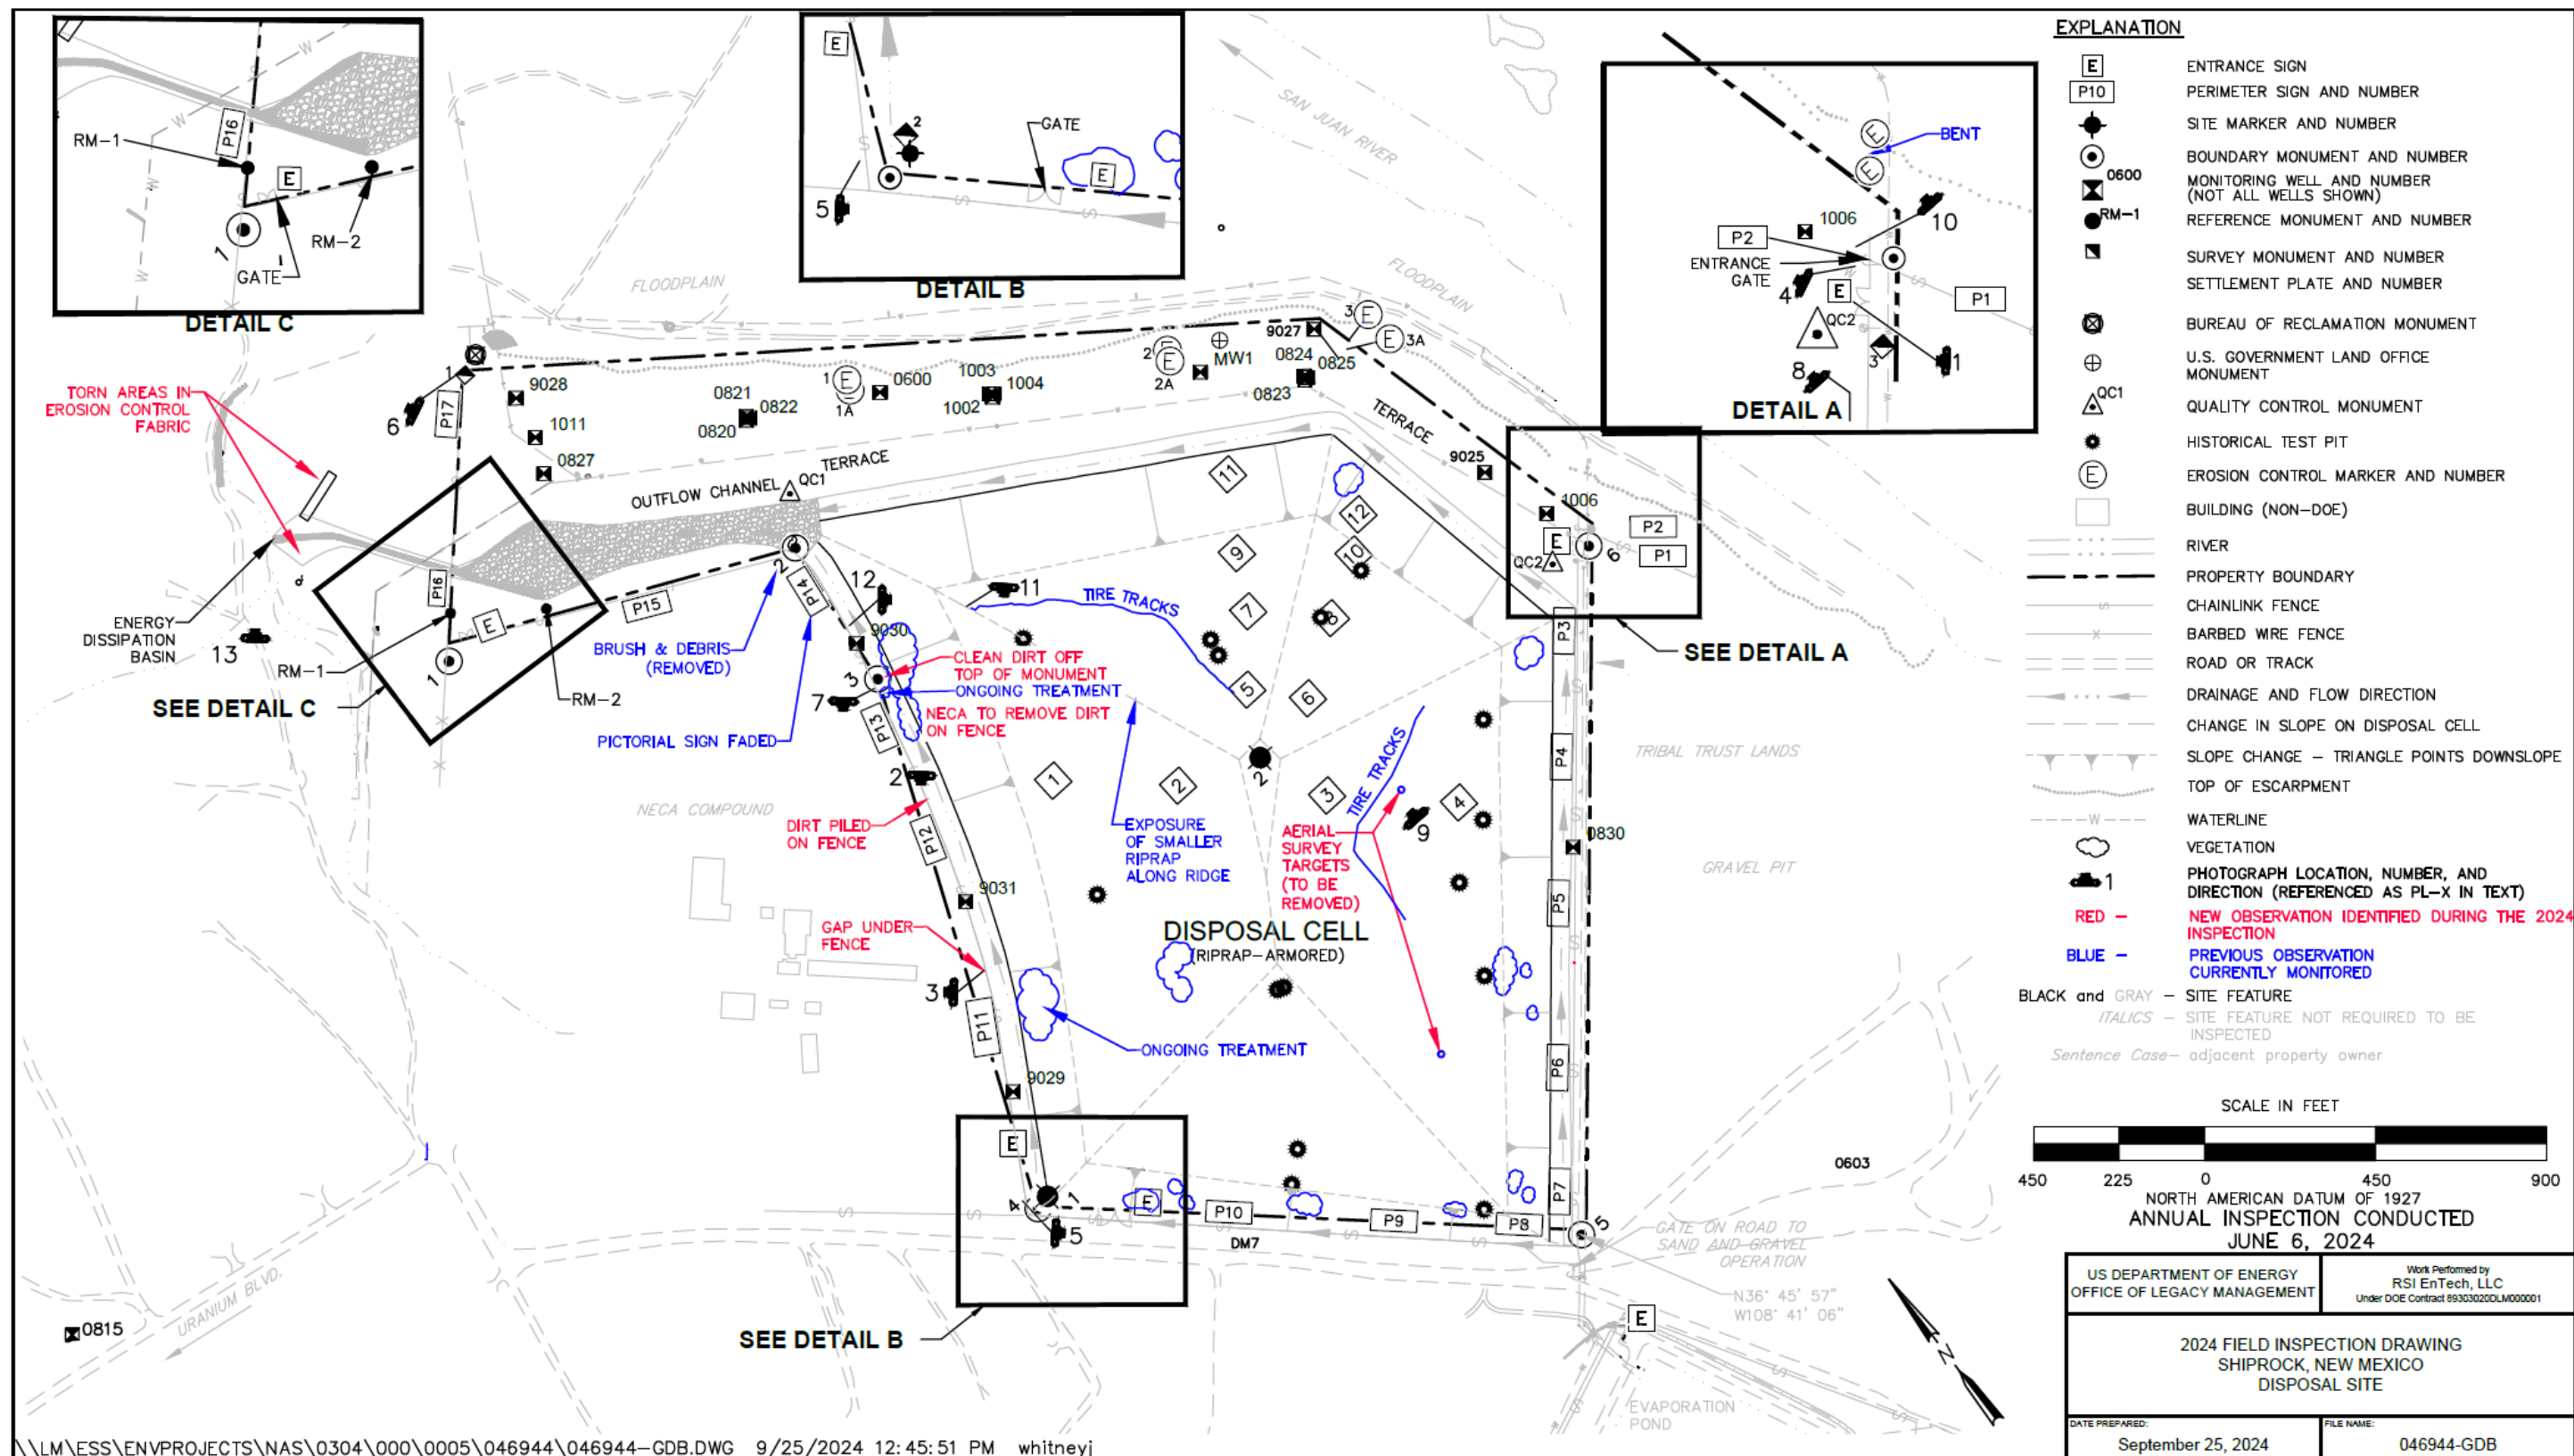
Figure 16-1. 2024 Annual Inspection Drawing for the Shiprock, New Mexico, Disposal Site

Figure 16-1 shows the locations of site features, including site surveillance features and inspection areas, in black and gray font. Some site features that are present but not required to be inspected are shown in italic font. Observations from previous inspections that are currently monitored are shown in blue, and new observations identified during the 2024 annual inspection are shown in red. Inspection results and recommended maintenance activities associated with site surveillance features are described in the following subsections. Photographs to support specific observations are noted in the text and in Figure 16-1 by photograph location (PL) numbers. The photographs and photograph log are presented in Section 16.10.
