Department of Energy  
Office of Legacy Management

SUBJECT: Status Report of Steps Taken Regarding Monitoring Results at Surface Water Point of Evaluation (POE) SW027

# **Report of Steps Taken Regarding Monitoring Results at Surface Water Point of Evaluation (POE) SW027**

## **August 31, 2010**

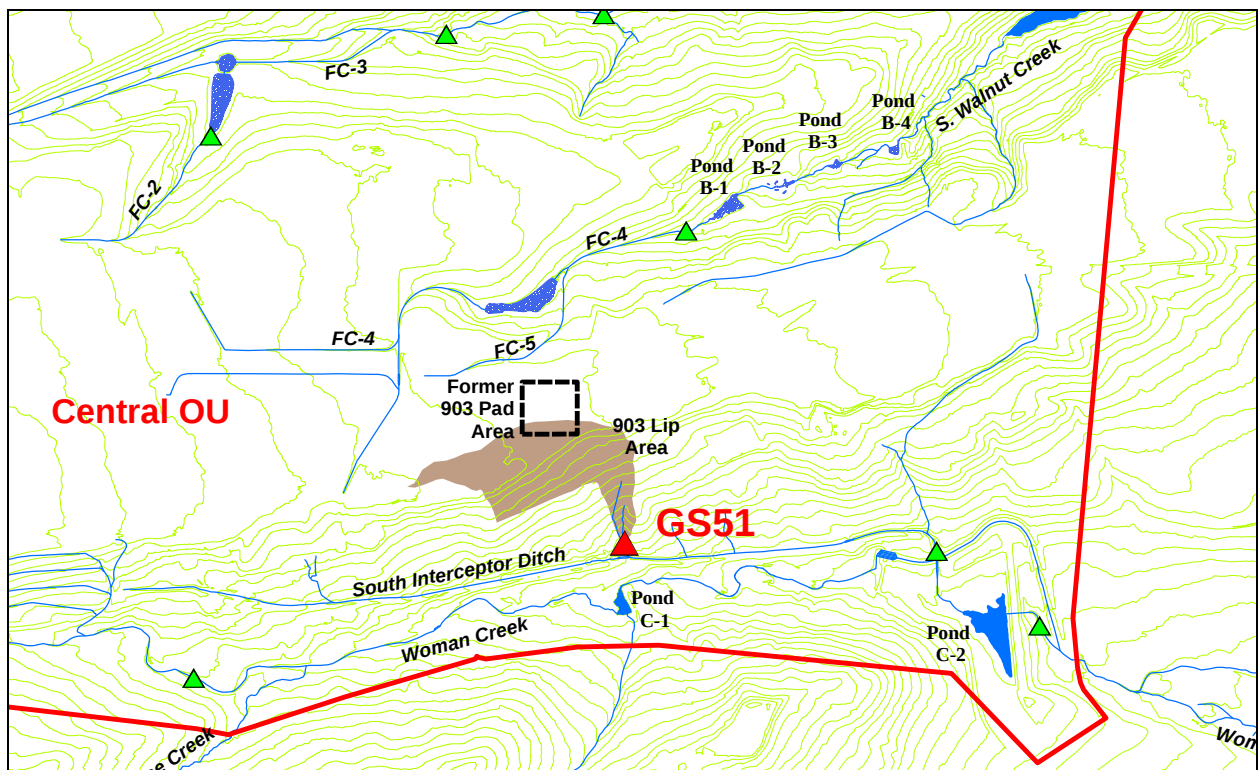
Figure 1. GS51 Drainage Area

Figures 1 and 2 show the drainage area for SW027 and the subdrainage within this area for GS51. This drainage area includes the former 903 Pad Lip Area, designated Individual Hazardous Substance Site (HSS) 900-155, which lies directly north of the SID. Large volumes of surface soil with residual Pu were removed from the surface of the 903 Lip Area in 2004, and the resulting surface was contoured and revegetated. Cleanup goals were met, but measurable concentrations of Pu in surface soil remained.

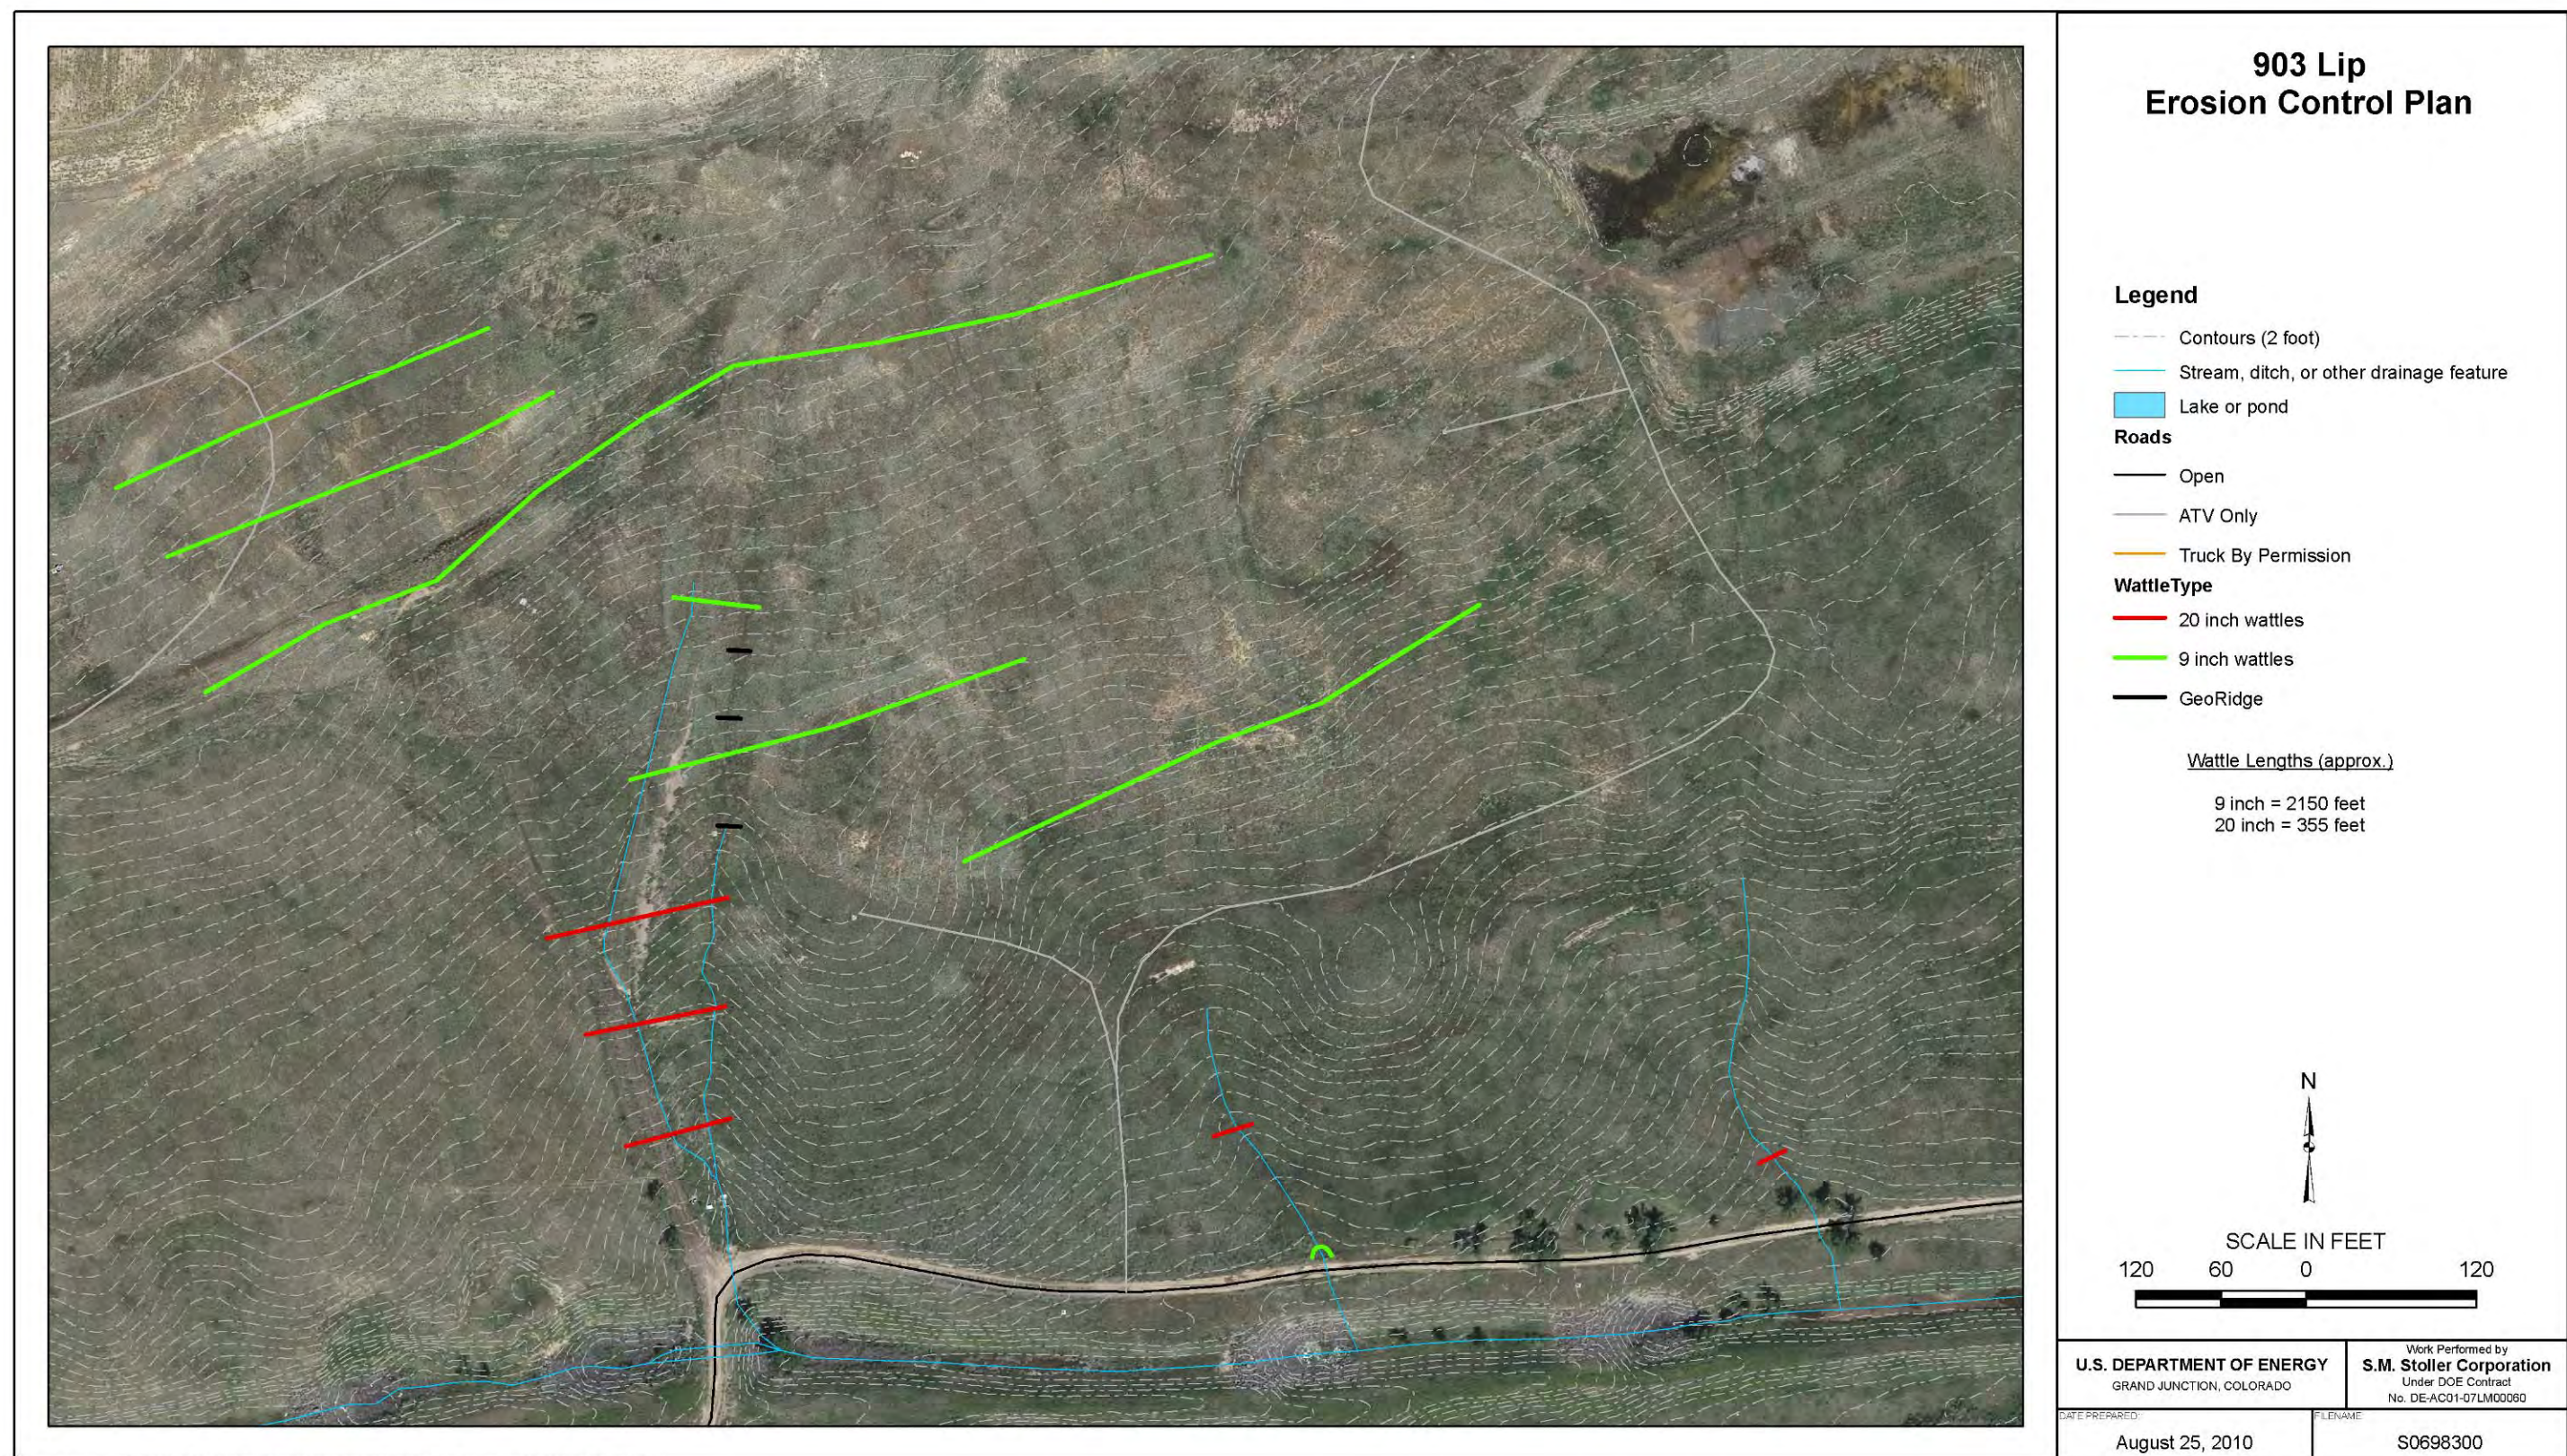
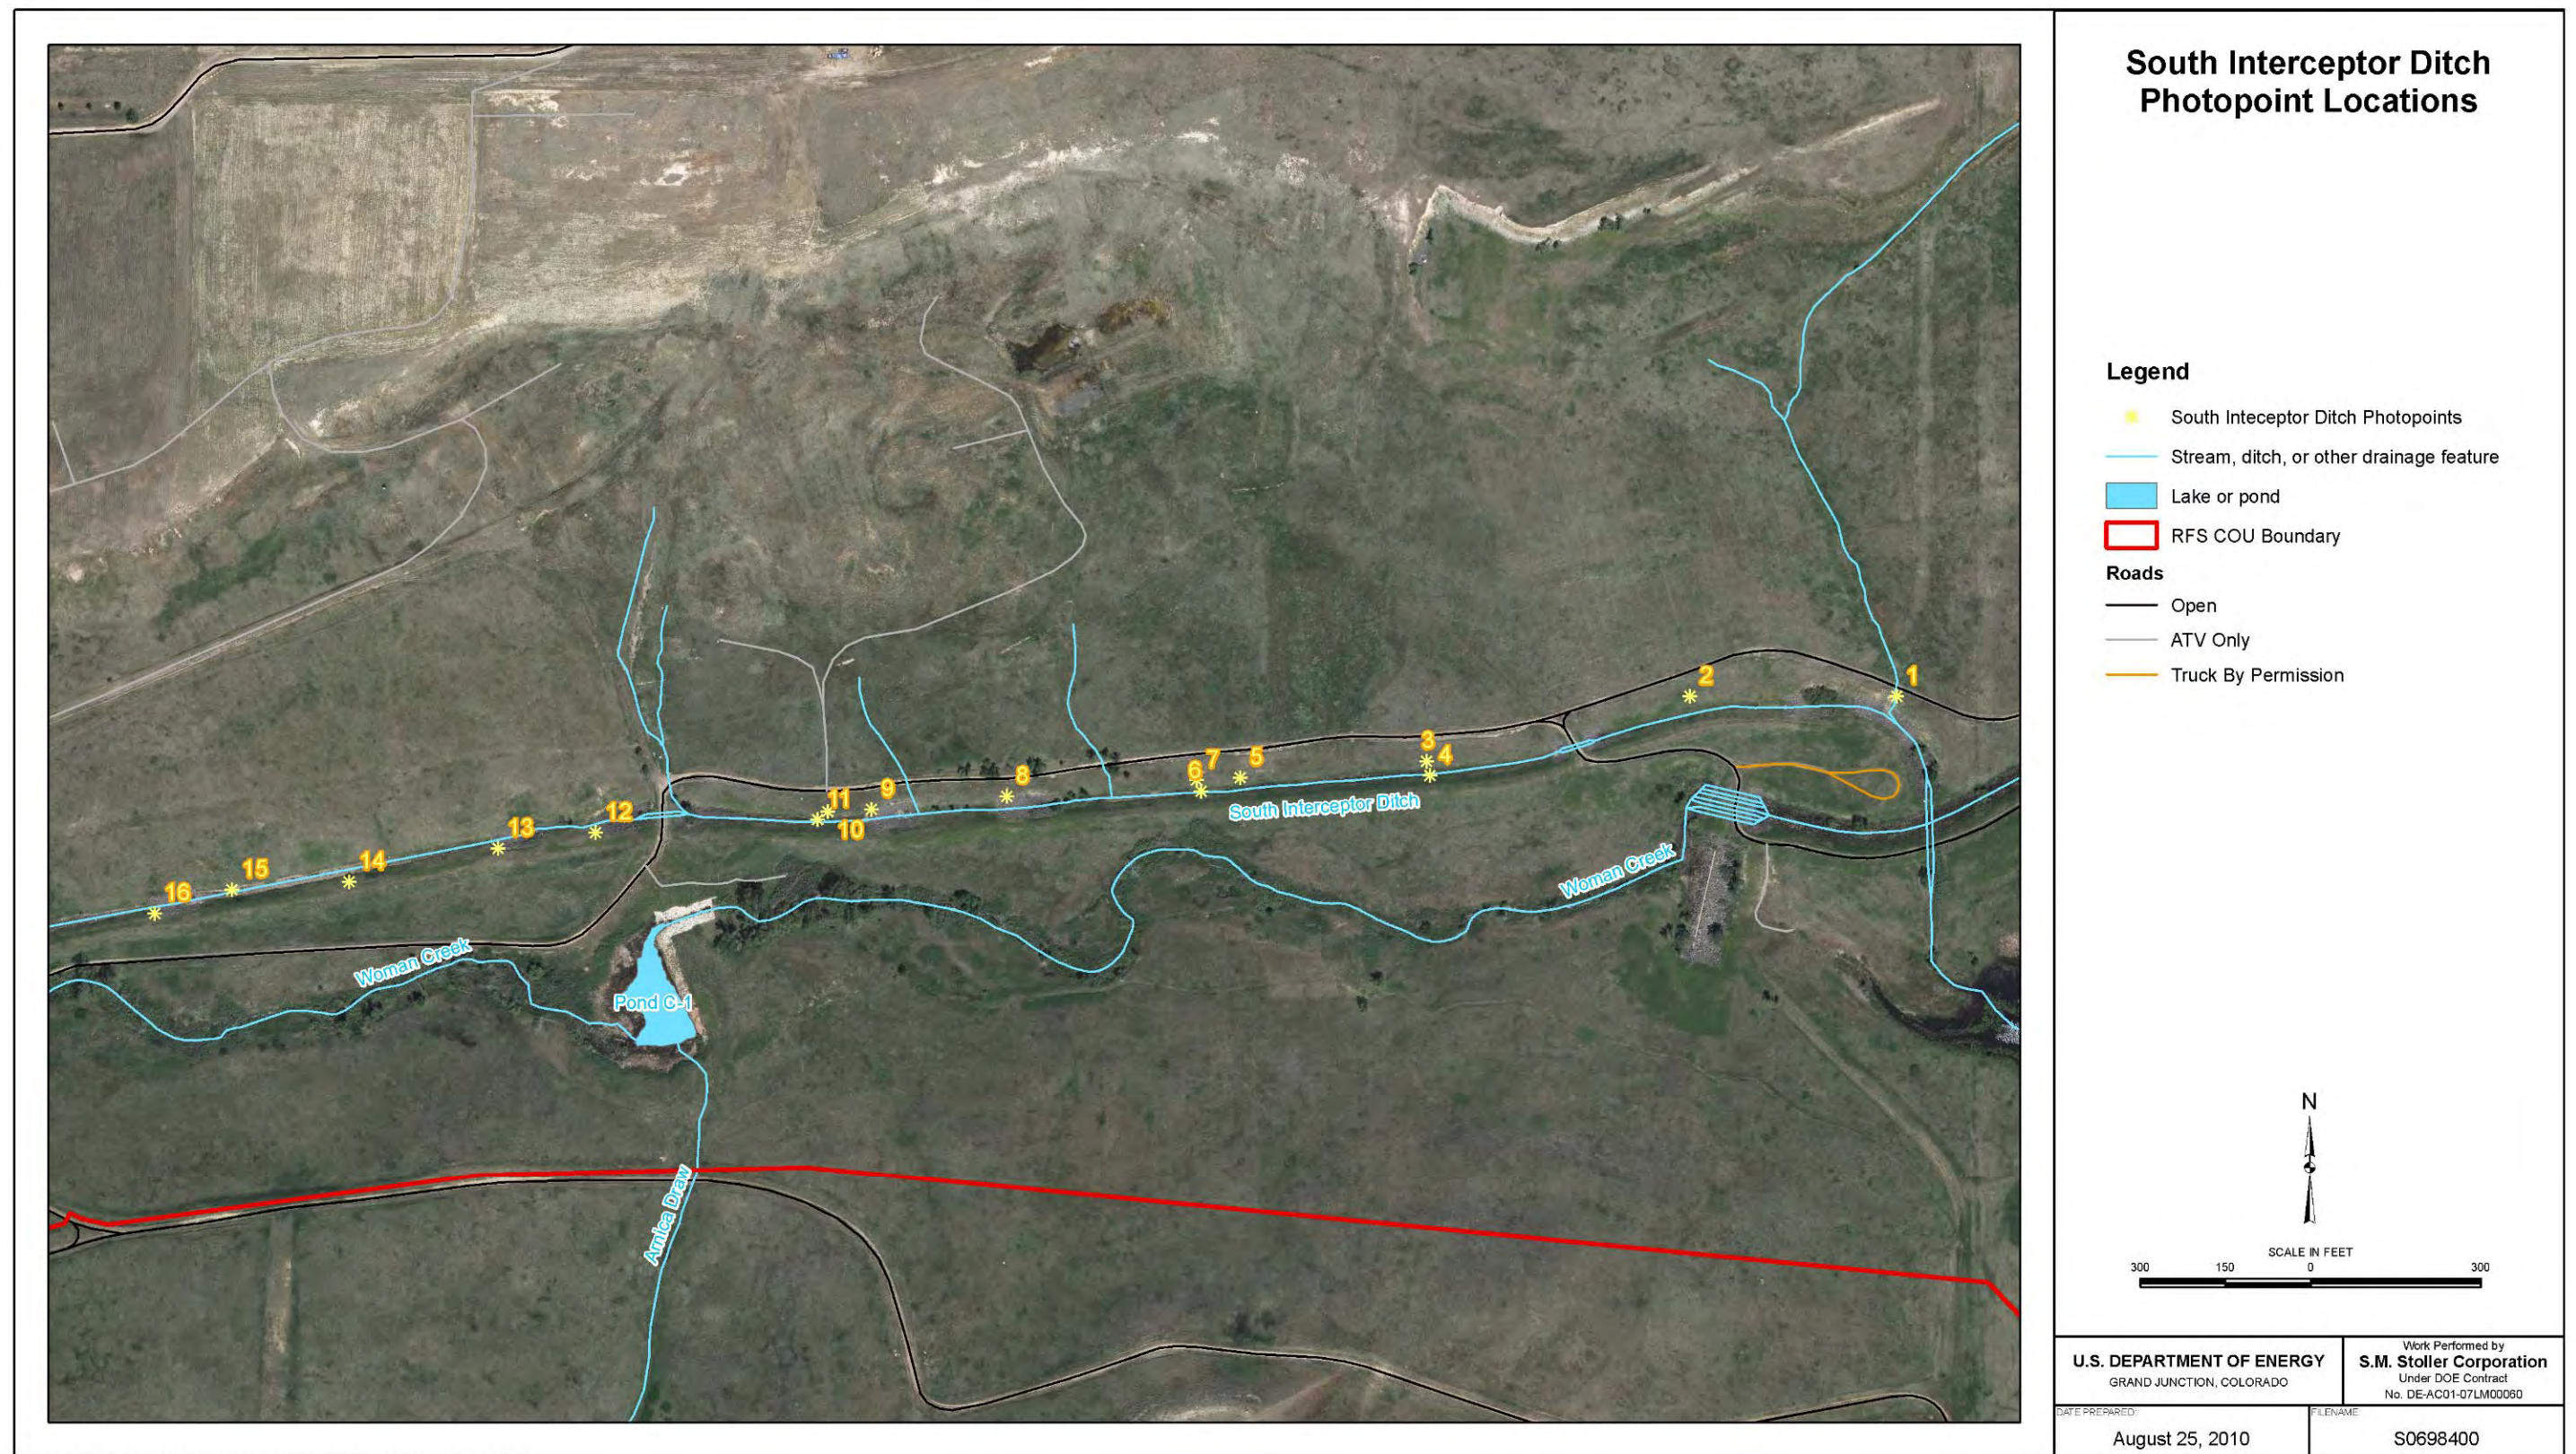
Figure 5. SID Photopoints

The SID channel is covered with areas of riprap, vegetation, and vegetation debris, which limit movement of sediment within the SID. Site personnel inspected areas of the SID during the June visits and conducted an additional walk-down of the SID area on August 23, 2010. The conditions in the SID were documented during the August visit with photographs taken from locations identified by field global-positioning system coordinates. Figure 5 shows the photograph (Photopoint) locations. Figures 6, 7, and 8 are photographs that illustrate the types of cover in the SID channel. Inspectors also noted that the SID channel banks had good stands of vegetation, and there were no conditions that indicate significant erosion, such as gullyng or washouts, or conditions that are precursors to significant erosion on the channel banks.

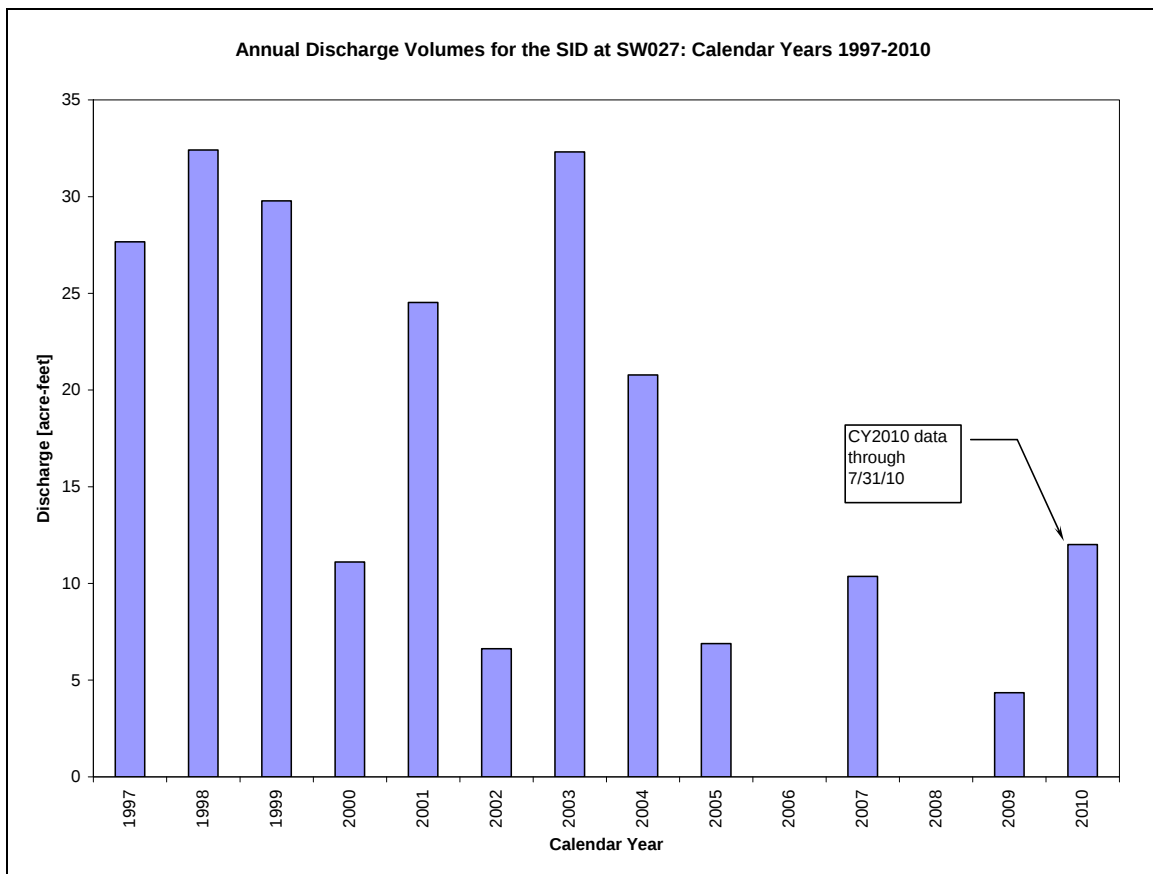
Figure 7. Flows at SW027

Figure 7 shows discharge volumes at SW027, and Figure 8 shows 12-month rolling average results at SW027. While the recent SW027 results indicate that the RFLMA standard for Pu will be exceeded when the April 2010, 12-month rolling average can be calculated, these results are within historical variability and do not indicate a previously unknown source or transport mechanism.
