17.0 Slick Rock, Colorado, Disposal Site

17.1 Compliance Summary

Figure 17-1. 2021 Annual Inspection Drawing for the Slick Rock, Colorado, Disposal Site

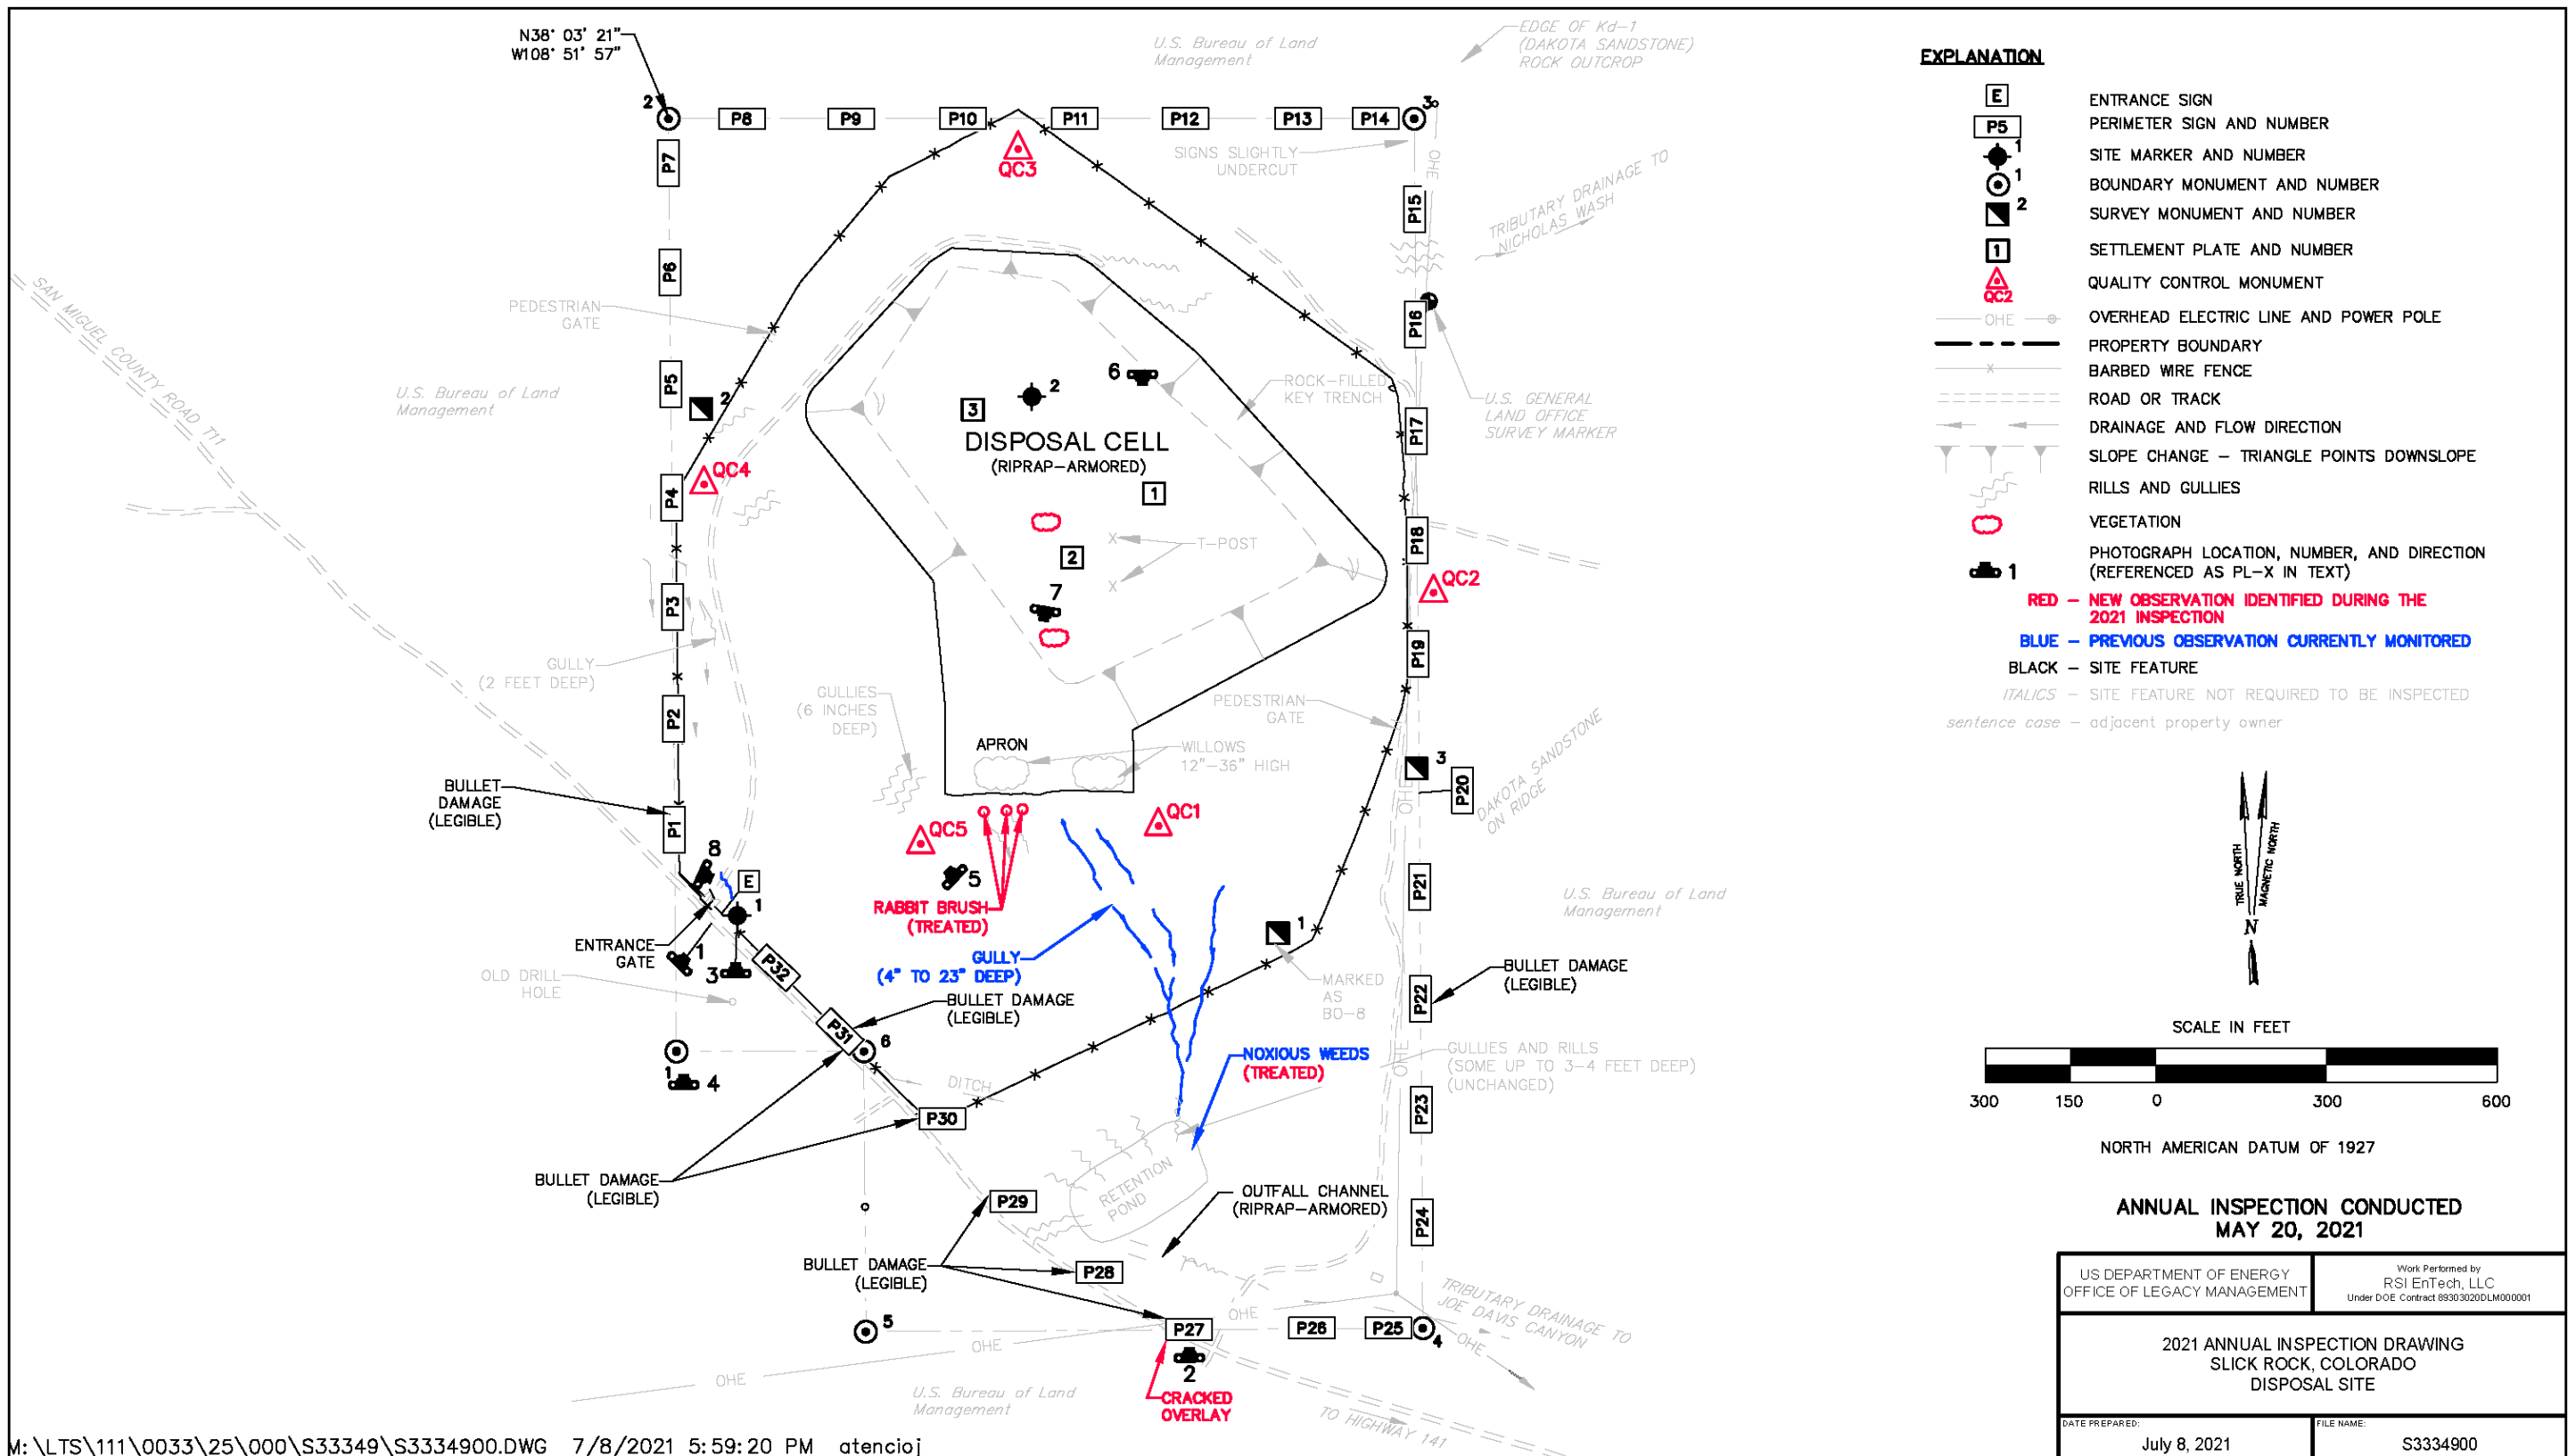
Figure 17-1 shows the locations of site features, including site surveillance features and inspection areas, in black and gray font. Site features that are present but not required to be inspected are shown in italic font. Observations from previous inspections that are currently monitored are shown in blue text, and new observations identified during the 2021 annual inspection are shown in red. Inspection results and recommended maintenance activities associated with site surveillance features are described in the following subsections. Photographs to support specific observations are identified in the text and in Figure 17-1 by photograph location (PL) numbers. The photographs and photograph log are presented in Section 17.10.
