17.0 Slick Rock, Colorado, Disposal Site

17.1 Compliance Summary

Figure 17-1. 2022 Annual Inspection Drawing for the Slick Rock, Colorado, Disposal Site

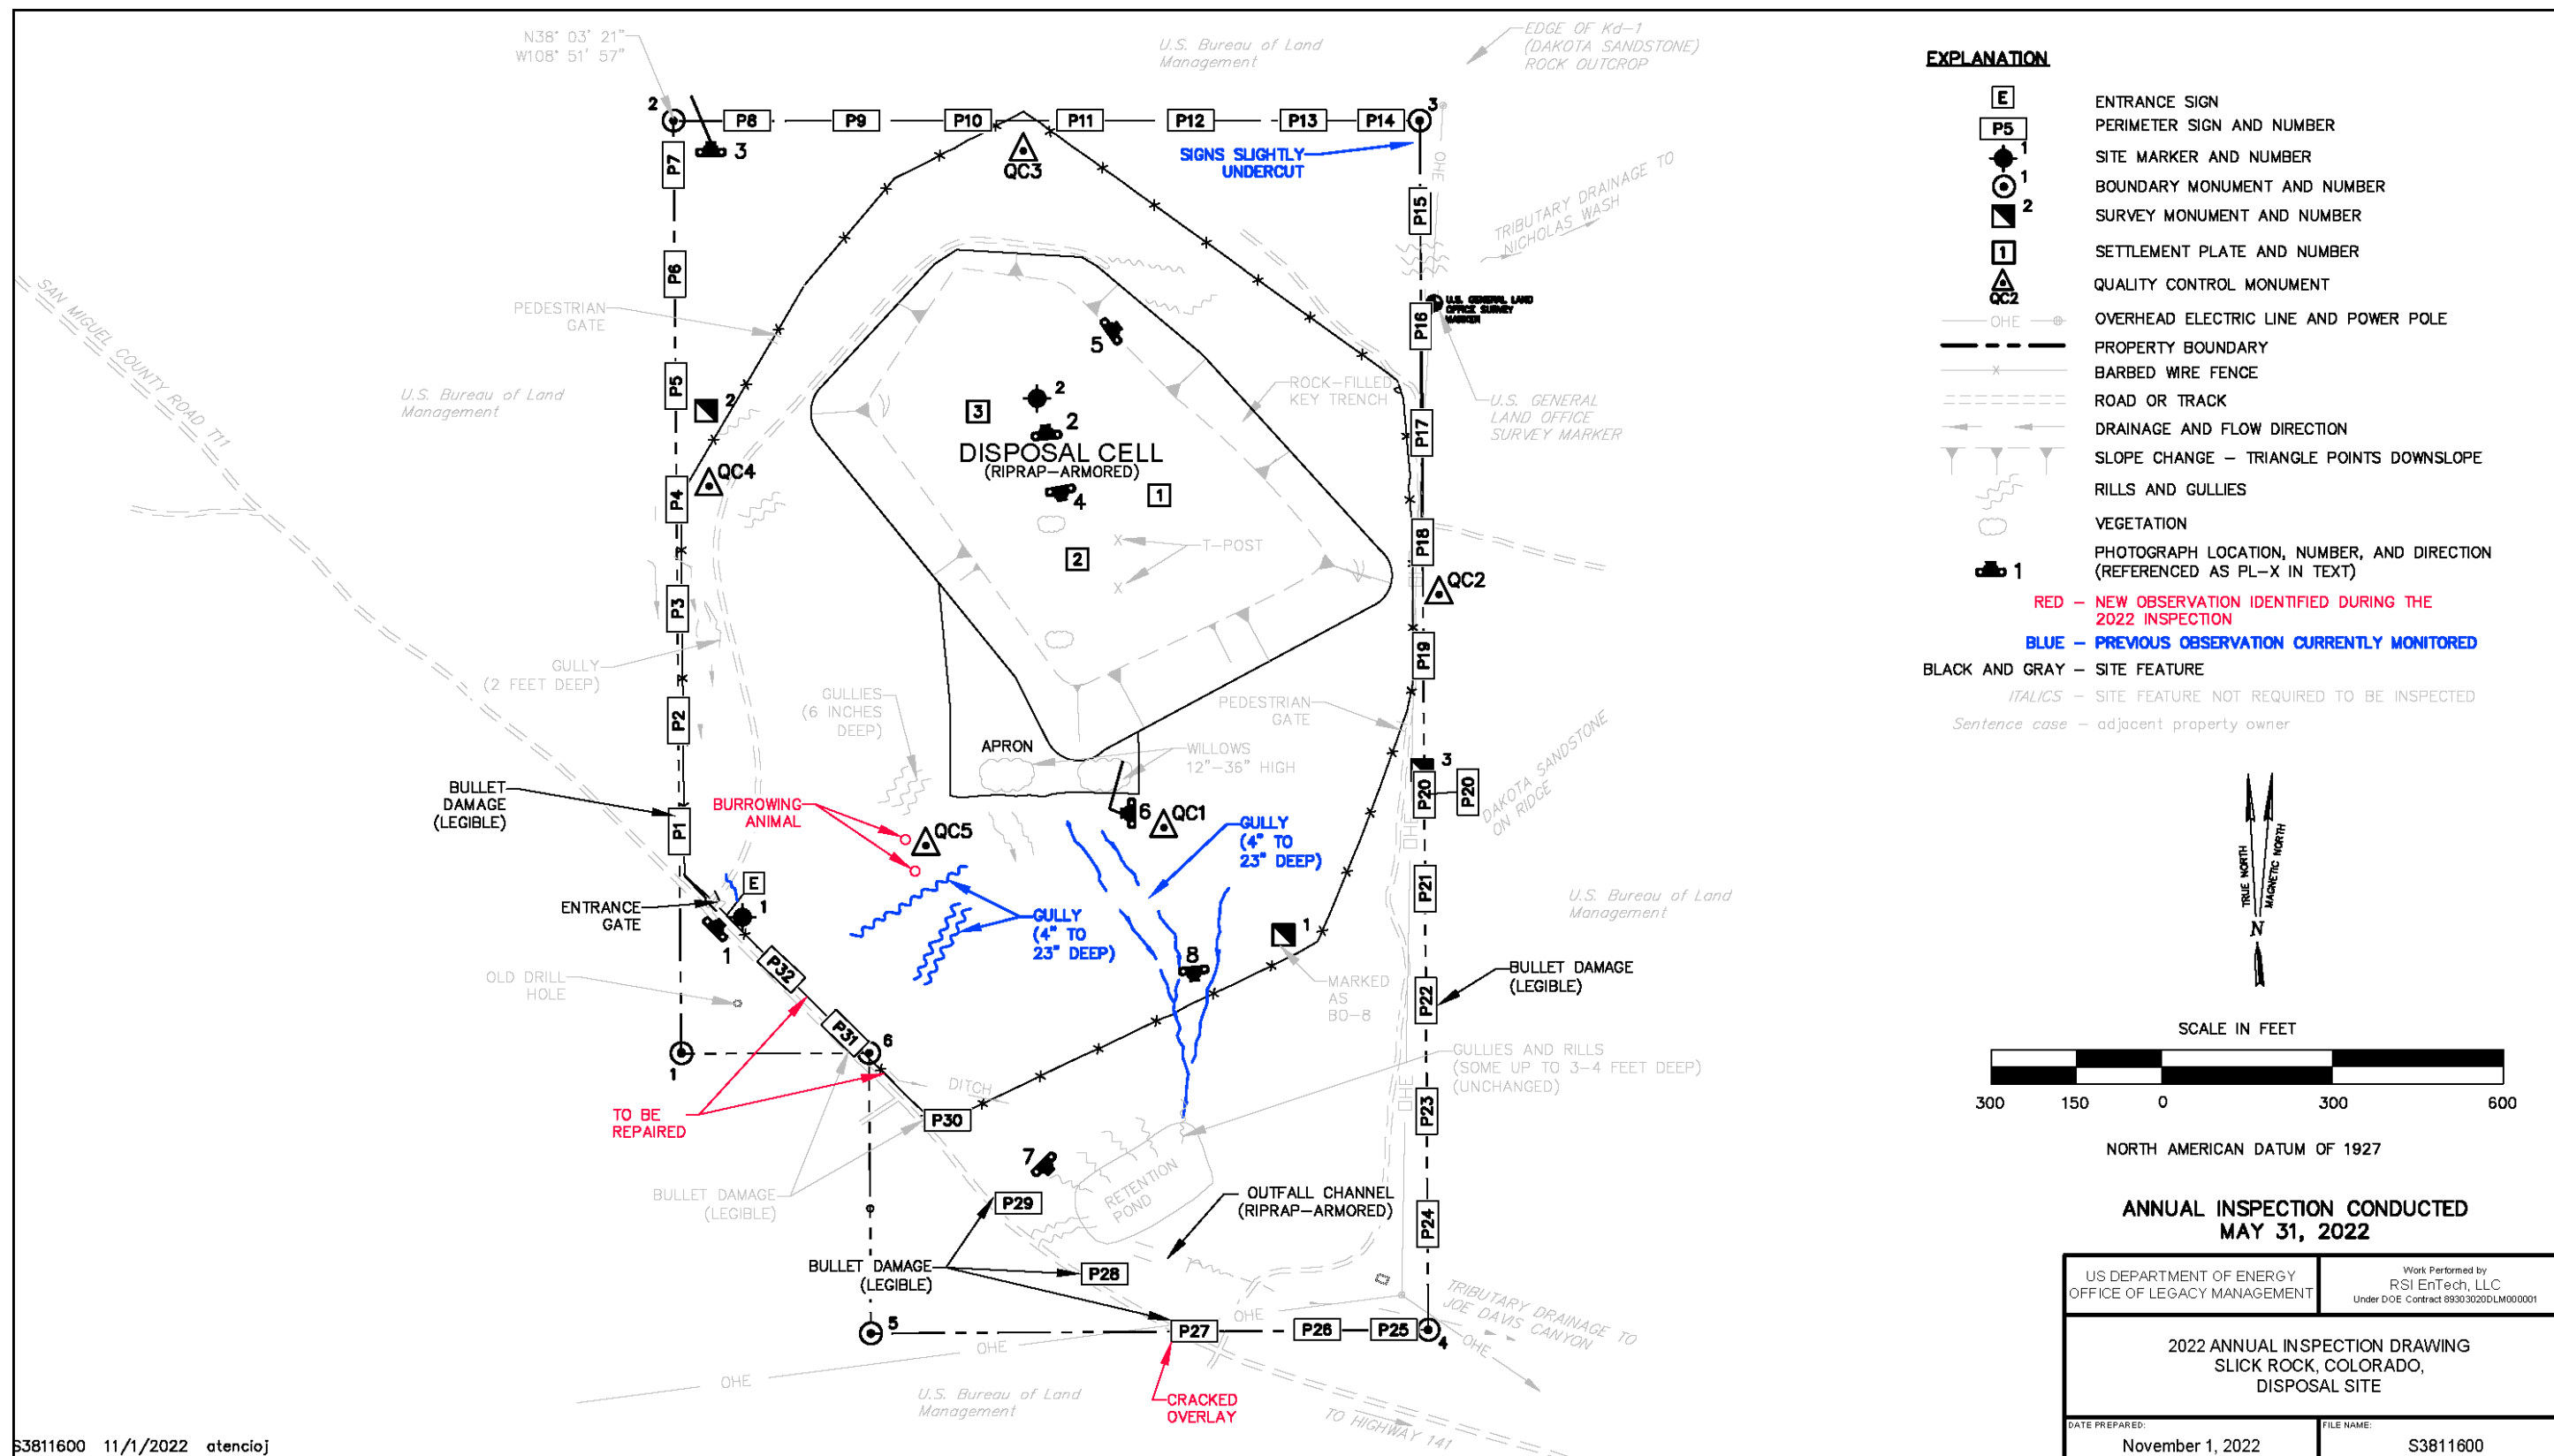
Figure 17-1 shows the locations of site features, including site surveillance features and inspection areas, in black and gray font. Some site features that are present but not required to be inspected are shown in italic font. Observations from previous inspections that are currently monitored are shown in blue, and new observations identified during the 2022 annual inspection are shown in red. Inspection results and recommended maintenance activities associated with site surveillance features are described in the following subsections. Photographs to support specific observations are noted in the text and in Figure 17-1 by photograph location (PL) numbers. The photographs and photograph log are presented in Section 17.10.

Inspectors inspected the five aerial survey quality control monuments installed in 2021. The baseline aerial survey was performed in May 2022. Animal burrows were detected around quality control monument QC-5. No maintenance needs were identified.
