17.0 Slick Rock, Colorado, Disposal Site

17.1 Compliance Summary

The Slick Rock, Colorado, Uranium Mill Tailings Radiation Control Act (UMTRCA) Title I Disposal Site was inspected on May 22, 2024. No changes were observed on the disposal cell or in the associated drainage features. Inspectors identified routine maintenance needs but found no cause for a follow-up or contingency inspection. Groundwater monitoring is not required.

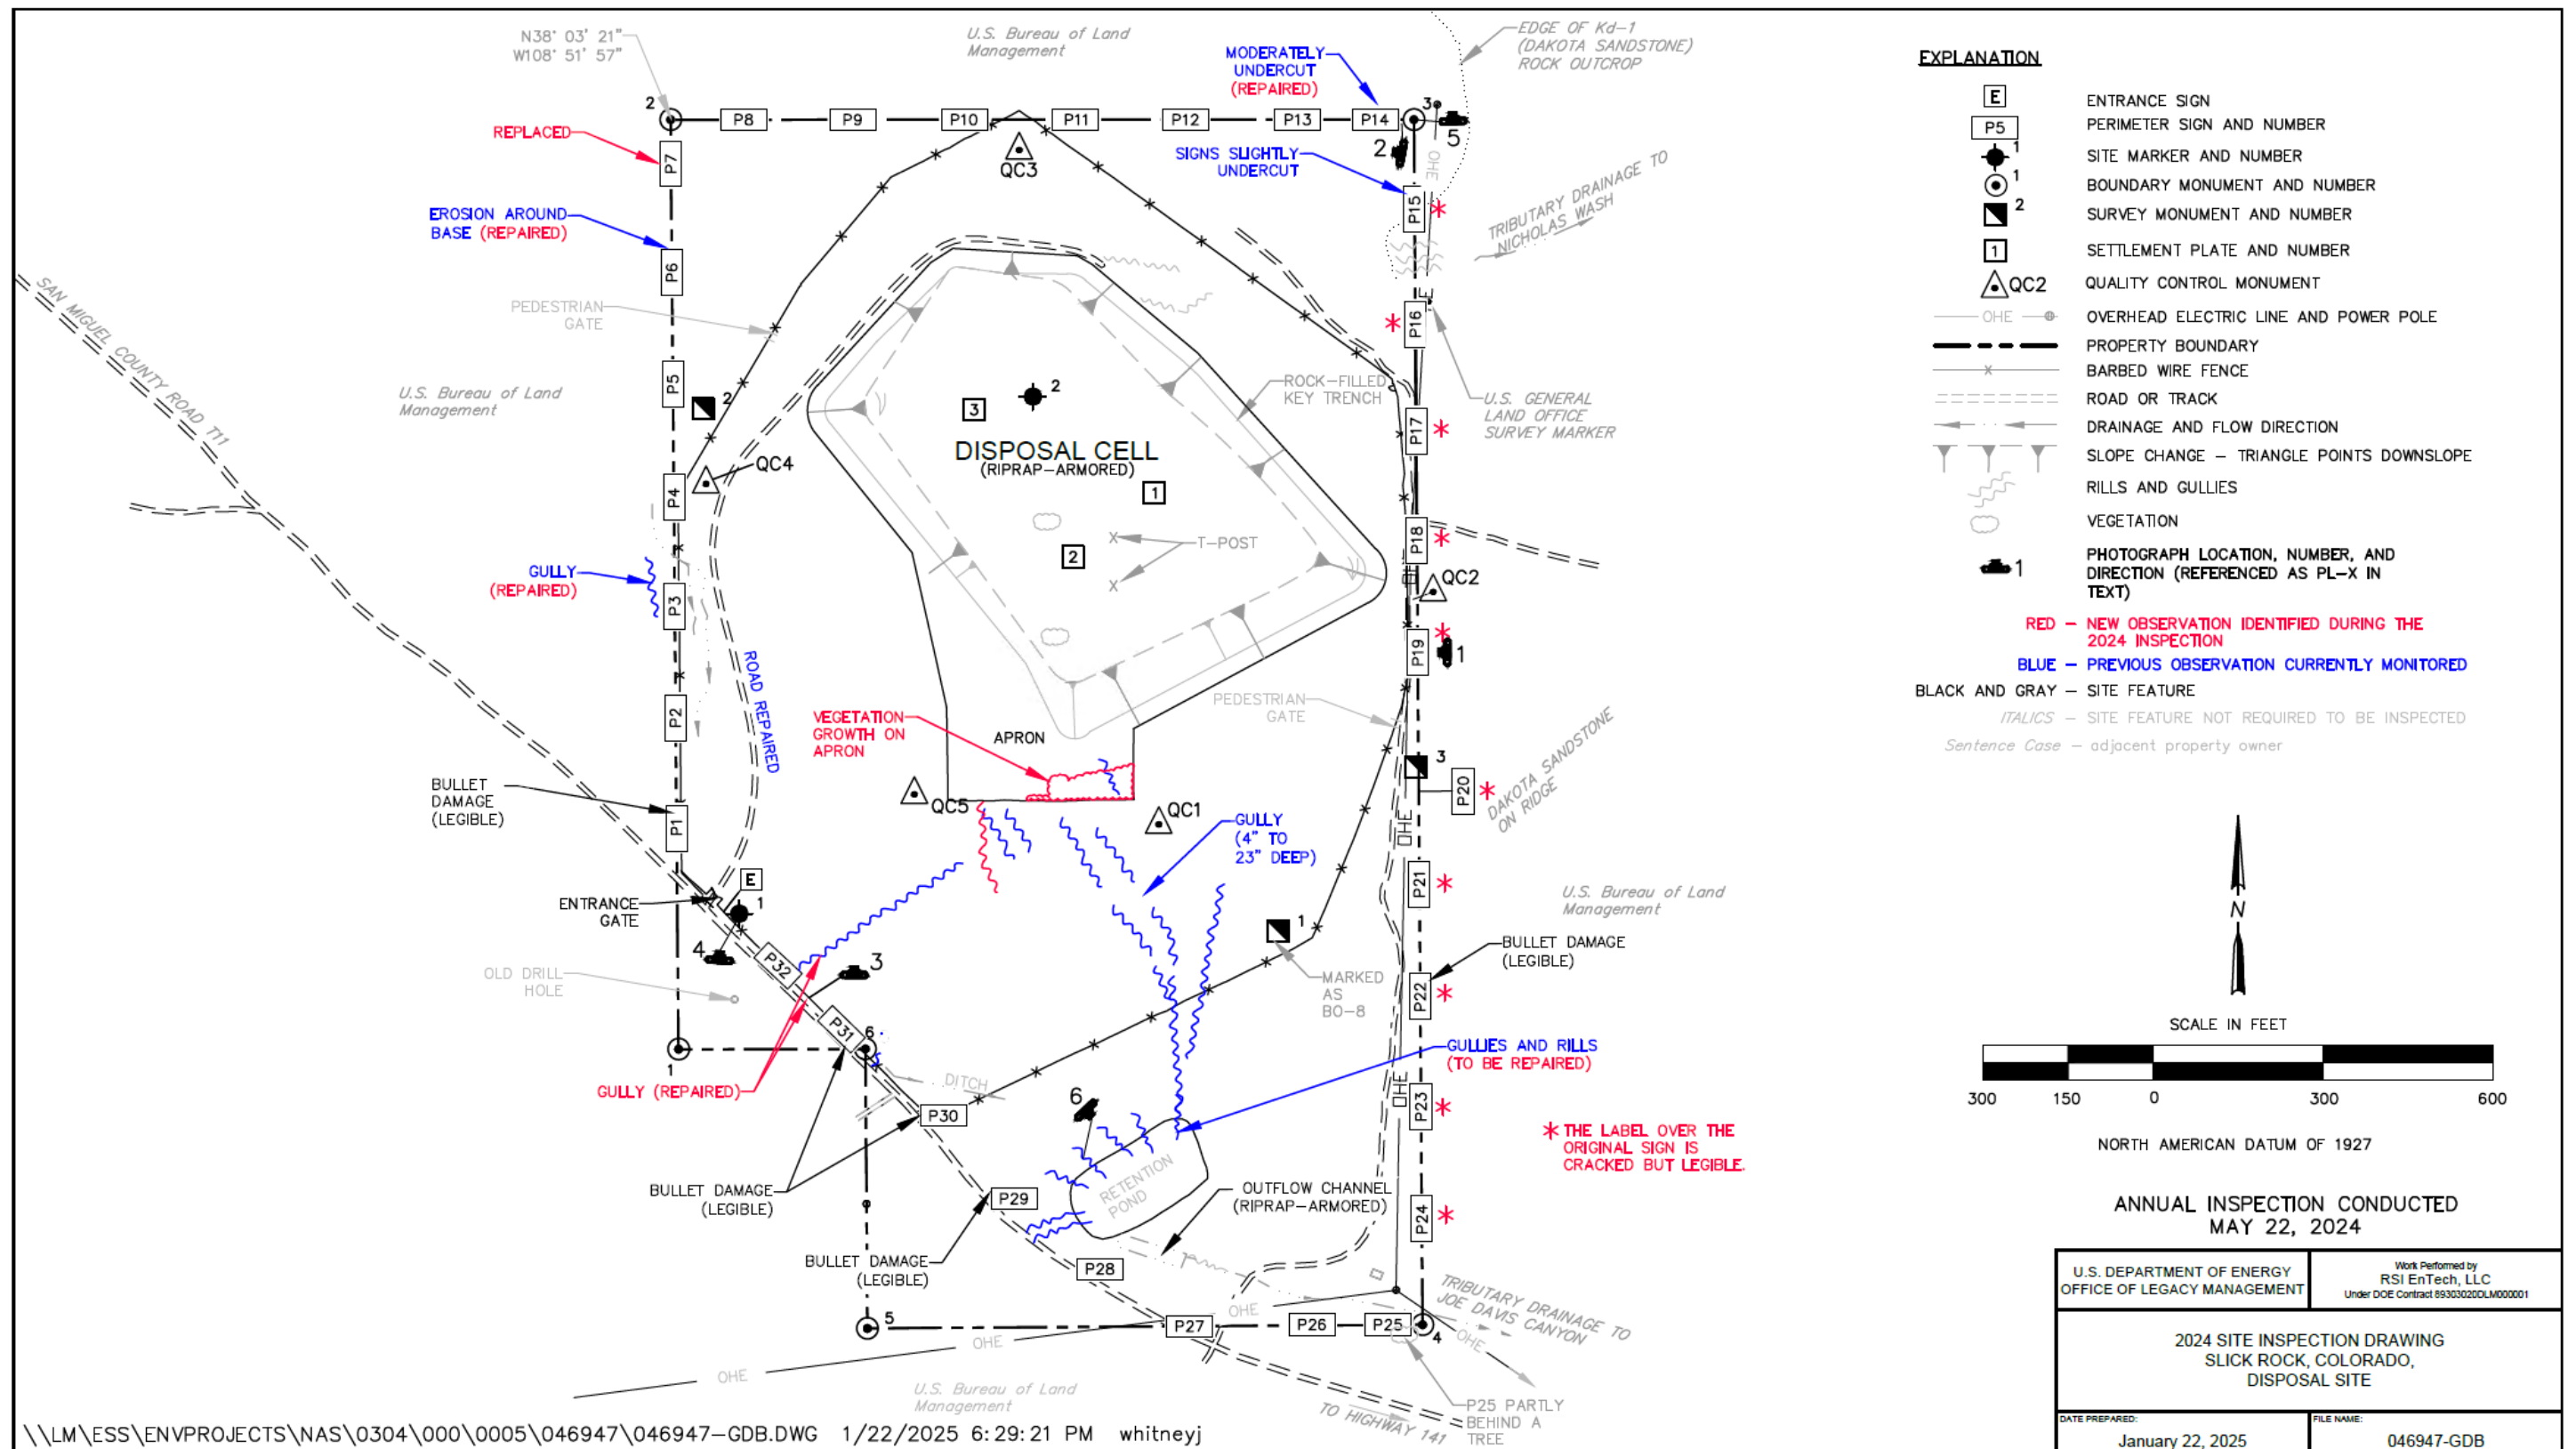
Figure 17-1. 2024 Annual Inspection Drawing for the Slick Rock, Colorado, Disposal Site

Figure 17-1 shows the locations of site features, including site surveillance features and inspection areas, in black and gray font. Some site features that are present but not required to be inspected are shown in italic font. Observations from previous inspections that are currently monitored are shown in blue, and new observations identified during the 2024 annual inspection are shown in red. Inspection results and recommended maintenance activities associated with site surveillance features are described in the following subsections. Photographs to support specific observations are noted in the text and in Figure 17-1 by photograph location (PL) numbers. The photographs and photograph log are presented in Section 17.10.
