18.0 Spook, Wyoming, Disposal Site

The Spook, Wyoming, Uranium Mill Tailings Radiation Control Act (UMTRCA) Title I Disposal Site was inspected on July 14, 2021. No changes were observed on the land surface of the disposal cell. Perimeter sign P5 was observed to be delaminating and will be replaced, but inspectors found no cause for a follow-up or contingency inspection. Groundwater monitoring is not required.

Figure 18-1. 2021 Annual Inspection Drawing for the Spook, Wyoming, Disposal Site

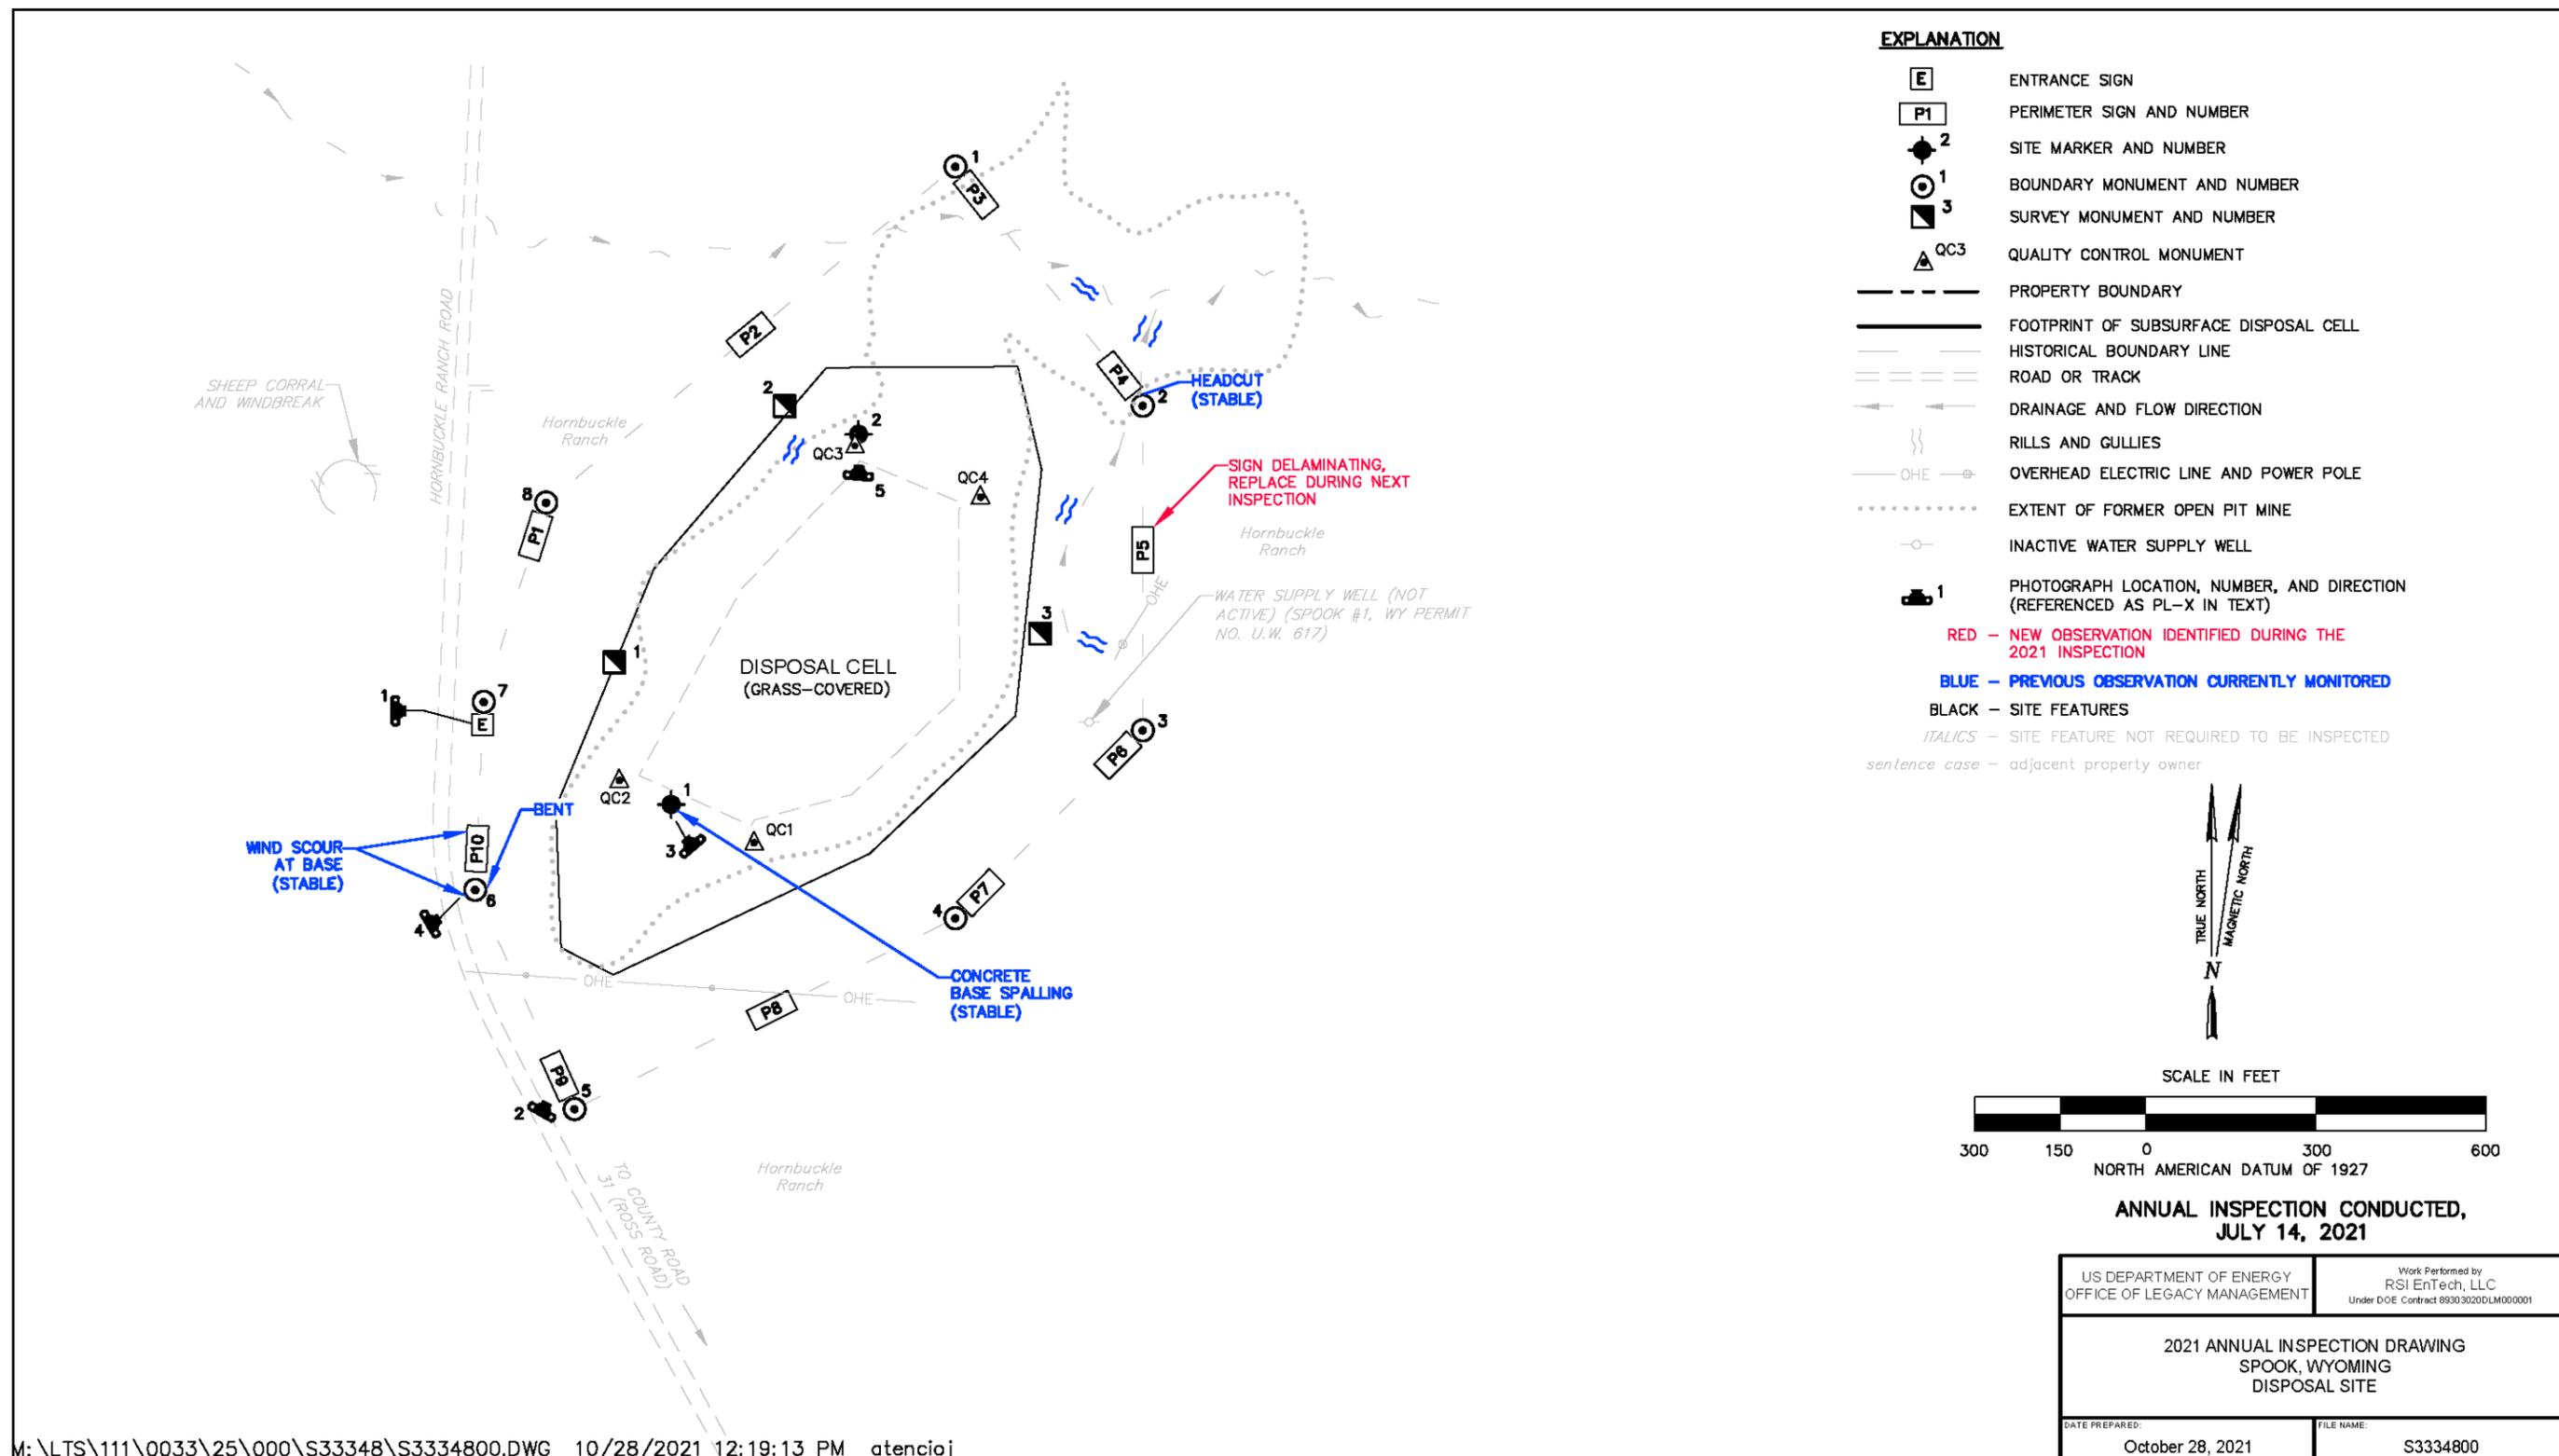
Figure 18-1 shows the locations of site features, including site surveillance features and inspection areas, in black and gray font. Site features that are present but not required to be inspected are shown in italic font. Observations from previous inspections that are currently monitored are shown in blue font. New observations are shown in red font. Inspection results and recommended maintenance activities associated with site surveillance features are included in the following subsections. Photographs to support specific observations are identified in the text and in Figure 18-1 by photograph location (PL) numbers. The photographs and photograph log are presented in Section 18.10.

Four aerial survey quality control monuments were installed in 2019 following the site inspection (PL-5). The quality control monument locations are shown in Figure 18-1. No maintenance needs were identified.
