19.0 Tuba City, Arizona, Disposal Site

19.1 Compliance Summary

Figure 19-1. 2021 Annual Inspection Drawing for the Tuba City, Arizona, Disposal Site

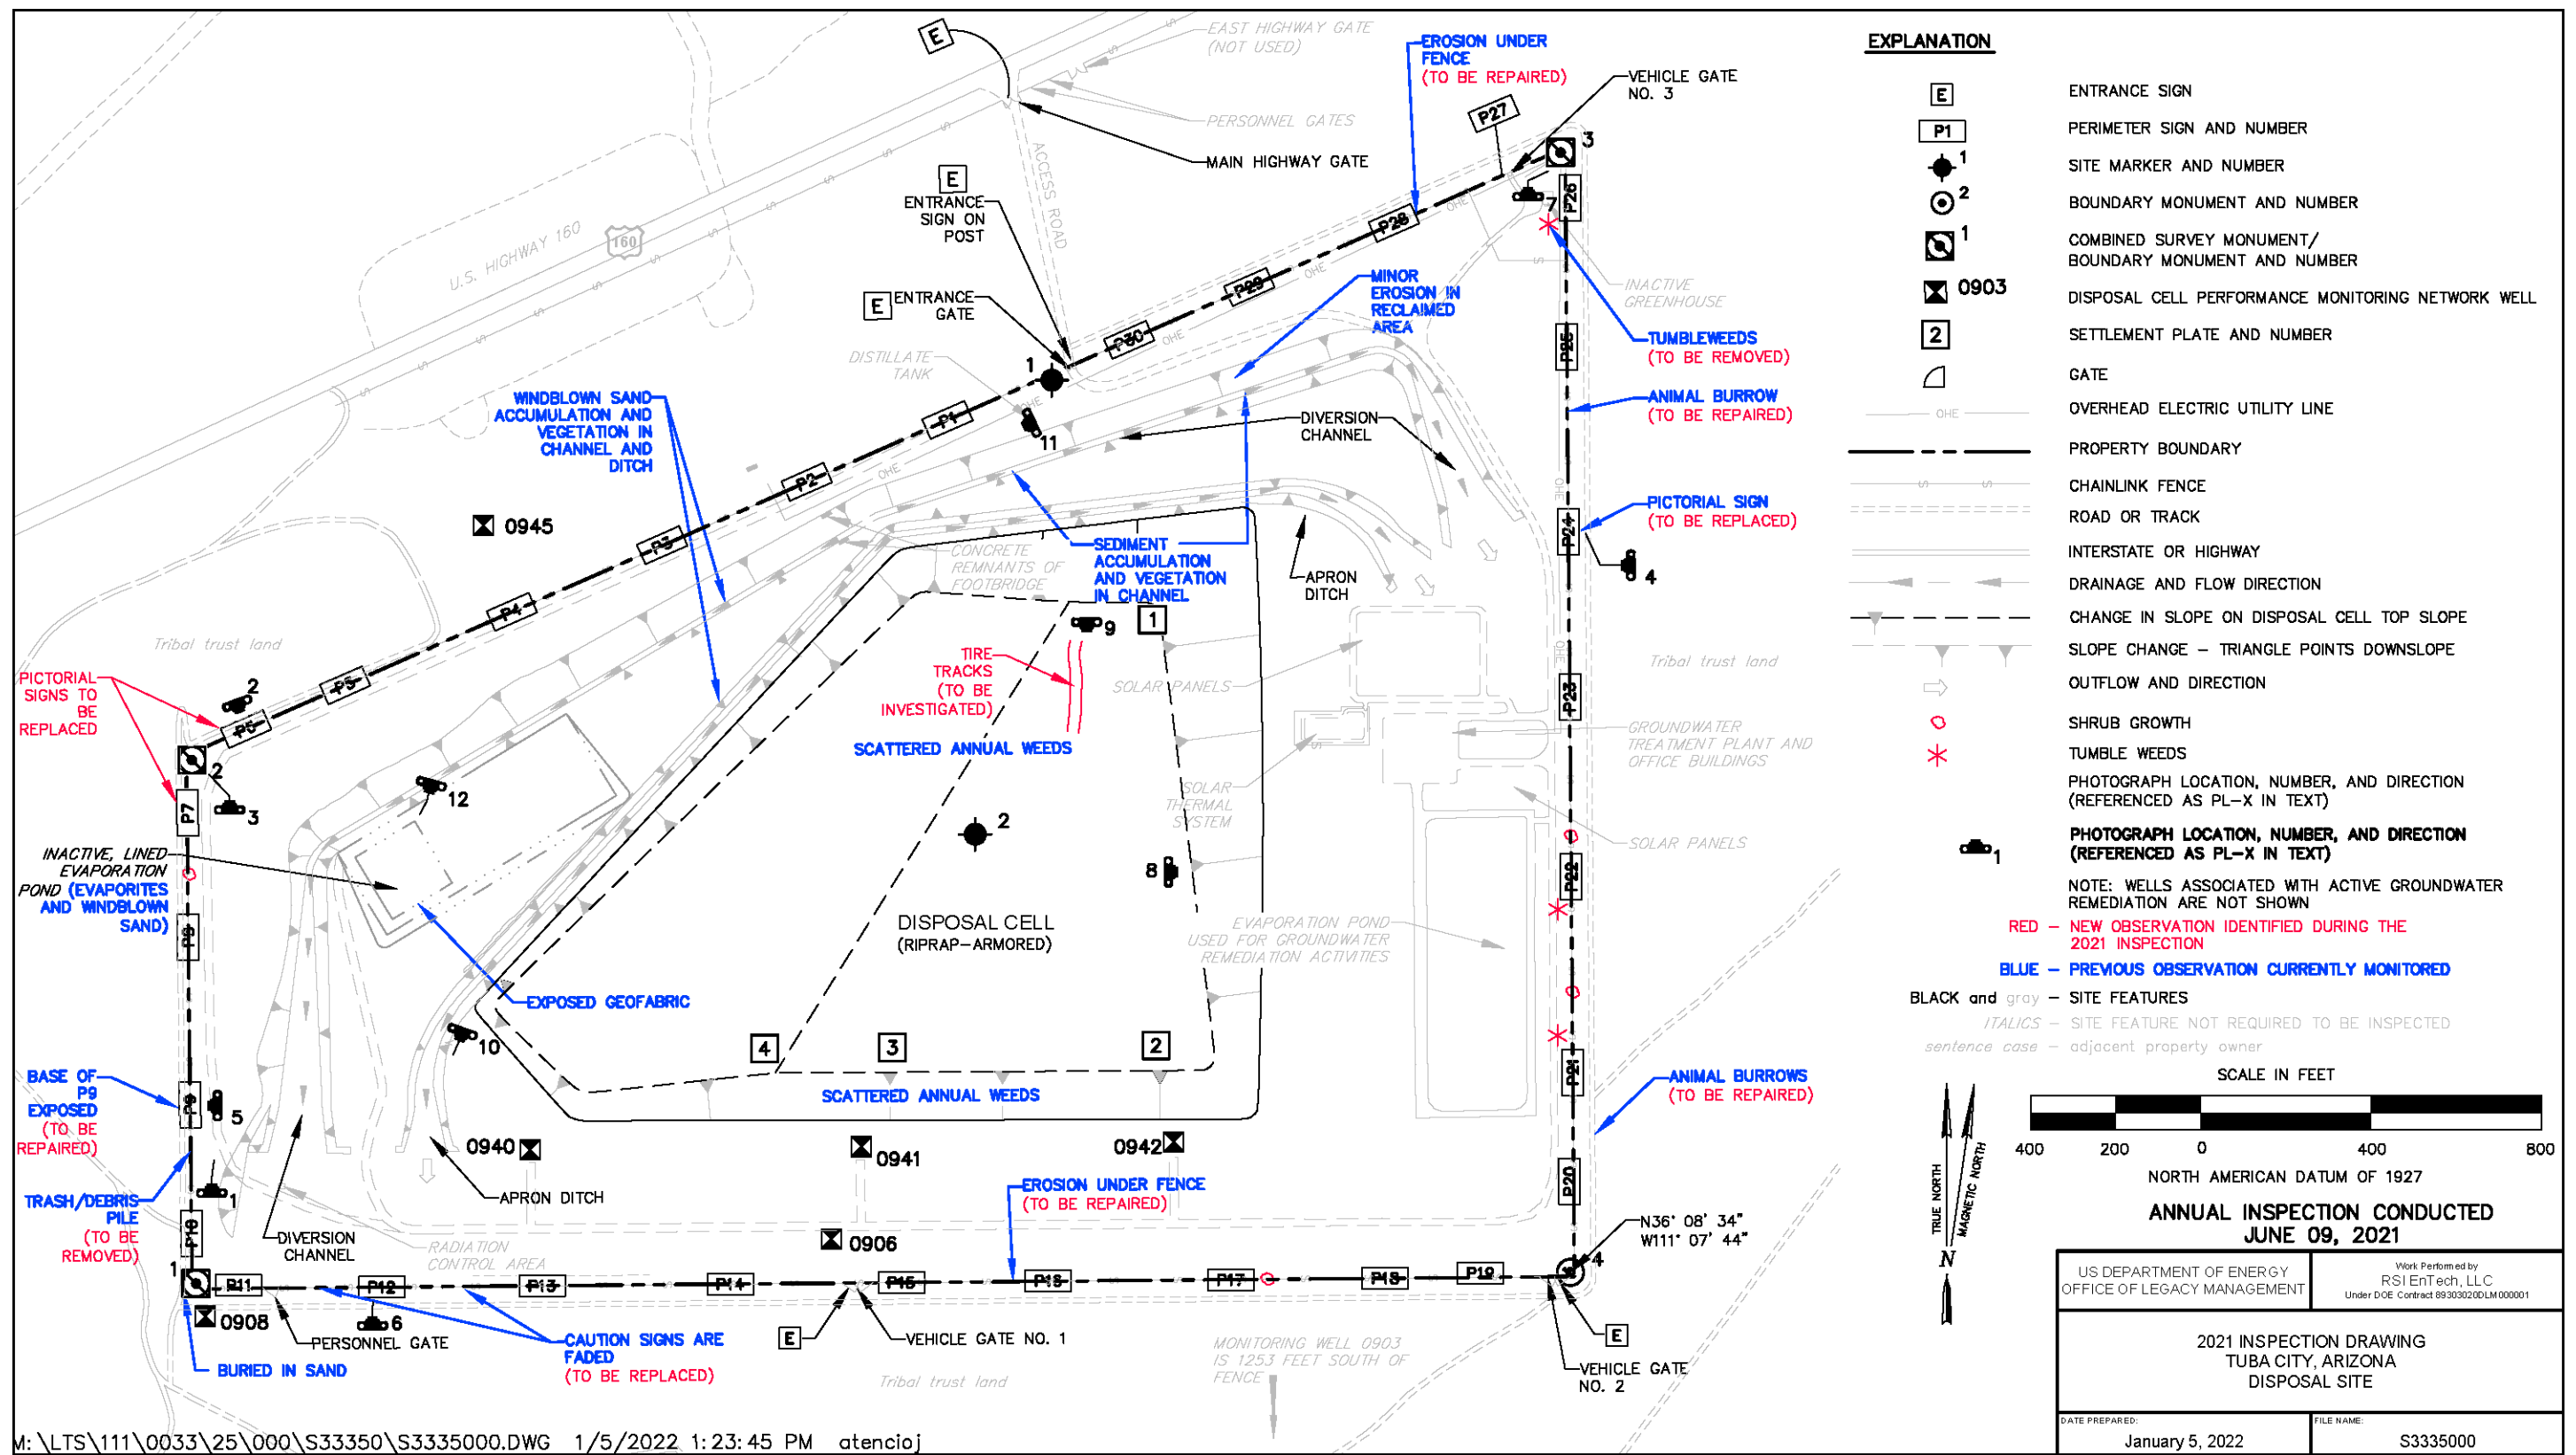
Figure 19-1 shows the locations of site features, including site surveillance features and inspection areas, in black and gray font. Site features that are present but not required to be inspected are shown in italic font. Observations from previous inspections that are currently monitored are shown in blue, and new observations identified during the 2021 annual inspection are shown in red font. Inspection results and recommended maintenance activities associated with site surveillance features are included in the following subsections. Photographs to support specific observations are identified in the text and in Figure 19-1 by photograph location (PL) numbers. The photographs and photograph log are presented in Section 19.10.

A chainlink perimeter fence encloses the site. Windblown sand continues to accumulate along the western perimeter fence and road (PL-1). The sand accumulation is not of concern at this time. Inspectors found several areas of accumulated tumbleweeds along the eastern fence line that will be cleared to reduce a potential fire hazard once Navajo Nation travel restrictions are lifted.

The erosion reported in 2020 under the fence near perimeter sign P16 has developed into a significant gap under the fence; a similar gap was also observed near perimeter sign P28. Animal burrows under the fence line near perimeter signs P20 and P25 identified in the 2020 inspection are still in need of repair. Perimeter sign P9 is being undercut by wind erosion (PL-5). Two faded signs warning of high voltage near perimeter sign P-12 were identified in the 2020 inspection. These maintenance tasks will be conducted once travel restrictions to the Navajo Nation are lifted (PL-6).
