19.0 Tuba City, Arizona, Disposal Site

19.1 Compliance Summary

The Tuba City, Arizona, Uranium Mill Tailings Radiation Control Act (UMTRCA) Title I Disposal Site was inspected on May 17, 2022. No significant changes were observed on the disposal cell or in the associated drainage features. Inspectors identified maintenance needs but found no cause for a follow-up inspection.

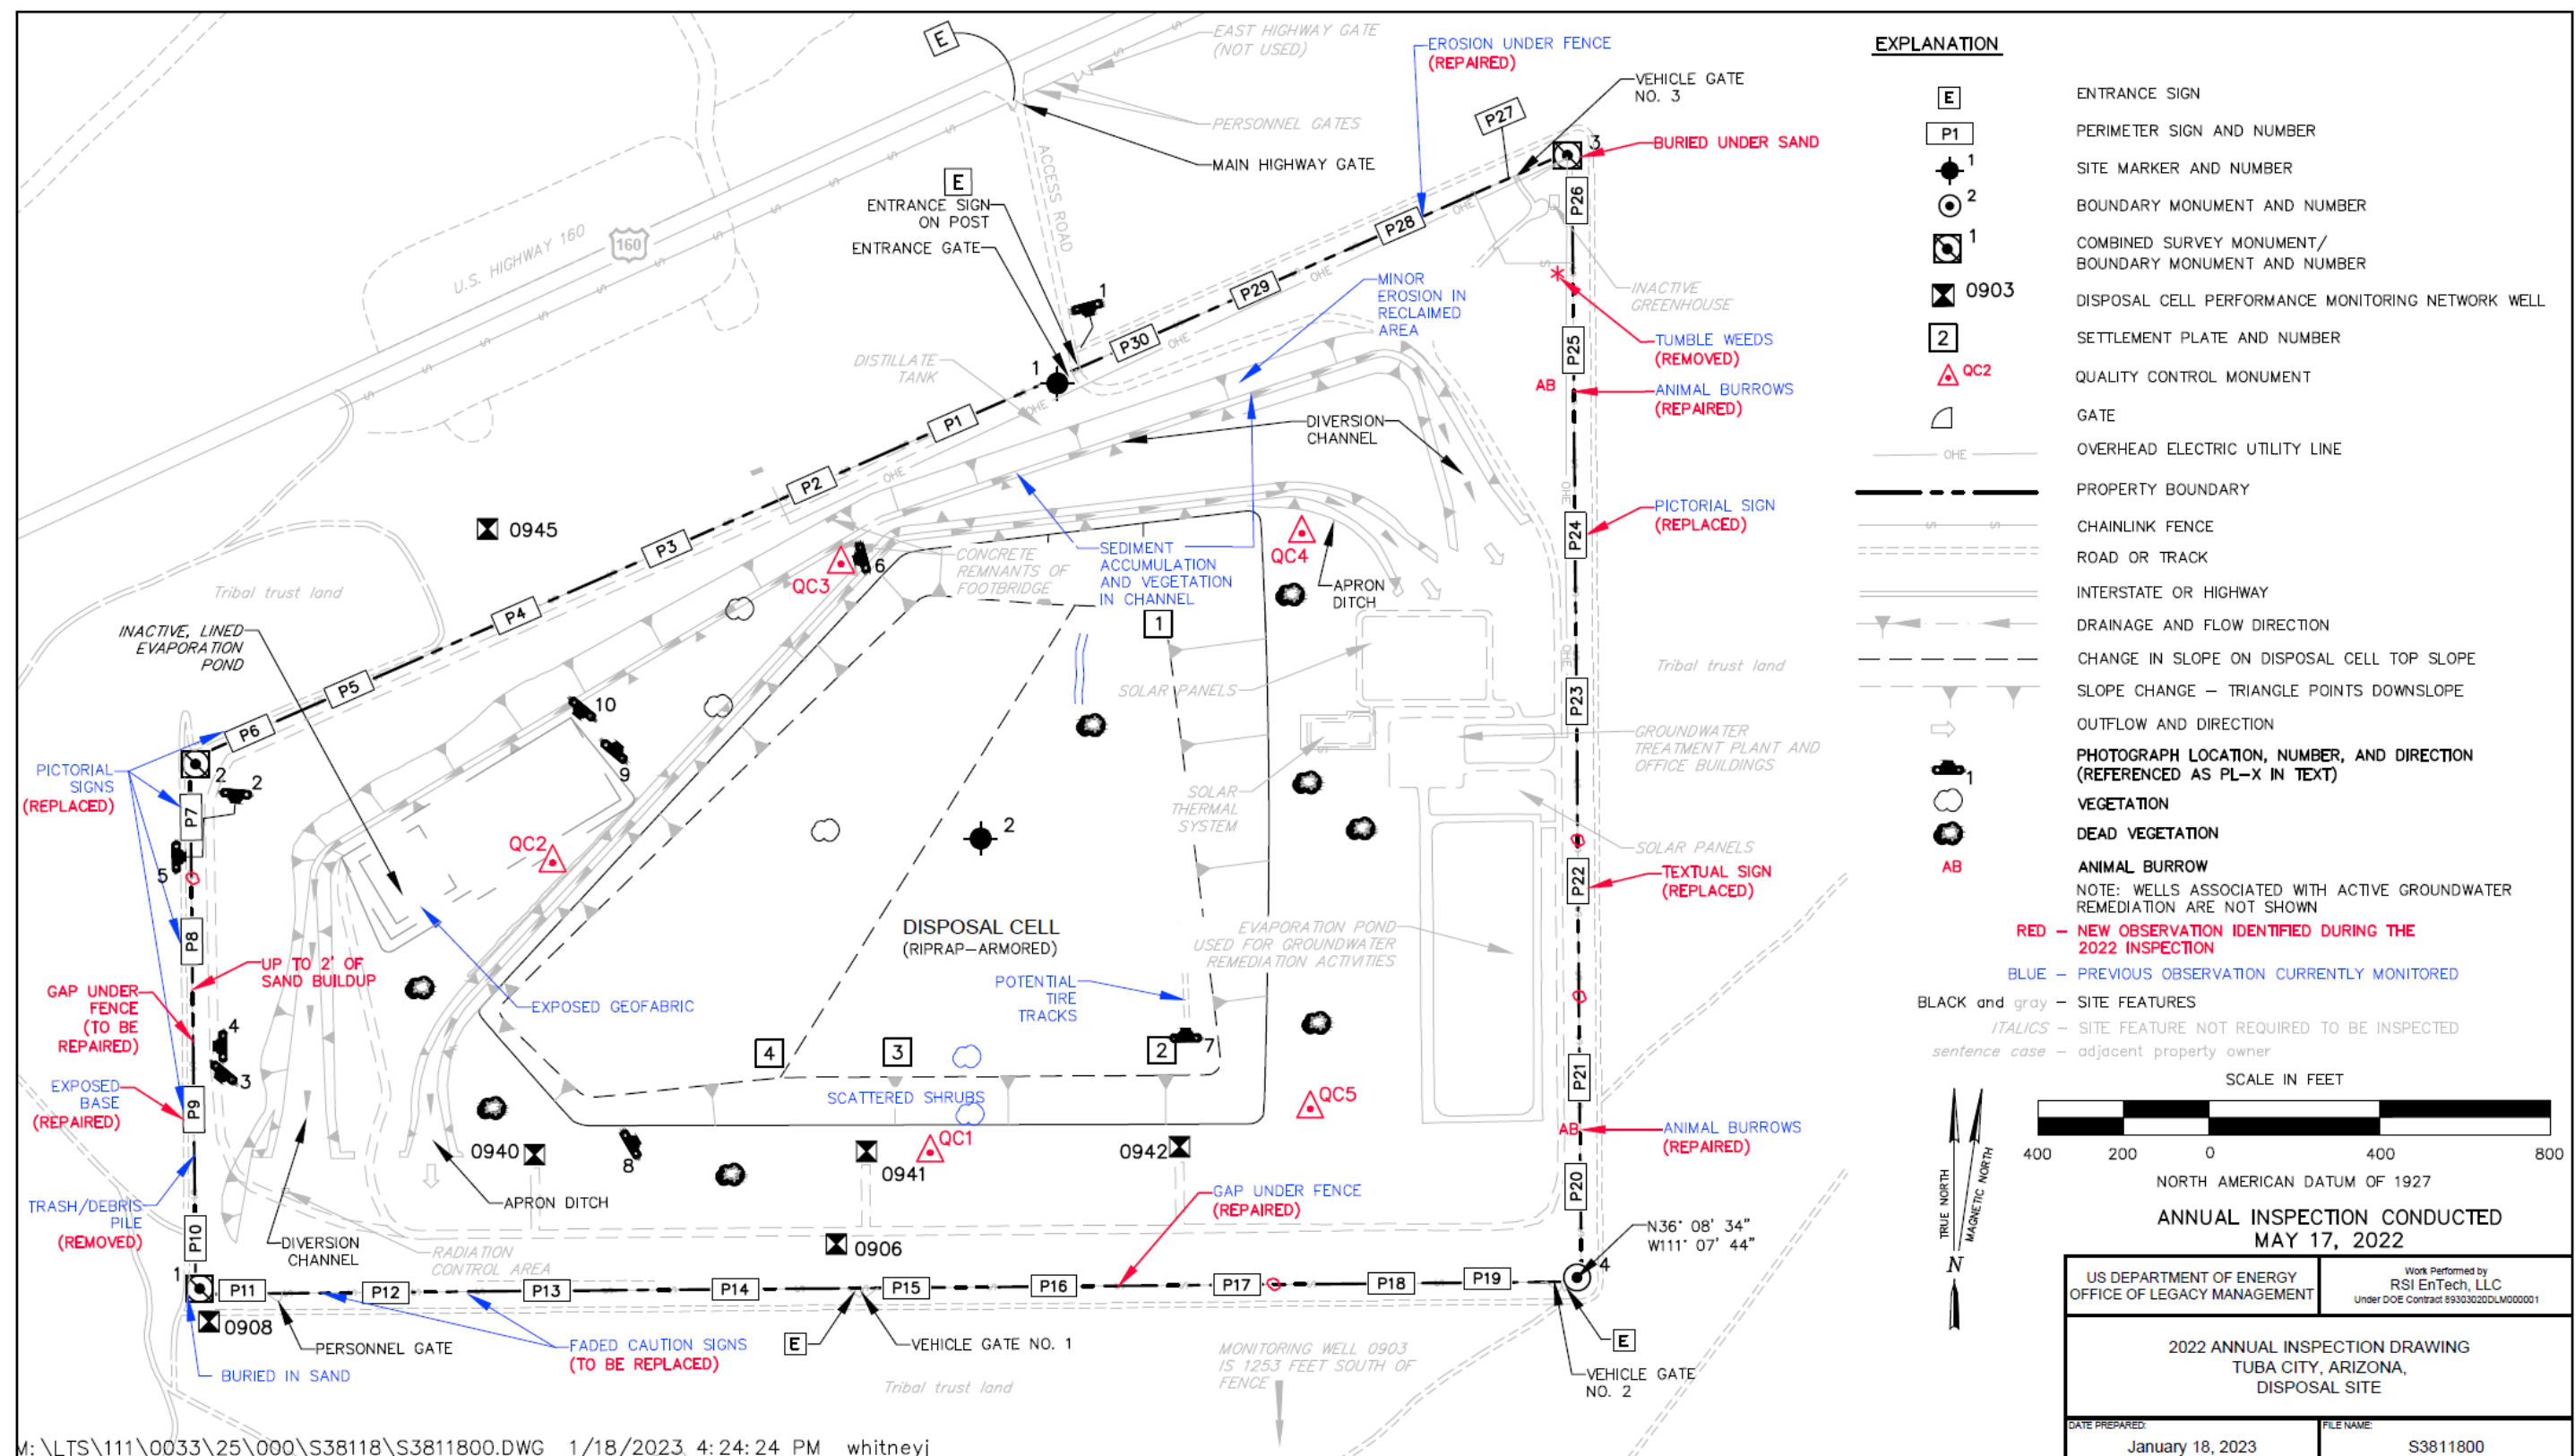
Figure 19-1 shows the locations of site features, including site surveillance features and inspection areas, in black and gray font. Some site features that are present but not required to be inspected are shown in italic font. Observations from previous inspections that are currently monitored are shown in blue, and new observations identified during the 2022 annual inspection are shown in red. Inspection results and recommended maintenance activities associated with site surveillance features are described in the following subsections. Photographs to support specific observations are noted in the text and in Figure 19-1 by photograph location (PL) numbers. The photographs and photograph log are presented in Section 19.10.

Access to the site is from U.S. Highway 160. Perpetual access to the site is granted by the Custodial Access Agreement. A gate in a chainlink fence on the main highway right-of-way (Figure 19-1) allows access to the site via a gravel road. The entrance gate is in the inner chainlink perimeter fence between perimeter signs P1 and P30. Both gates were operational at the time of the inspection. Vehicle gates are also present in the northeast corner of the site and along the southern fence line to facilitate access for offsite activities. All gates were secured and functional.

A chainlink perimeter fence encloses the site. Windblown sand and tumbleweeds regularly accumulate along the perimeter fence line and road (PL-2 and PL-3) resulting in several gaps under the fence (PL-4). These areas will be repaired before the next inspection. Trash and debris have accumulated around perimeter sign P9 and were removed following the inspection.

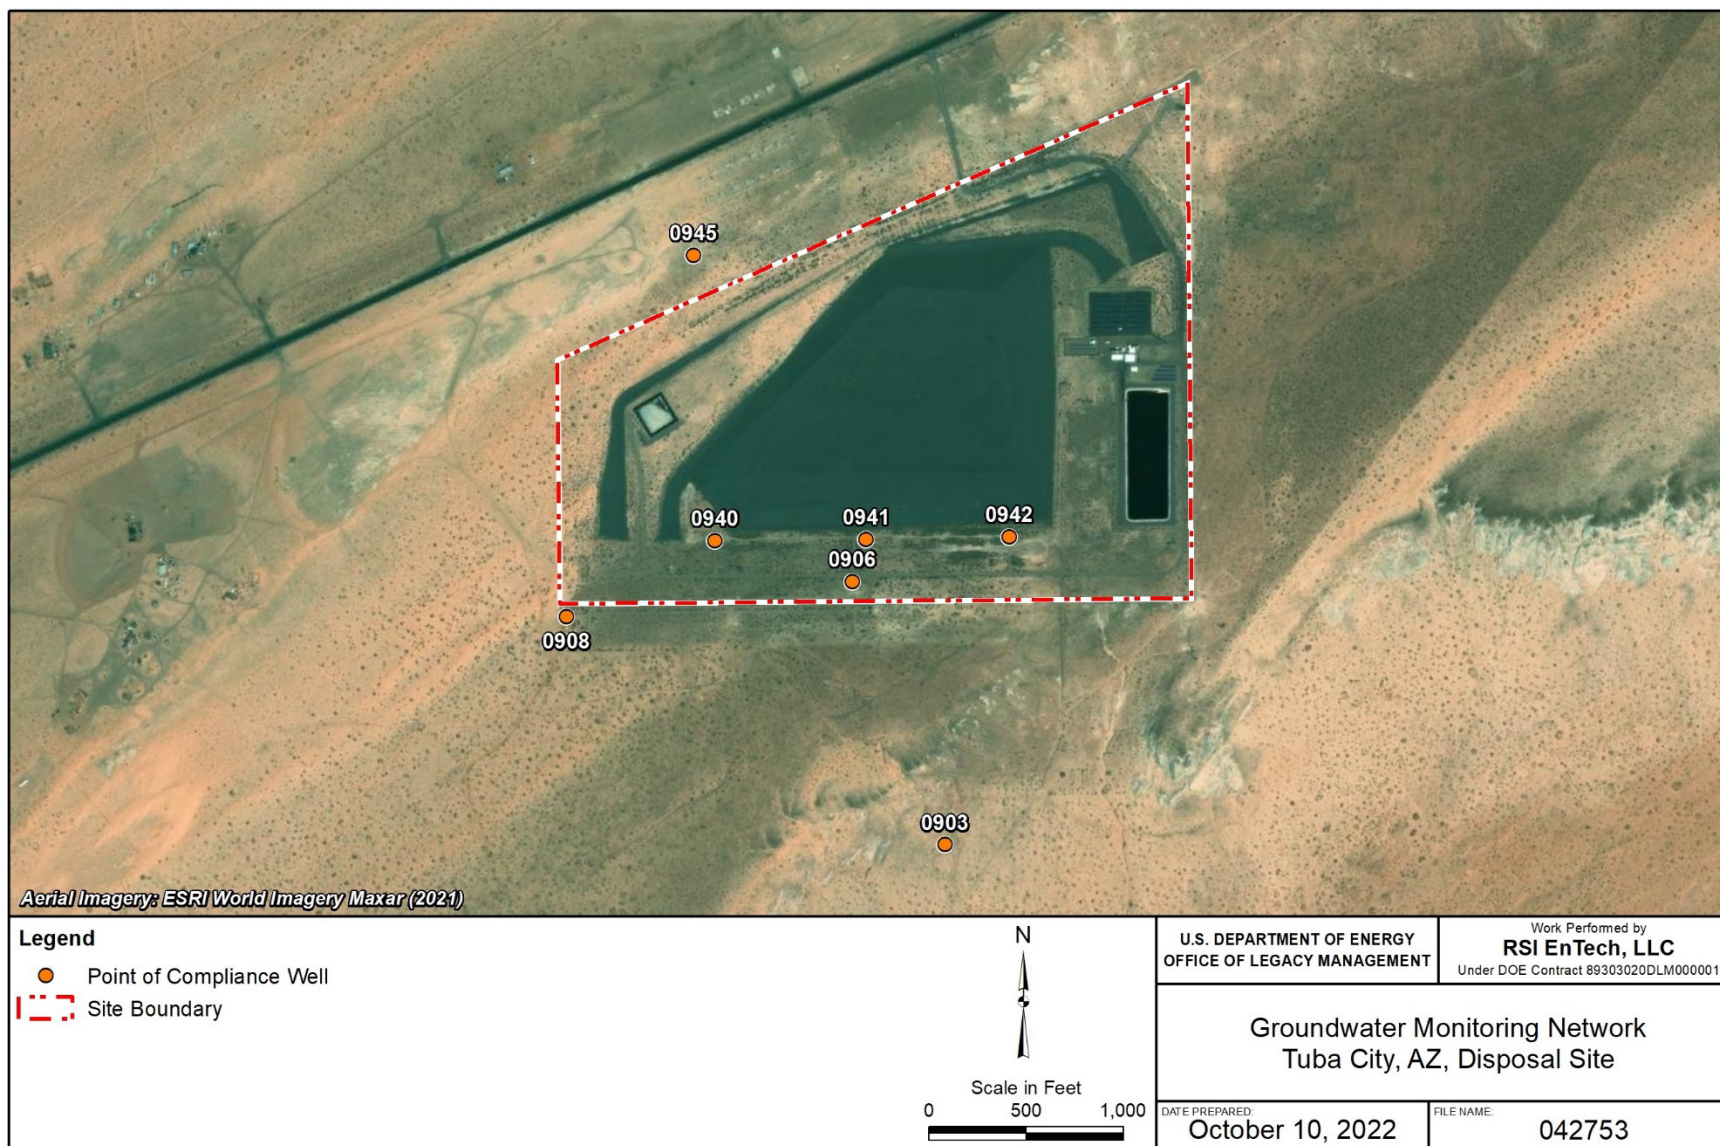
Figure 19-2. Groundwater Monitoring Network at the Tuba City, Arizona, Disposal Site

Seven wells (Figure 19-2 and Table 19-2) identified in the LTSP are monitored for four hazardous constituents: molybdenum, nitrate, selenium, and uranium (Table 19-2) (DOE 1996). As a baseline for cell performance evaluation, provisional upper baseline limits (UBLs) for the four constituents were calculated in accordance with the U.S. Environmental Protection Agency’s *Statistical Analysis of Groundwater Monitoring Data at RCRA Facilities—Interim Final Guidance* (EPA 1989) and documented in the LTSP (DOE 1996). The UBLs are listed in Table 19-3.

Note: Well 0942 was converted from a monitoring well to an extraction well in 2015.
