## 19.0 Tuba City, Arizona, Disposal Site

### 19.1 Compliance Summary

The Tuba City, Arizona, Uranium Mill Tailings Radiation Control Act (UMTRCA) Title I Disposal Site was inspected on May 2, 2023. No significant changes were observed on the disposal cell or in the associated drainage features. Inspectors identified maintenance needs but found no cause for a follow-up inspection.

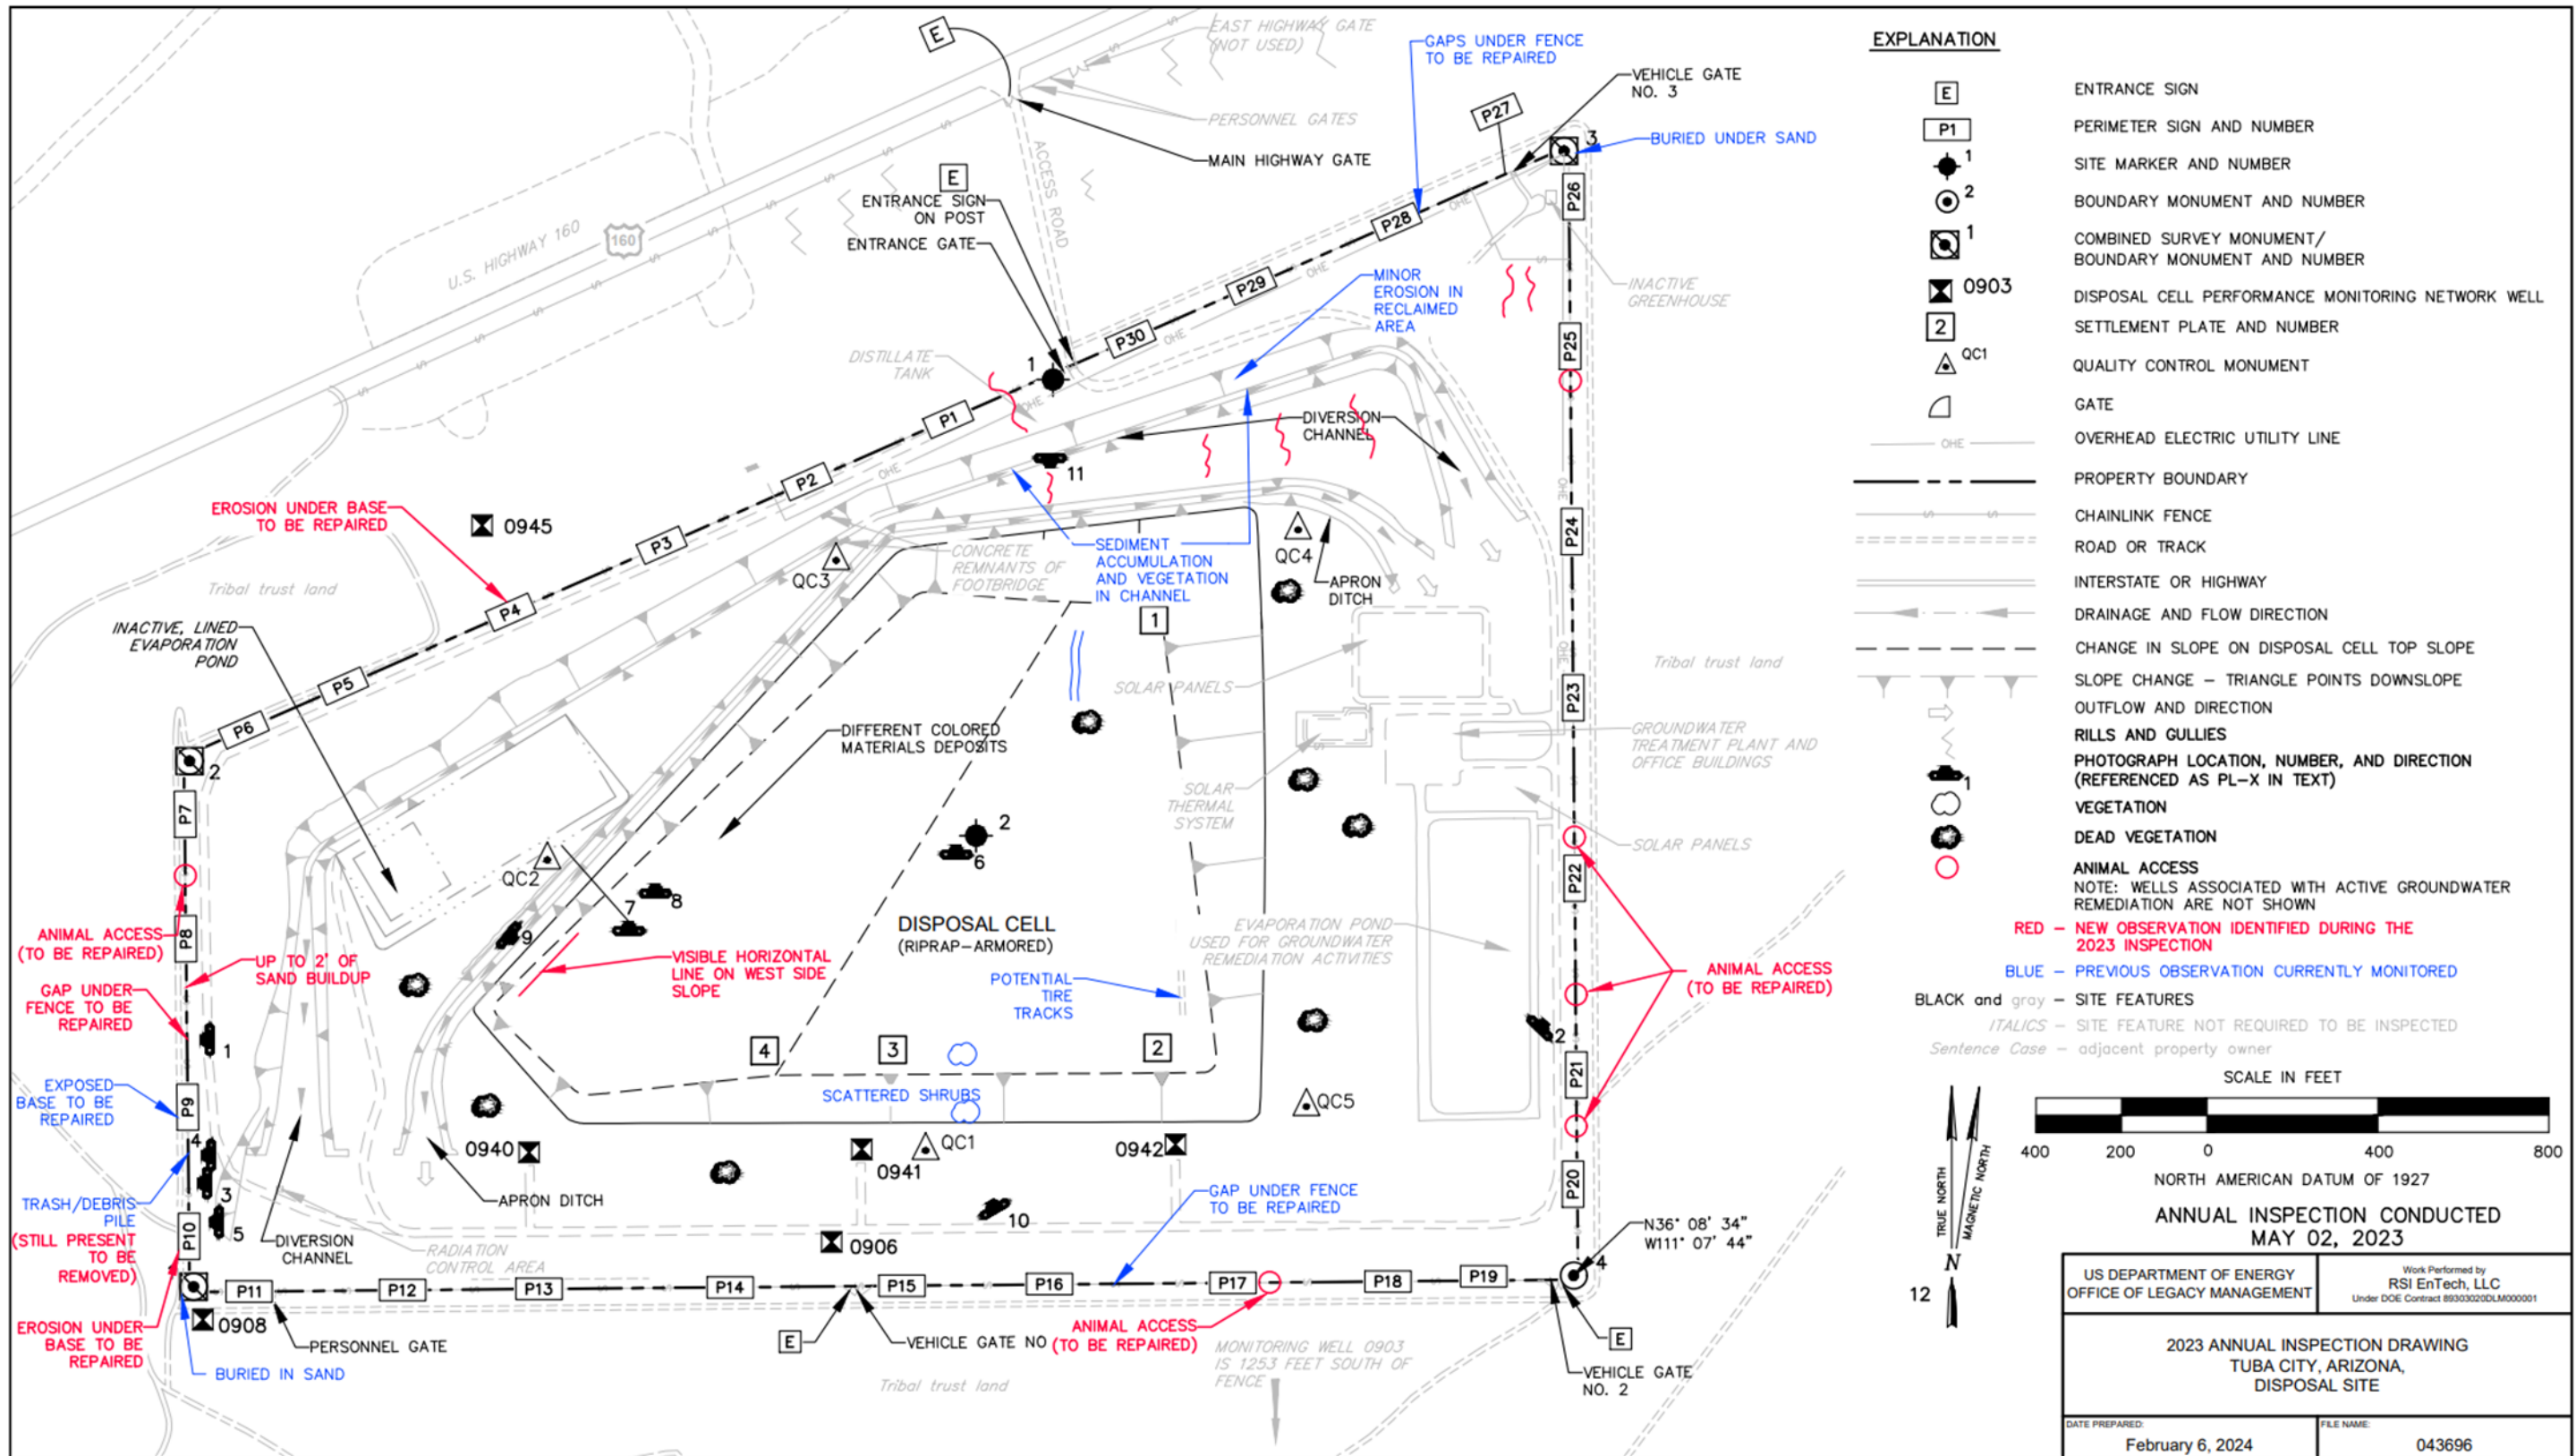
Figure 19-1. 2023 Annual Inspection Drawing for the Tuba City, Arizona, Disposal Site

Figure 19-1 shows the locations of site features, including site surveillance features and inspection areas, in black and gray font. Some site features that are present but not required to be inspected are shown in italic font. Observations from previous inspections that are currently monitored are shown in blue, and new observations identified during the 2023 annual inspection are shown in red. Inspection results and recommended maintenance activities associated with site surveillance features are described in the following subsections. Photographs to support specific observations are noted in the text and in Figure 19-1 by photograph location (PL) numbers. The photographs and photograph log are presented in Section 19.10.

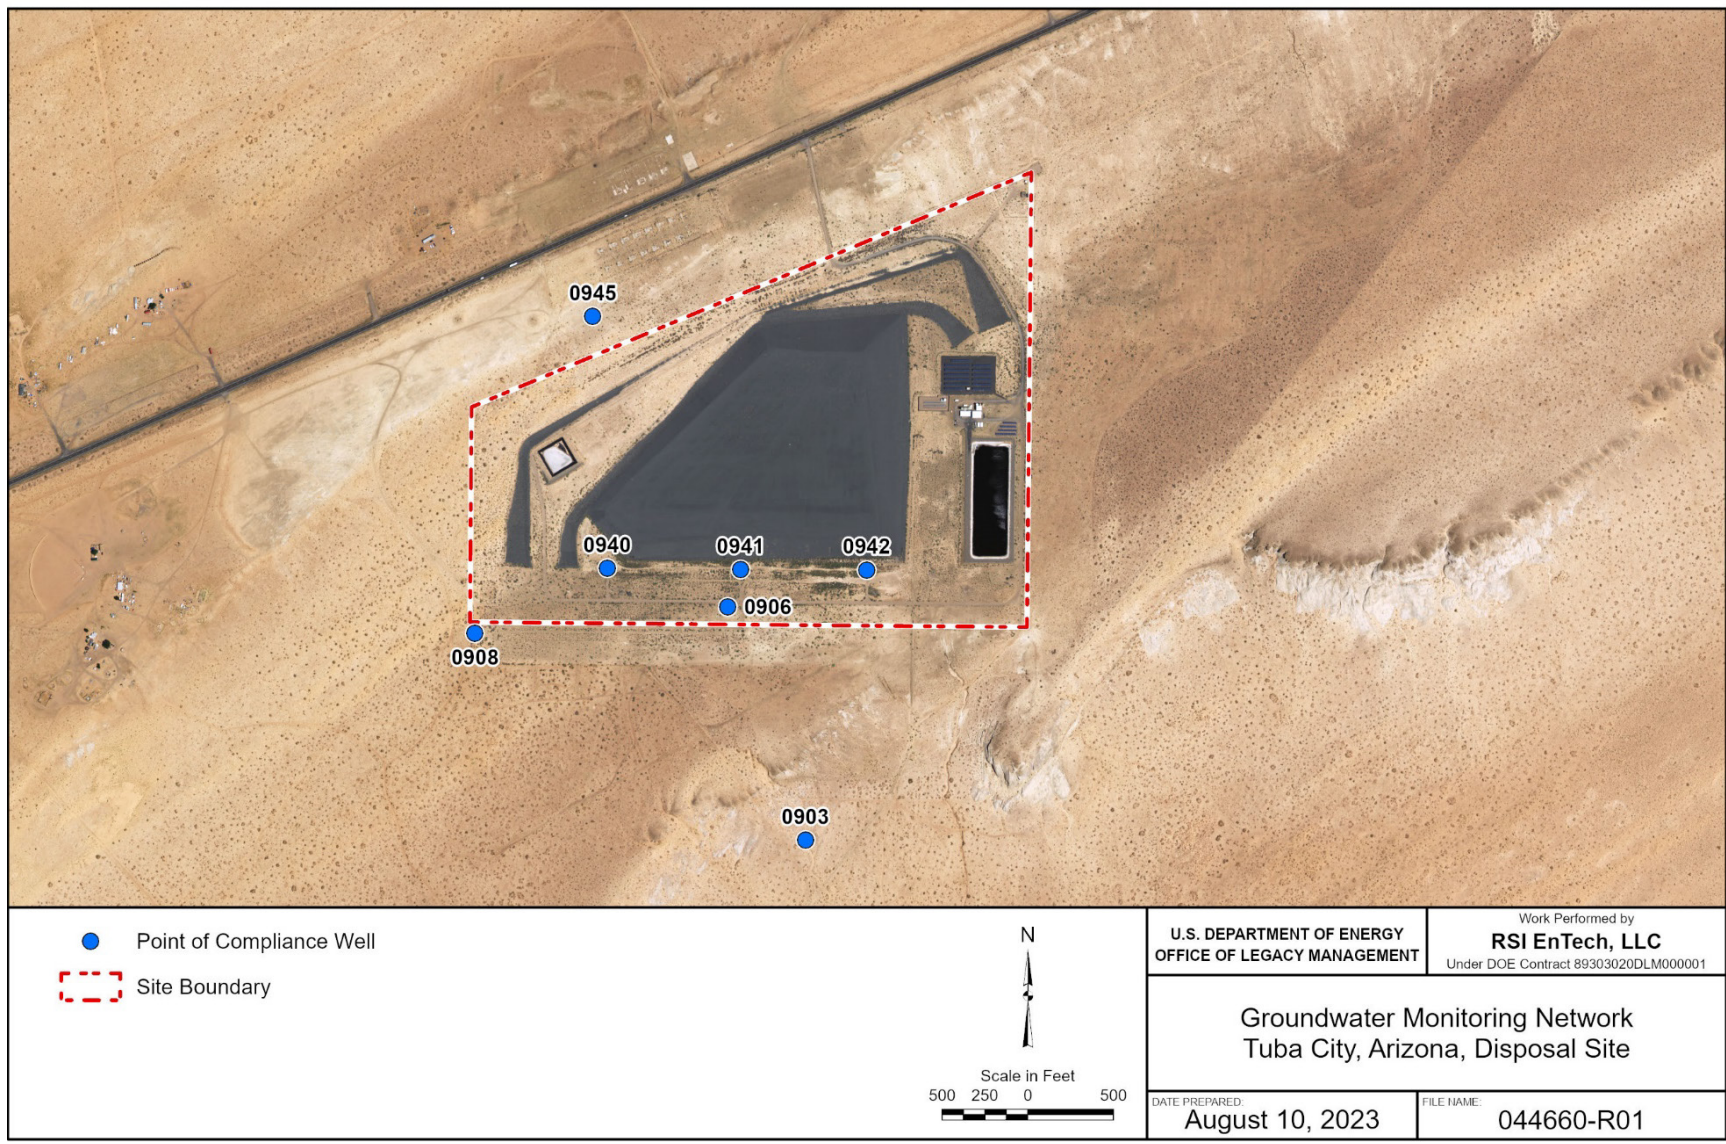
*Figure 19-2. Evaluative Groundwater Monitoring Network at the Tuba City, Arizona, Disposal Site*

**Note:** Well 0942 was converted from a monitoring well to an extraction well in 2015.

Seven wells (Figure 19-2 and Table 19-2) identified in the LTSP are monitored for four hazardous constituents: molybdenum, nitrate, selenium, and uranium (Table 19-2) (DOE 1996). As a baseline for cell performance evaluation, provisional upper baseline limits (UBLs) for the four constituents were calculated in accordance with the U.S. Environmental Protection Agency’s *Statistical Analysis of Ground-Water Monitoring Data at RCRA Facilities, Interim Final Guidance* (EPA 1989) and documented in the LTSP (DOE 1996). The UBLs are listed in Table 19-3.
