## 2.0 Burrell, Pennsylvania, Disposal Site

The Burrell, Pennsylvania, Uranium Mill Tailings Radiation Control Act (UMTRCA) Title I Disposal Site was inspected on October 29, 2024. No changes were observed on the disposal cell or in the associated drainage features. Inspectors identified minor maintenance needs but found no cause for a follow-up inspection.

Figure 2-1. 2024 Annual Inspection Drawing for the Burrell, Pennsylvania, Disposal Site

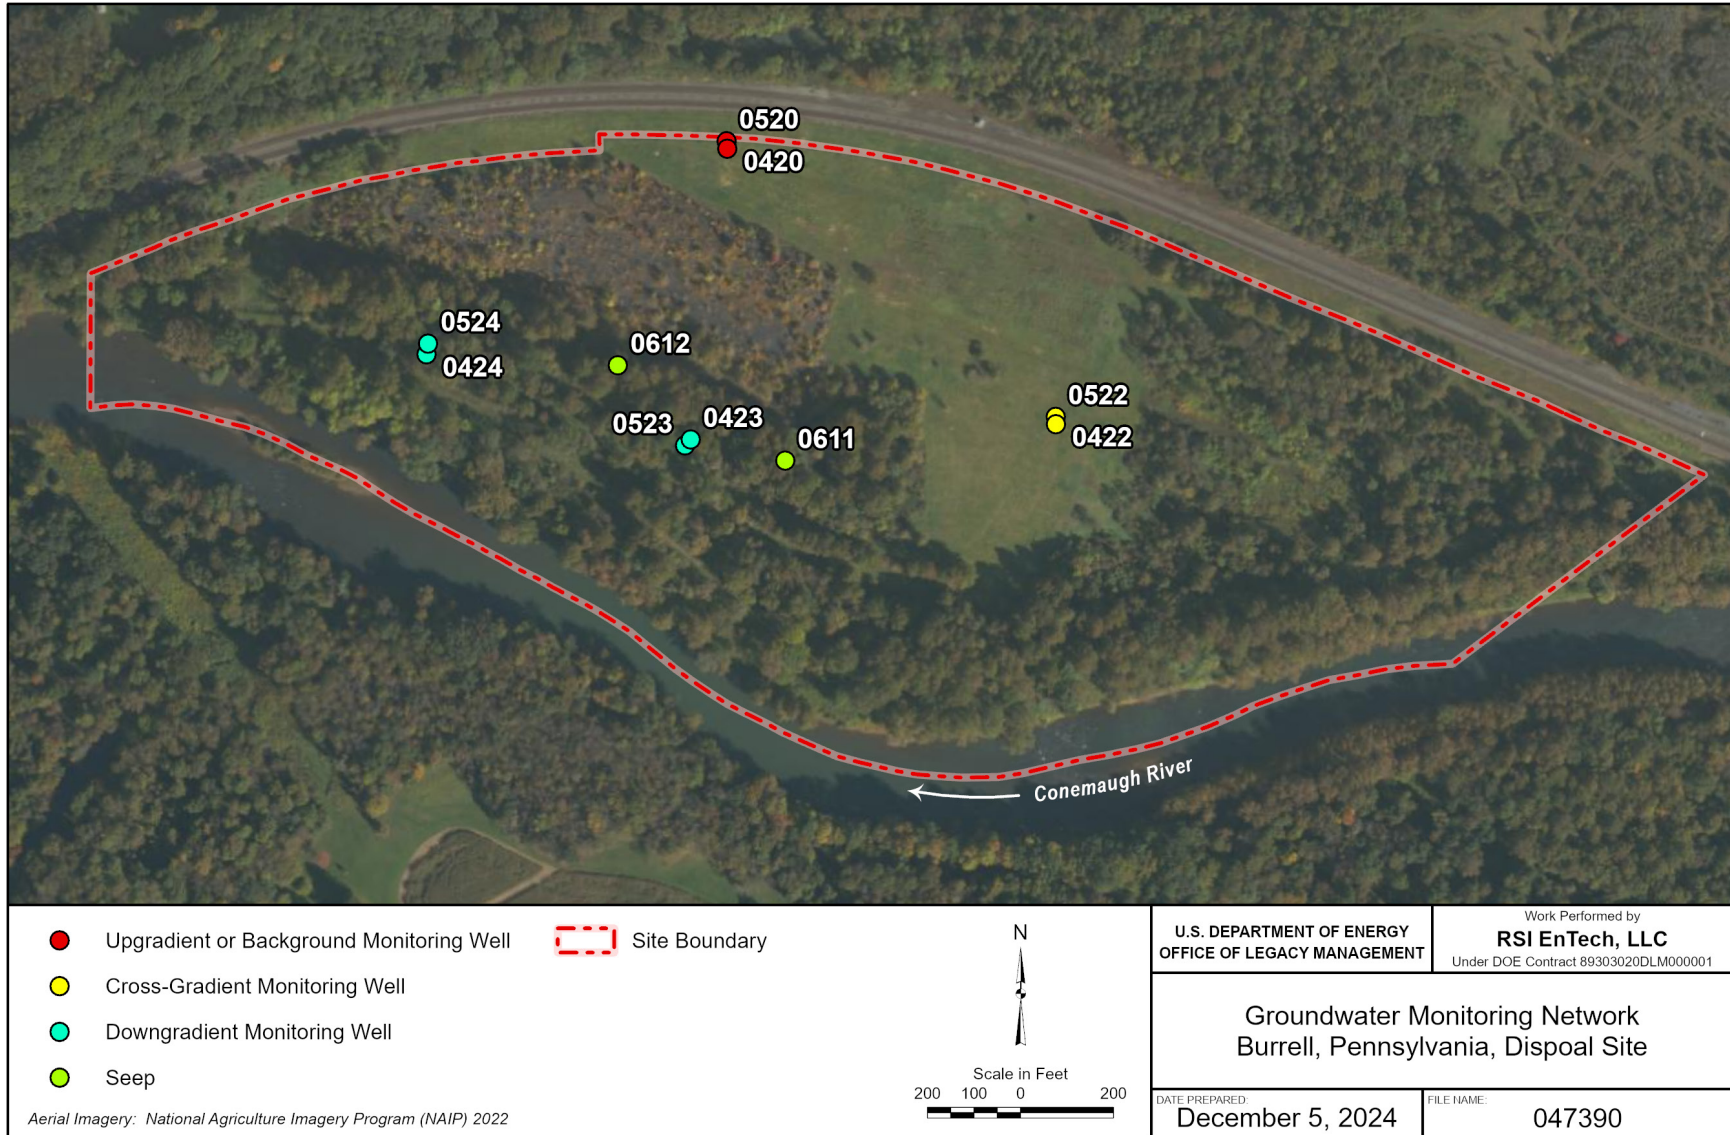
Figure 2-2. Groundwater Monitoring Network for the Burrell, Pennsylvania, Disposal Site

The most recent sampling event occurred in October 2023. Two of the shallow monitoring wells (wells 0422 and 0423) had insufficient recharge to sample. Consistent with most historical observations, seeps 0611 and 0612 were also dry at that time. However, seep 0611 was moist during the 2024 inspection.
