# 1.0 Bluewater, New Mexico, Disposal Site

## 1.1 Compliance Summary

The site, approximately 9 miles northwest of Grants, New Mexico, was inspected September 10–11, 2020. The annual inspection, which routinely occurs in March, was delayed by coronavirus-related travel restrictions. The inspection was conducted by J. Cario, N. Keller, and D. Traub of the Legacy Management Support (LMS) contractor. B. Tsosie (LM site manager), B. Frazier (LM), and A. Rheubottom (New Mexico Environment Department [NMED]) attended the inspection. The purposes of the inspection were to confirm the integrity of visible features at the site, identify changes in conditions that might affect conformance with the LTSP, and determine the need, if any, for maintenance or additional inspection and monitoring.

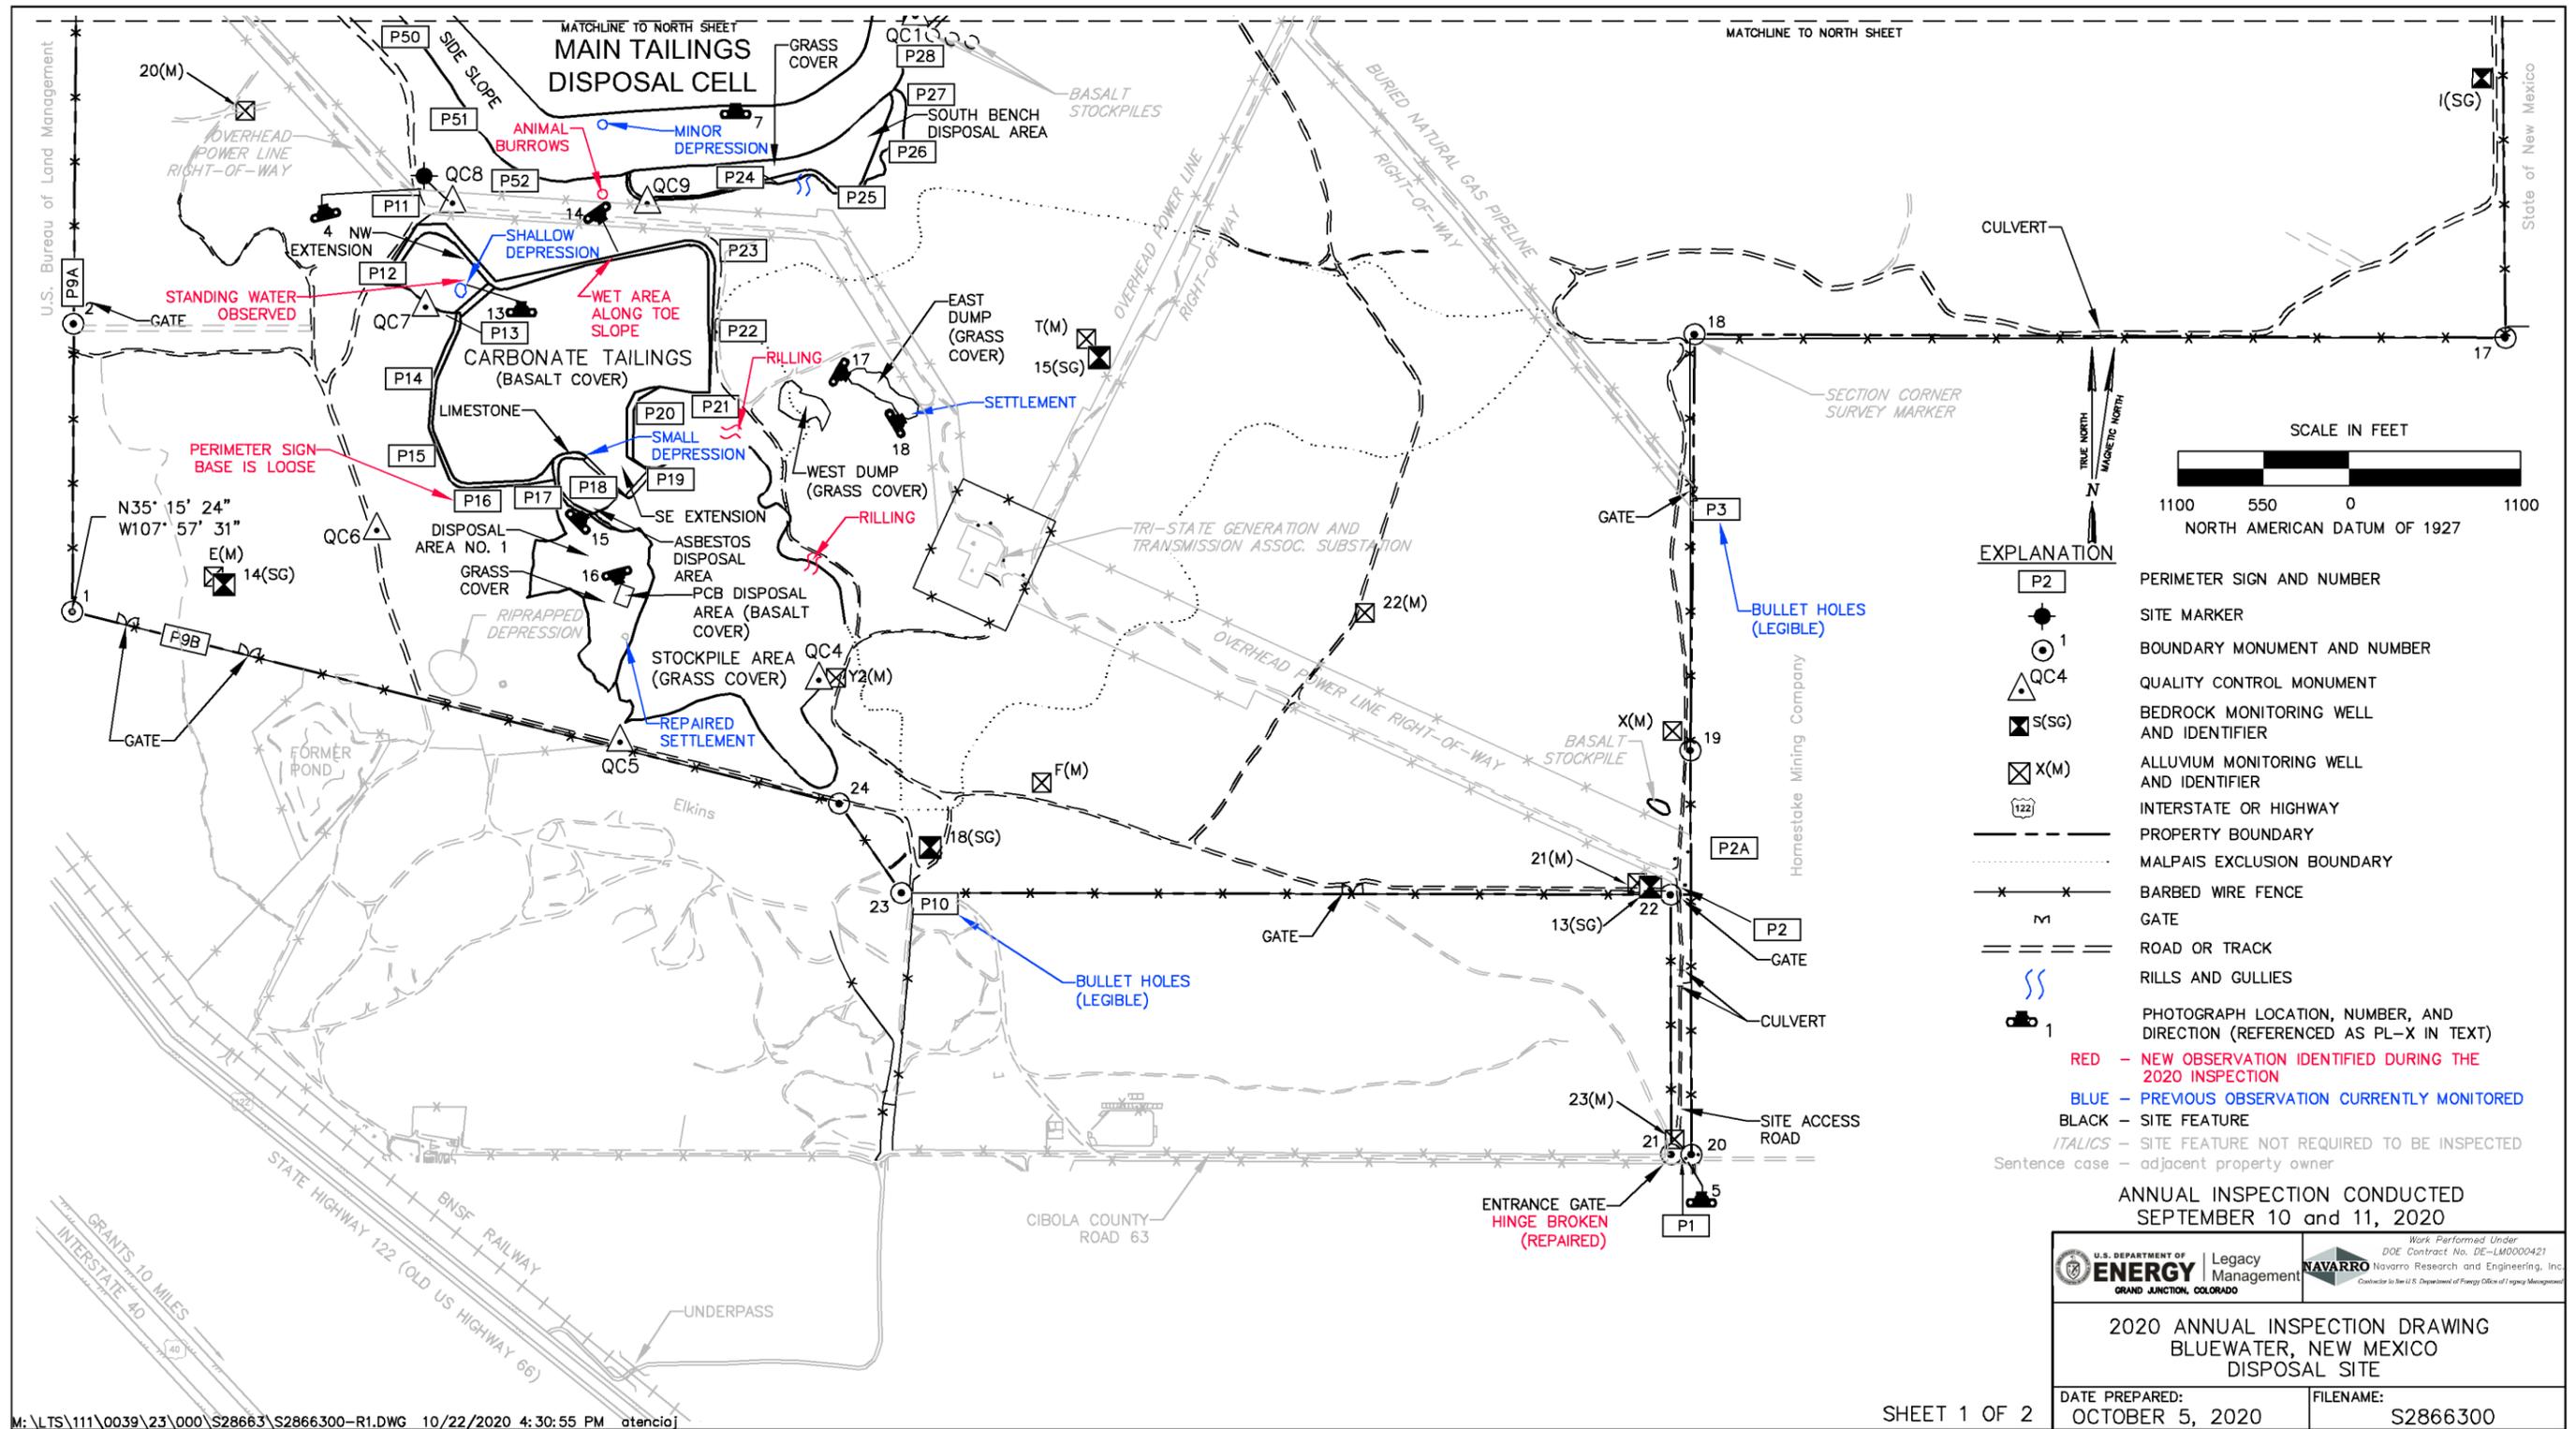
Figure 1-1. 2020 Annual Inspection Drawing for the Bluewater, New Mexico, Disposal Site (South Area)

Figure 1-1 and Figure 1-2 show the locations of site features in black and gray font, including site surveillance features and inspection areas. Site features that are present but not required to be inspected are shown in italic font. Observations from previous inspections that are currently monitored are shown in blue text, and new observations are shown in red type. Inspection results and recommended maintenance activities associated with site surveillance features are included in the following subsections. Photographs to support specific observations are identified in the text and in Figure 1-1 and Figure 1-2 by photograph location (PL) numbers. The photographs and photograph log are presented in Section 1.9.

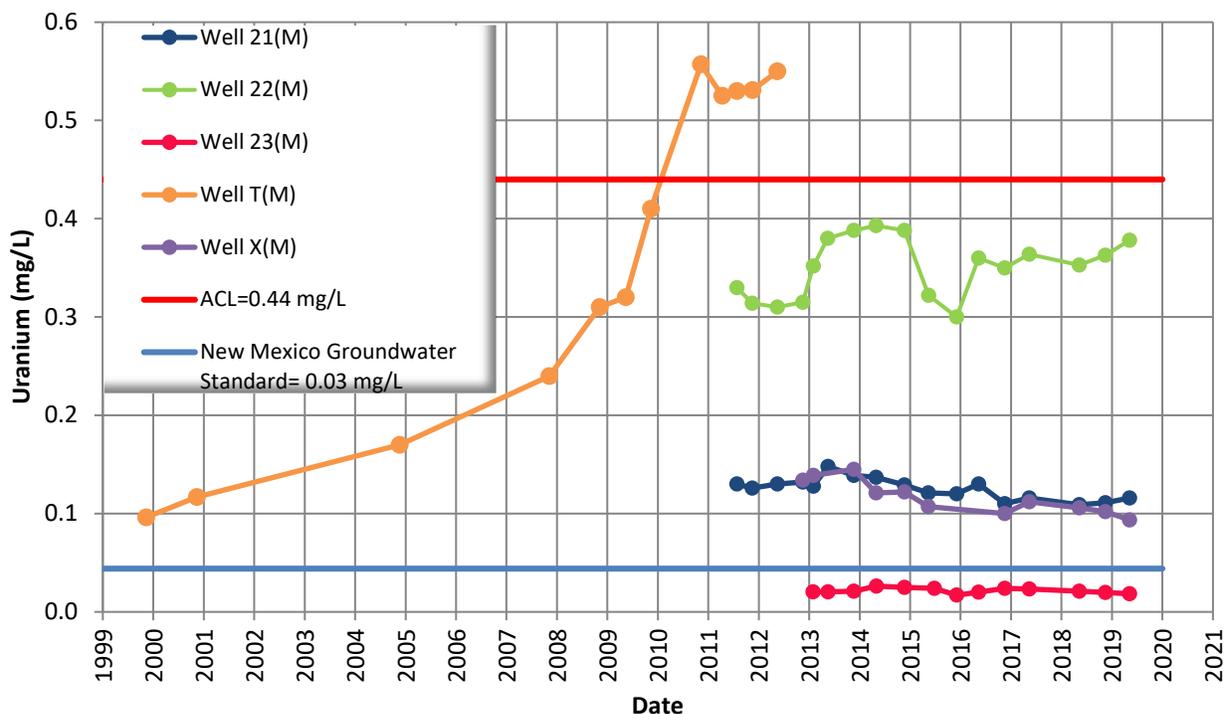
Figure 1-4. Uranium Concentrations in Alluvial Aquifer POC Well T(M) and Downgradient Wells at the Bluewater, New Mexico, Disposal Site

Figure 1-4 shows historical uranium concentrations measured at POC well T(M) and four additional wells screened in the alluvial aquifer. As this figure shows, the uranium concentration at well T(M) trended upward since LM began monitoring the well in 1999, and the November 2010 concentration of 0.557 mg/L was the first of five uranium concentrations that exceeded the ACL of 0.44 mg/L. LM notified NRC of the exceedance upon receiving the 2010 results from the laboratory. Well T(M) was sampled in May 2012 as declining water levels due to drought indicated it would soon go dry. Well T(M) has remained dry since 2012. Well 21(M) in the southeast corner of the site and POE well X(M) near the site's east boundary show a slightly decreasing trend in uranium concentration since 2013 (Figure 1-4). However, the elevated uranium concentrations at these two wells in recent years indicate that alluvial groundwater with uranium concentrations exceeding the New Mexico groundwater standard (0.03 mg/L) is discharging from the site toward the southeast. NRC requested that LM evaluate the performance of the main tailings disposal cell to assess whether seepage from the cell between 2005 and 2010 had increased to the extent it was responsible for the elevated uranium concentrations measured at POC well T(M) (see Figure 1-4) before it dried up. Based on an assessment of the disposal cell cover and an accompanying evaluation of the water balance for the main tailings disposal cell, the increase in uranium concentrations in well T(M) is not attributed to a compromise of the disposal cell's performance, and there was no surge of tailings-fluid seepage from the main tailings cell since it was closed (DOE 2014). It was further concluded that water levels in well T(M) decreased during the early 2000s below the contact between the alluvium and underlying Chinle Formation from 2008 to 2012. The simultaneous increase in uranium concentration was attributed to the declining water level and the influence of contaminated groundwater migrating through and interacting with weathered Chinle Formation materials, with the resulting fluids obscuring the water chemistry of groundwater in nearby portions of the alluvial aquifer that remained saturated (DOE 2014).

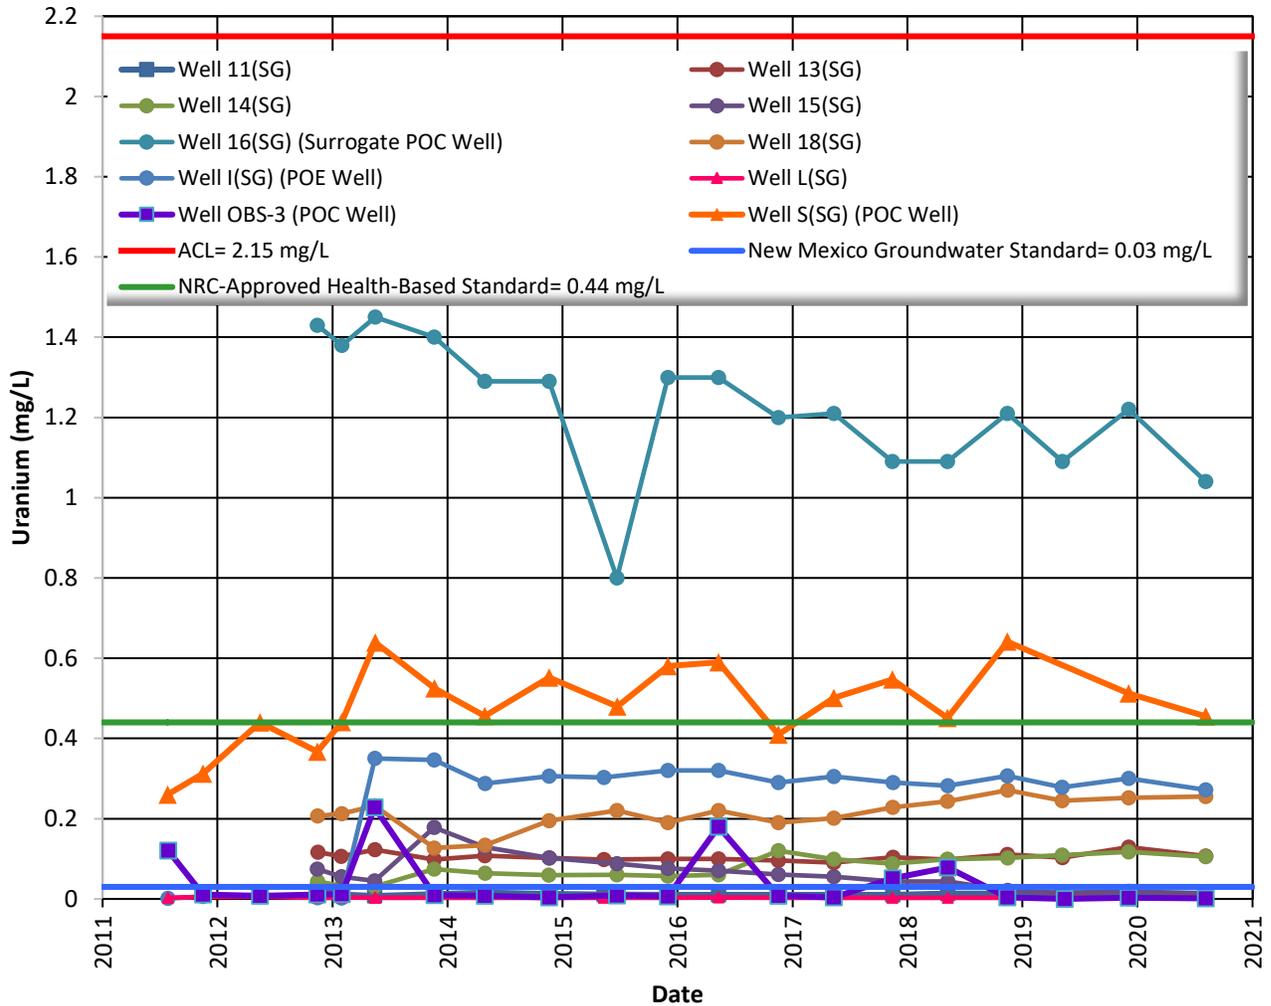
Figure 1-5. Uranium Concentrations in the San Andres/Glorieta Aquifer at the Bluewater, New Mexico, Disposal Site

Figure 1-5 shows uranium concentrations in the SAG aquifer. Uranium concentrations in well I(SG) before 2013 are not shown because an incorrect sampling depth in the well led to erroneously low results. Uranium concentrations at POC wells OBS-3 and S(SG) are not shown in Figure 1-5 because the well screens are encrusted with iron scale that has resulted in erroneously low uranium concentrations since LM began sampling the wells.

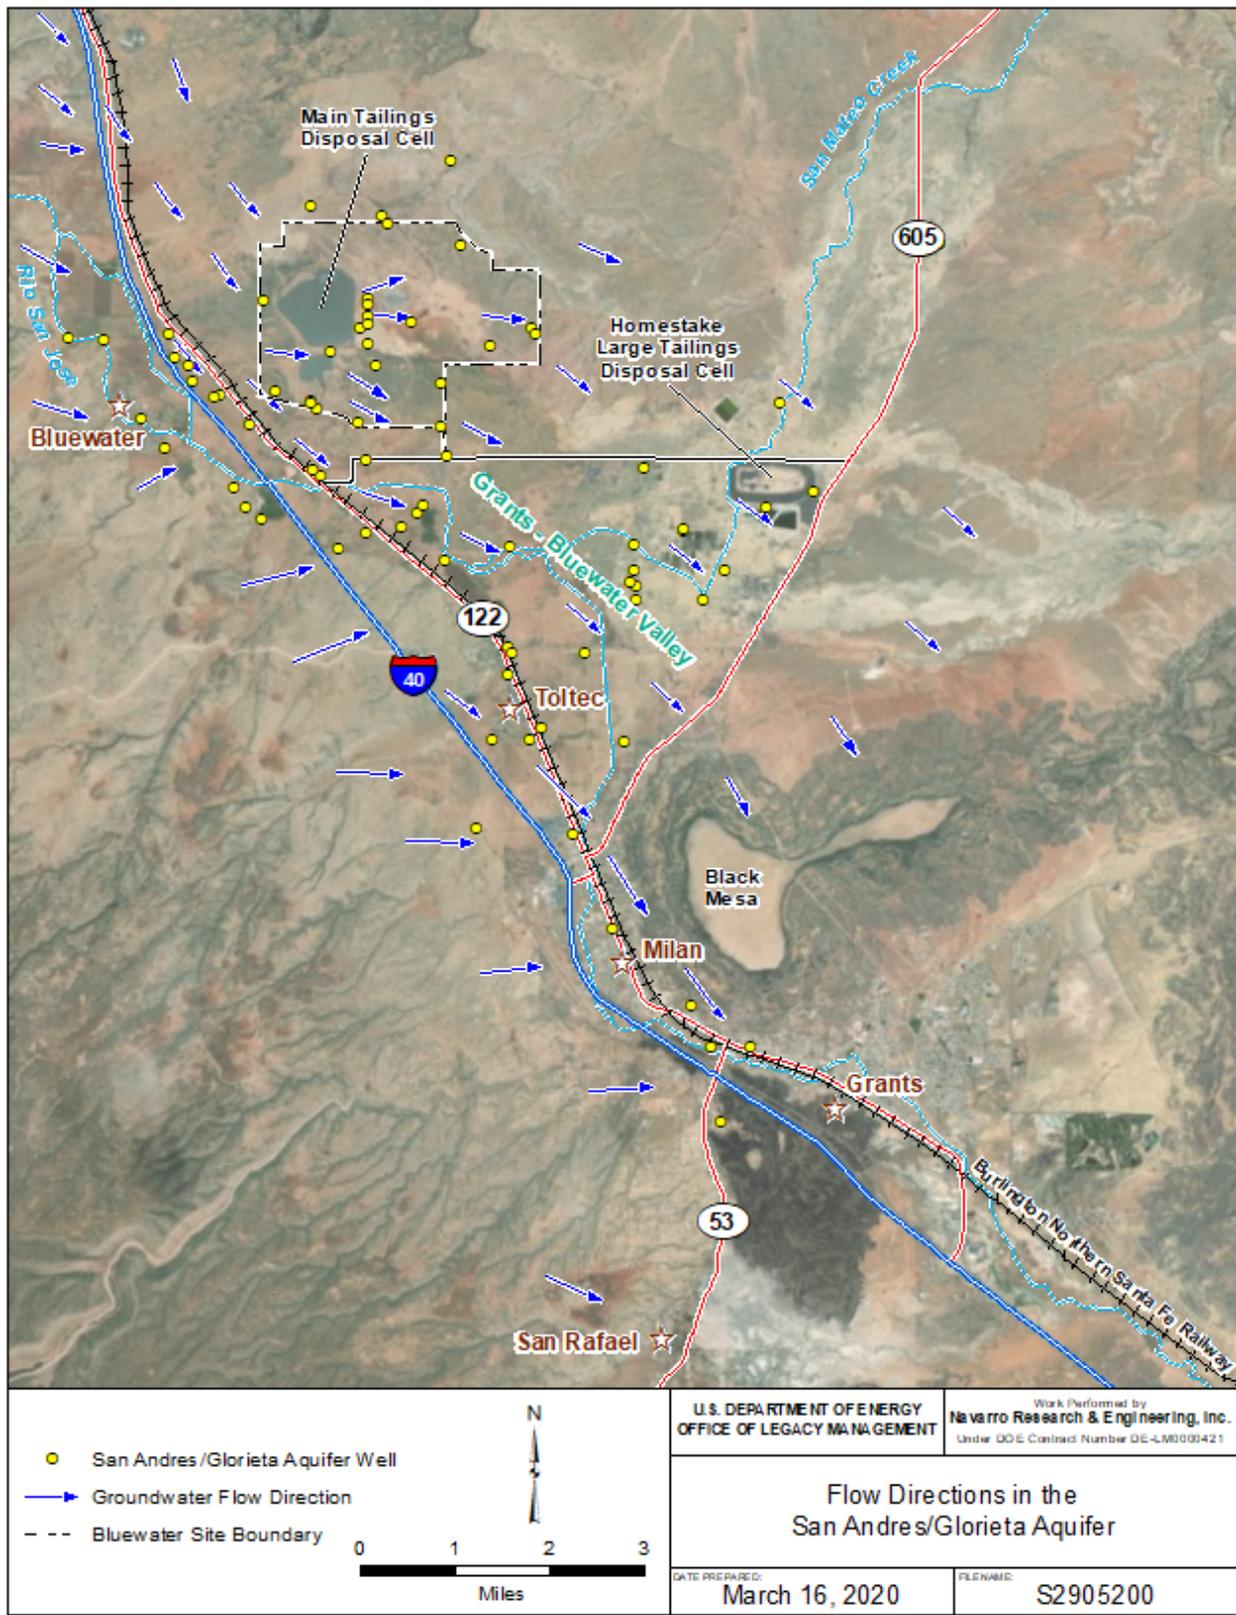
Figure 1-6. Groundwater Flow Directions in the San Andres/Glorieta Aquifer at the Bluewater, New Mexico, Disposal Site

The extent of uranium contamination in the SAG aquifer and the potential risk to downgradient groundwater users was evaluated in LM's groundwater conceptual model (DOE 2014) and in an update to the plume maps (DOE 2019). Evaluation of previous groundwater studies in the region and available groundwater data indicated that the ambient flow path of the groundwater in the aquifer from the site is to the east-southeast. The groundwater from the site passes under the Homestake mill site and turns south toward Grants because of the influence of a major fault that passes under Grants (San Rafael Fault). The flow path from the site is to the north of the Milan municipal wells (Figure 1-6).

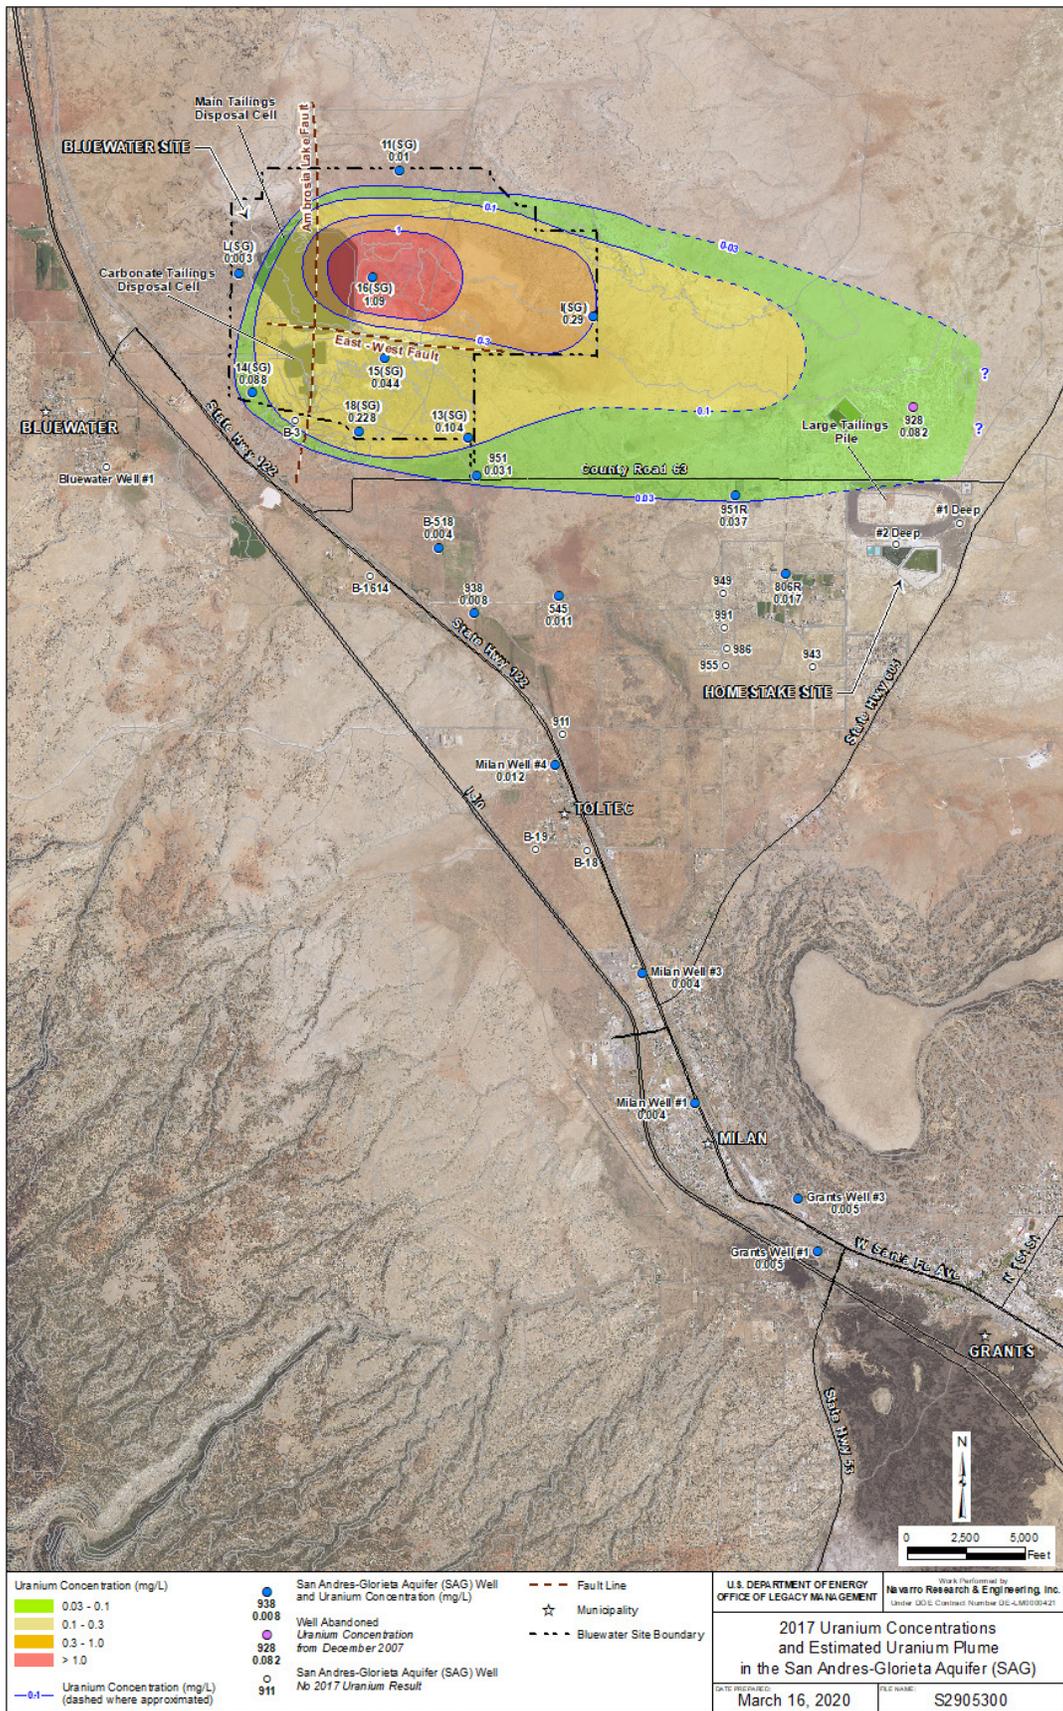
Figure 1-7. 2017 Estimated Uranium Plume in the San Andres/Glorieta Aquifer (DOE 2019)

The estimated extent of the uranium plume based on data collected primarily in 2017, described in the updated groundwater model (DOE 2019), is shown in Figure 1-7. The uranium plume follows the groundwater flow path, and the leading portion is near the Homestake site. Groundwater monitoring results obtained by various entities over the last several decades indicate that uranium contamination from Bluewater mill operations reached the Homestake site by 1980 and that the plume has essentially stabilized (i.e., it is not continuing to migrate to the east). Uranium concentrations attenuate with distance from the site primarily through dispersion instead of chemical reduction because of the absence of a reducing environment in the aquifer formations (DOE 2014). No known drinking water wells are completed within the uranium plume, and site-derived uranium contamination in the SAG aquifer is not expected to impact the Milan or Grants municipal water supplies that are pumped from SAG aquifer wells (DOE 2014; DOE 2019).
