2.0 Edgemont, South Dakota, Disposal Site

2.1 Compliance Summary

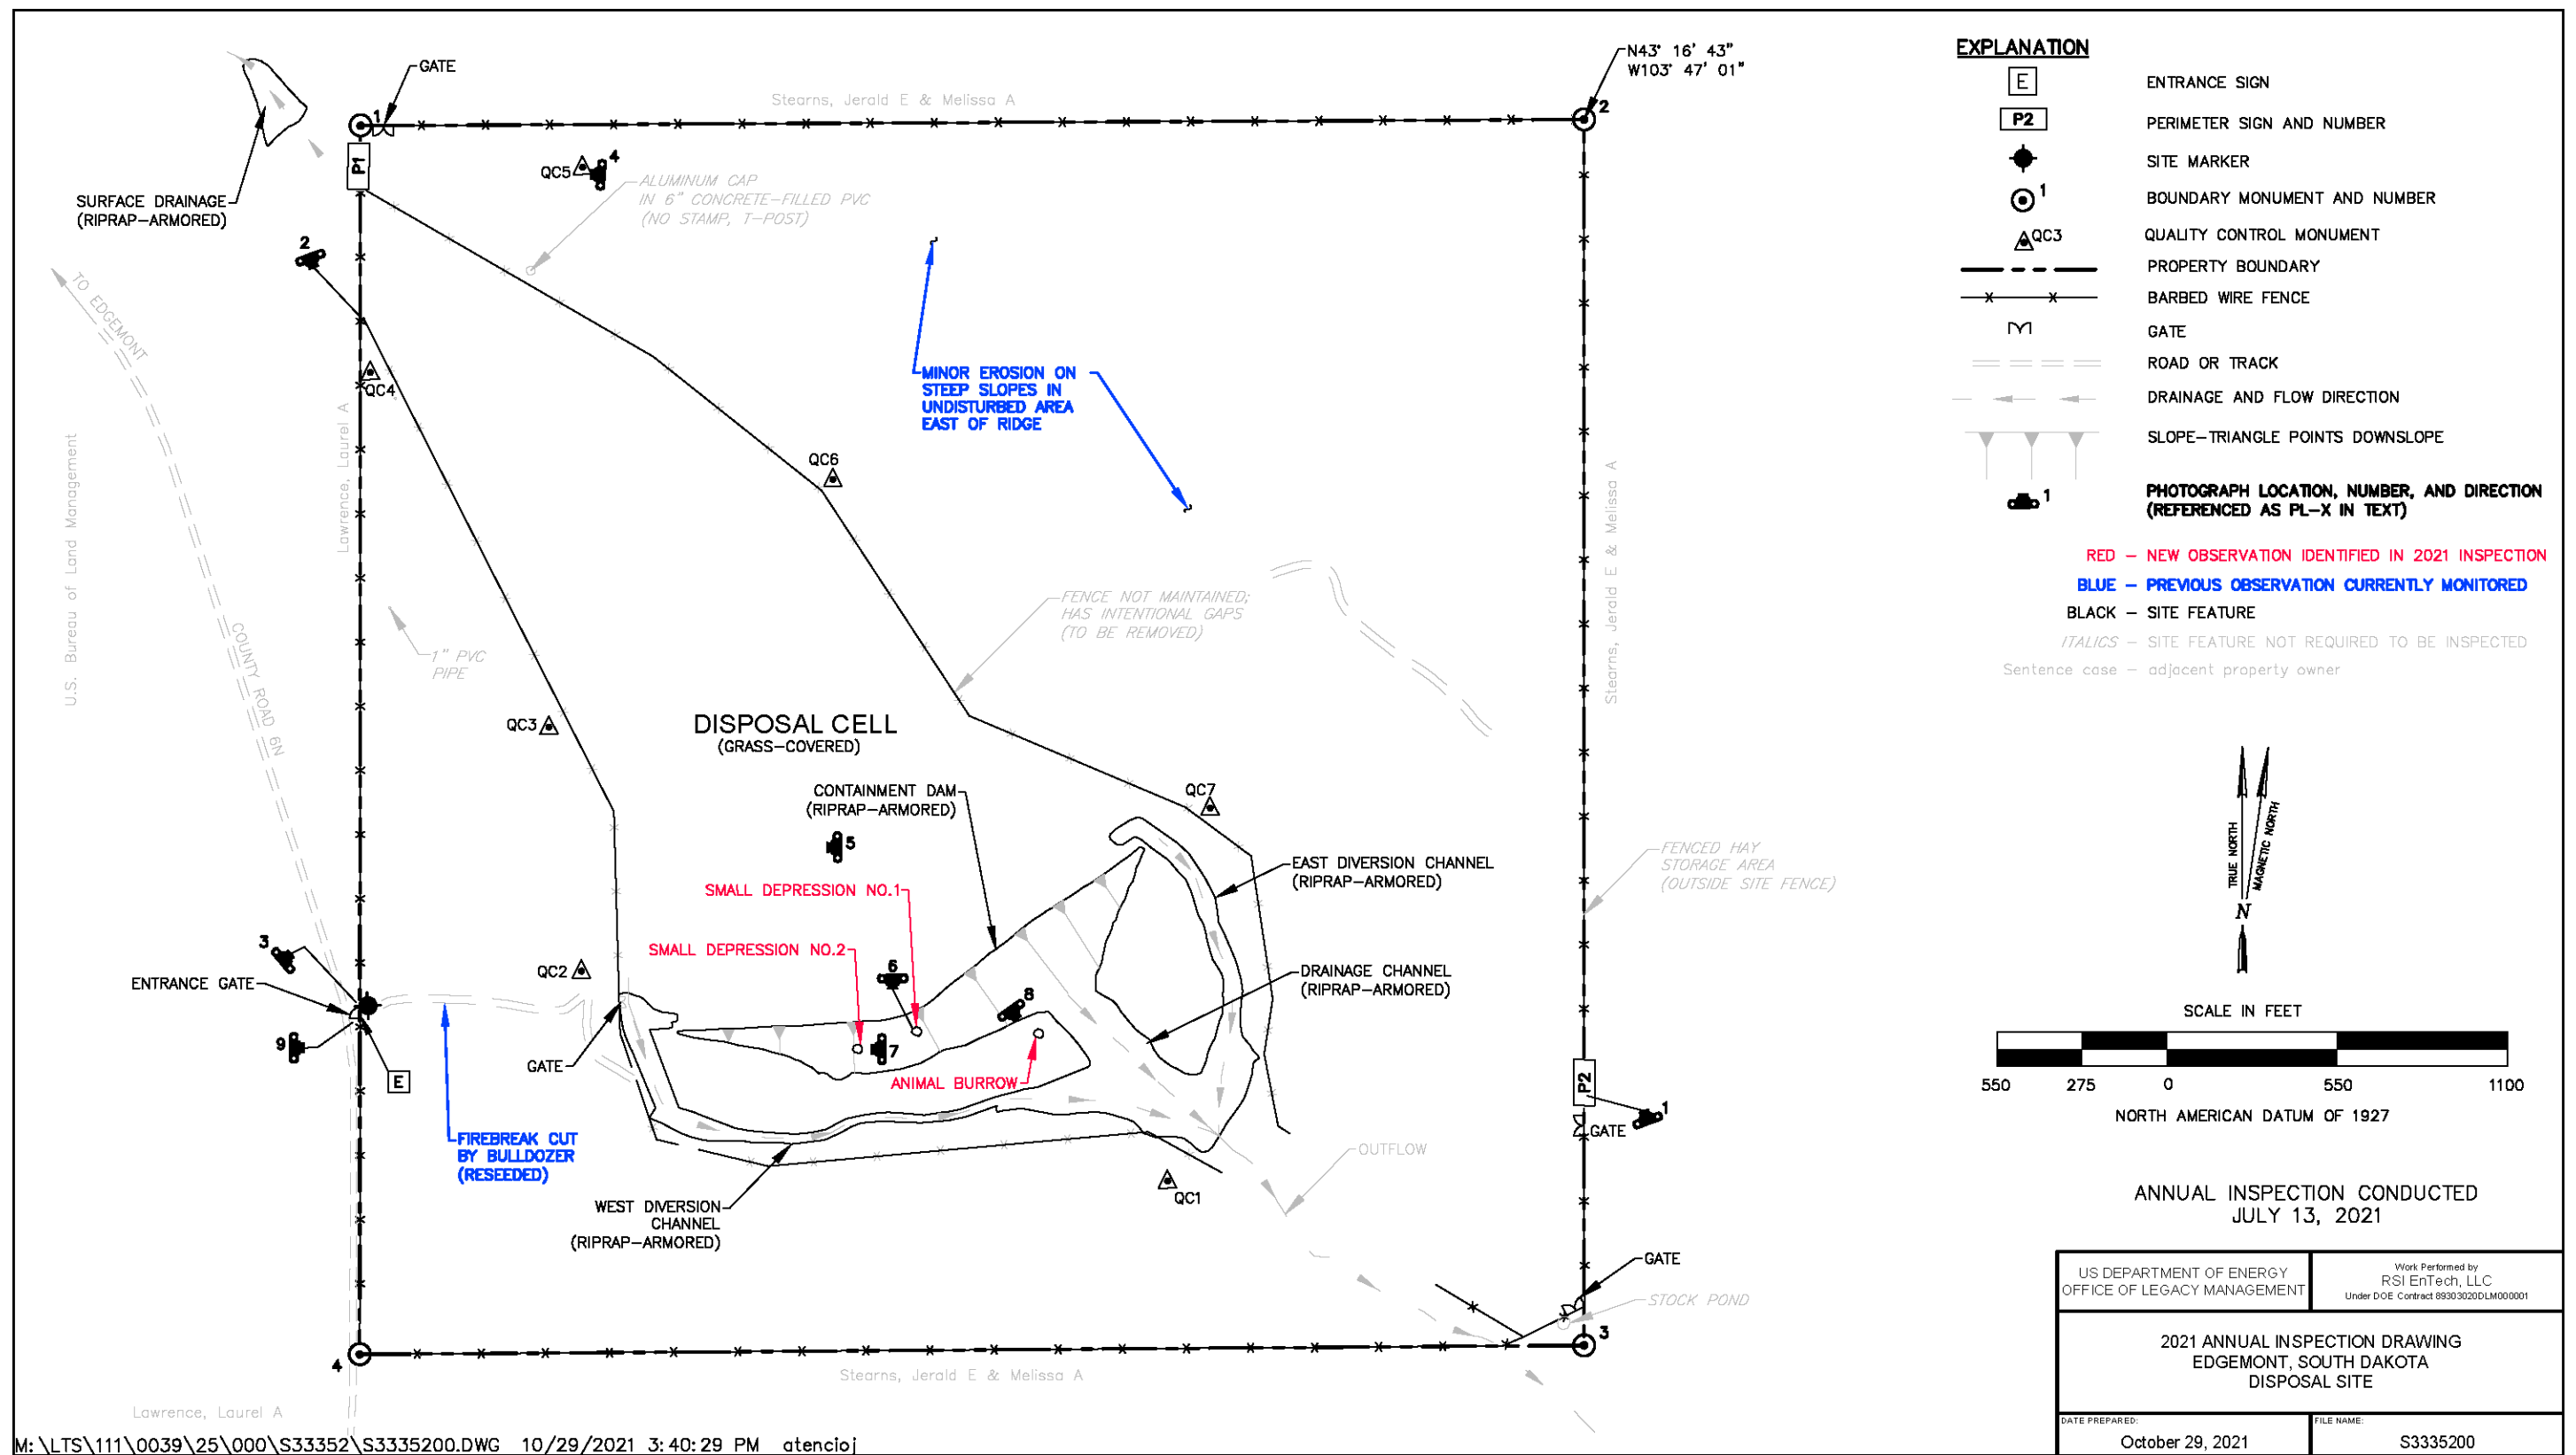
Figure 2-1. 2021 Annual Inspection Drawing for the Edgemont, South Dakota, Disposal Site

Figure 2-1 shows the locations of site features, including site surveillance features and inspection areas, in black and gray font. Site features that are present but not required by the LTSP to be inspected are shown in italic font. Observations from previous inspections that are currently monitored are shown in blue type, and new observations identified during the 2021 annual inspection are shown in red type. Inspection results and recommended maintenance activities associated with site surveillance features are included in the following subsections. Photographs to support specific observations are identified in the text and in Figure 2-1 by photograph location (PL) numbers. The photographs and photograph log are presented in Section 2.9.
