5.0 Sherwood, Washington, Disposal Site

5.1 Compliance Summary

The Sherwood, Washington, Uranium Mill Tailings Radiation Control Act (UMTRCA) Title II Disposal Site (site) was inspected June 9, 2021. The disposal cell, containment dam, and associated drainage features were functioning as designed. Inspectors identified one missing perimeter sign, which was replaced during the subsequent groundwater sampling event in July 2021. No additional maintenance needs or cause for a follow-up inspection were identified.

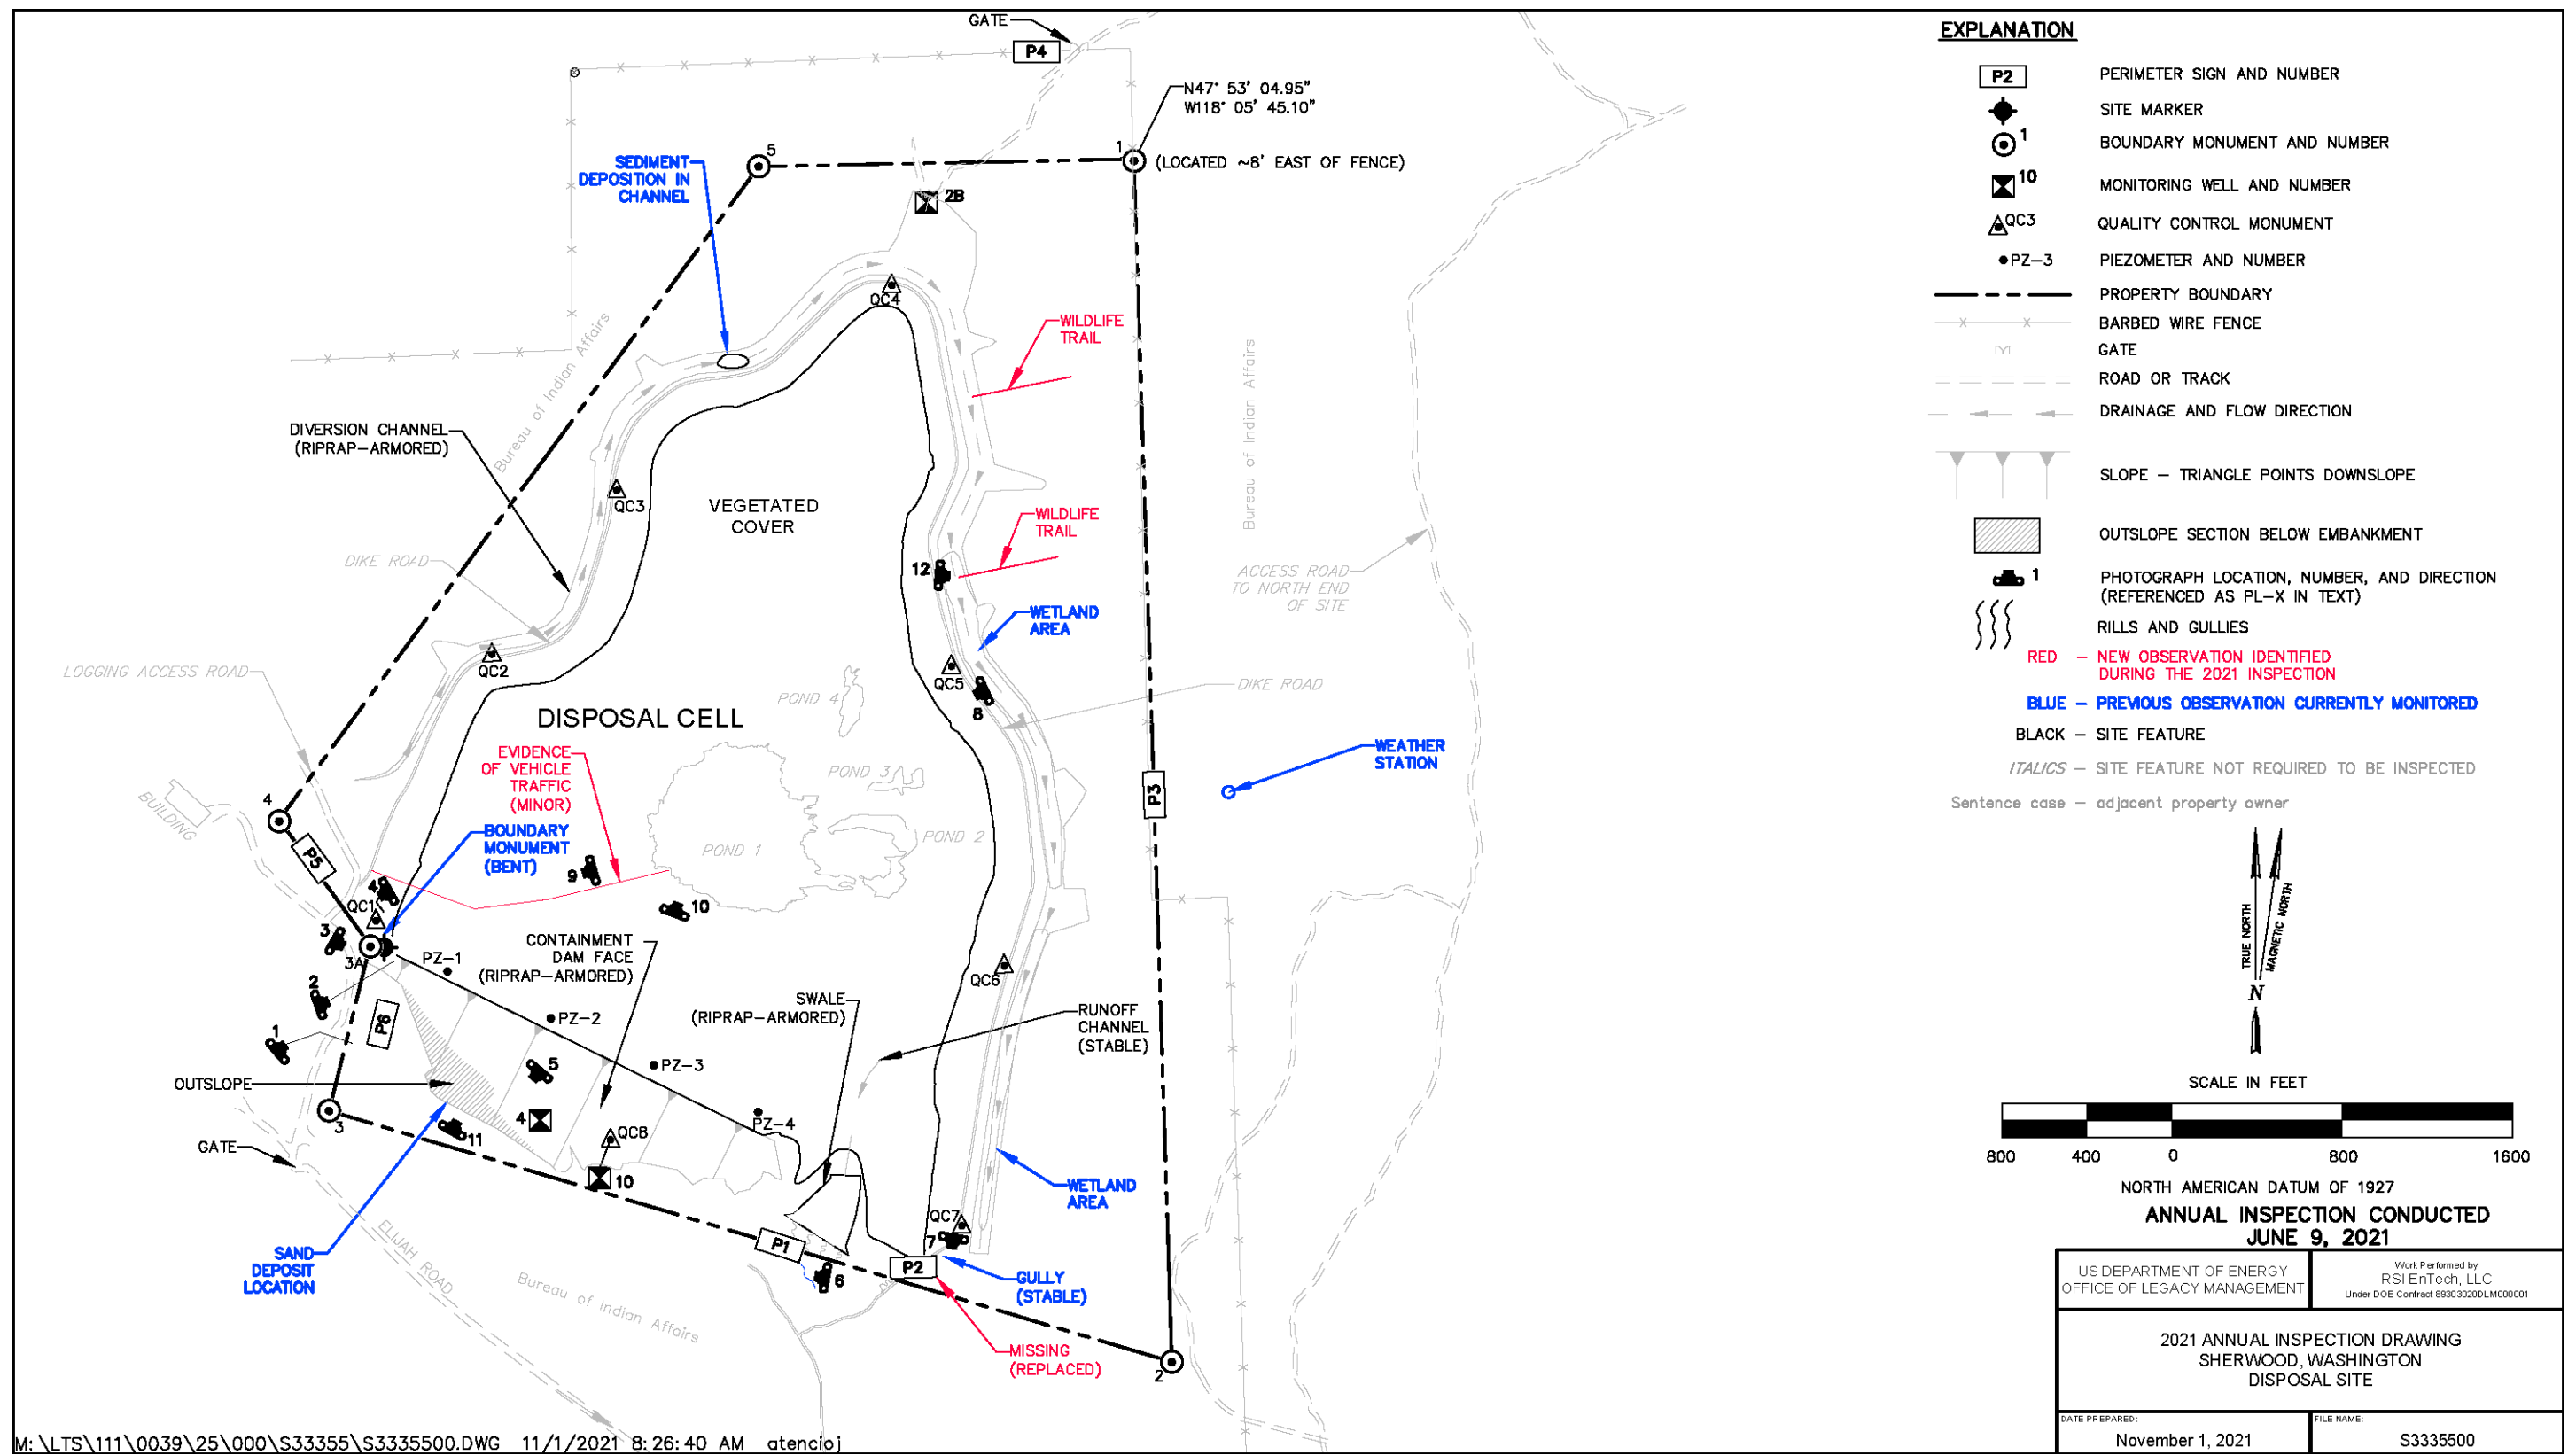
Figure 5-1. 2021 Annual Inspection Drawing for the Sherwood, Washington, Disposal Site

Figure 5-1 shows the locations of site features, including site surveillance features and inspection areas, in black and gray font. Site features that are present but not required to be inspected are shown in italic font. Observations from previous inspections that are currently monitored are shown in blue type, and new observations identified in the 2021 annual inspection are shown in red type. Inspection results and recommended maintenance activities associated with site surveillance features are included in the following subsections. Photographs to support specific observations are identified in the text and in Figure 5-1 by photograph location (PL) numbers. The photographs and photograph log are presented in Section 5.9.

During the 2016 annual inspection, one location at the base of the rock-covered containment dam face was found to have a deposit of sand that had washed out from underneath the rock cover, as evidenced by a shallow rock-filled erosion feature upgradient of the deposit (Figure 5-1). A subsequent follow-up inspection and evaluation identified that the sandy material was the same as natural undisturbed material nearby. During reclamation, this area of the site was used as a source for fill material used to contour the area below the toe of the containment dam. Review of original reclamation and as-built drawings showed that the toe of the containment dam is upslope from the area of erosion, which was confirmed during the follow-up investigations. Therefore, it was concluded that the sand deposit location is in a portion of the dam defined as the outslope in the construction completion report and does not impact the containment dam (DOE 2018b).

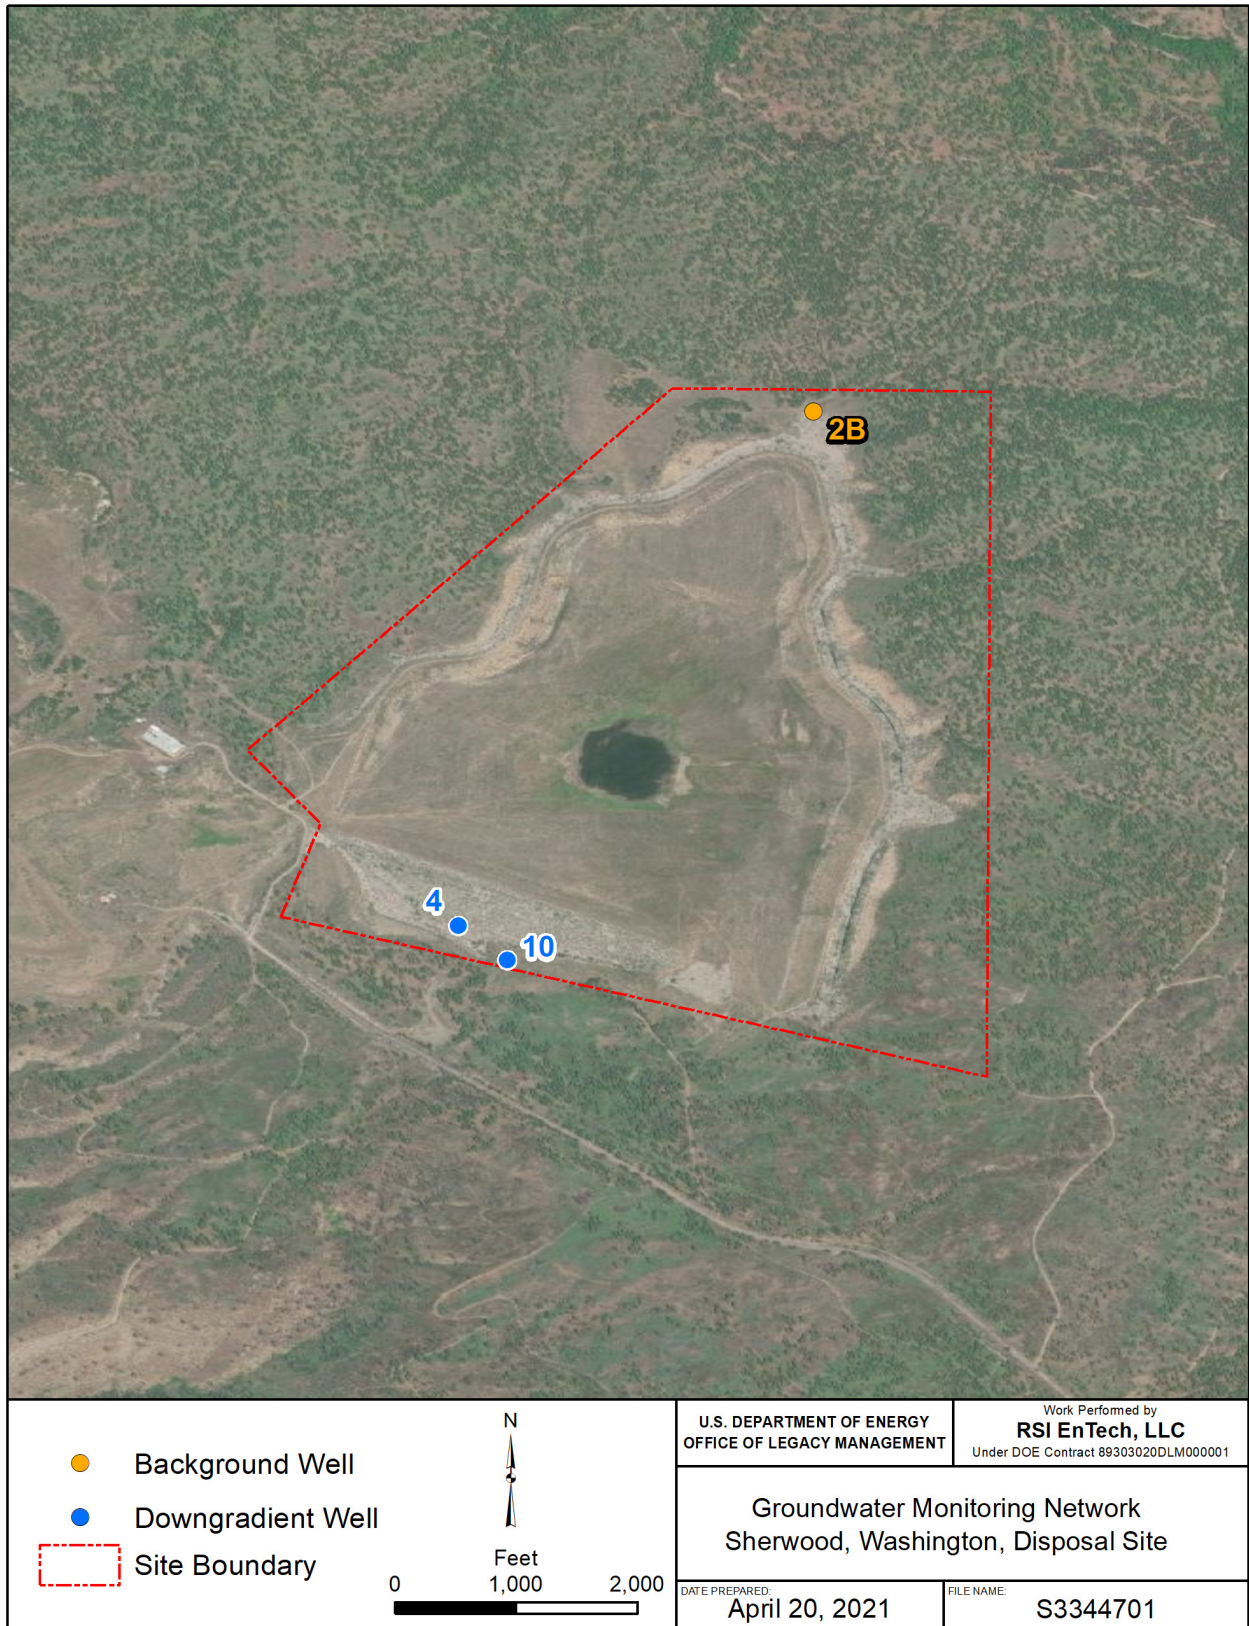
Figure 5-3. Groundwater Monitoring Network at Sherwood, Washington, Disposal Site

Groundwater compliance monitoring is not required at the site. However, as a best management practice stipulated in the LTSP, LM conducts limited groundwater monitoring for several indicator parameters. Samples are collected annually from background monitoring well 2B north of the disposal cell and from downgradient wells 4 and 10 near the base of the containment dam (Figure 5-3). Groundwater samples are analyzed for chloride and sulfate, which are primary indicator constituents, and for total dissolved solids.

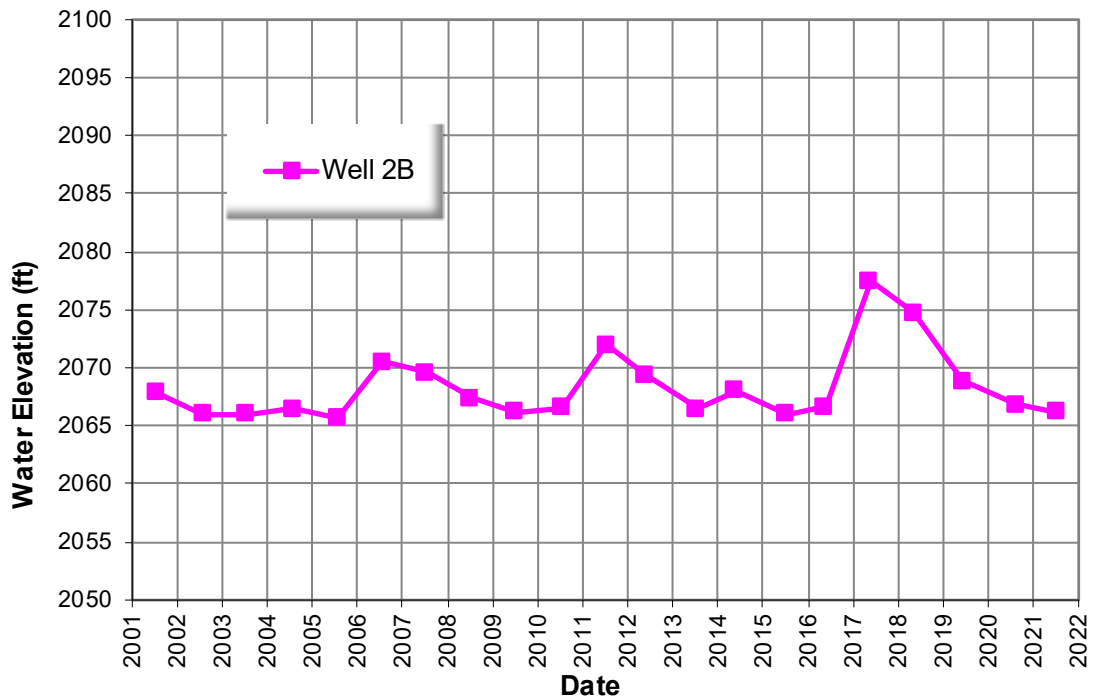
Figure 5-6. Well 2B Water Elevation Measurements at the Sherwood, Washington, Disposal Site

Time-concentration plots of chloride and sulfate for the three monitoring wells are shown in Figure 5-4 and Figure 5-5, respectively. Occurrences of slightly elevated chloride levels in well 4 correspond with the higher sulfate levels measured at the same location. Water elevations for each of the monitoring wells are shown in Figure 5-6 and Figure 5-7. Groundwater occurs in two hydrostratigraphic units: (1) the alluvium that lies on top of the bedrock surface and (2) the conductive bedrock, including weathered bedrock in the upper portion and unweathered or competent bedrock below. Monitoring well 10 is completed in the alluvium, and wells 2B and 4 are completed in the bedrock. Absolute values of water table elevations reported in Figure 5-6 and Figure 5-7 differ slightly from those in previous reports, but the trends are the same. The reason for the offset is the recent transformation of vertical datum from National Geodetic Vertical Datum of 1929 to North American Vertical Datum of 1988 in LM's environmental database.
