2.0 Edgemont, South Dakota, Disposal Site

The Edgemont, South Dakota, Uranium Mill Tailings Radiation Control Act (UMTRCA) Title II Disposal Site was inspected on July 20, 2022. No changes were observed in the disposal cell or drainage features. Inspectors identified no maintenance needs or cause for a follow-up inspection. Groundwater monitoring is not required at the site.

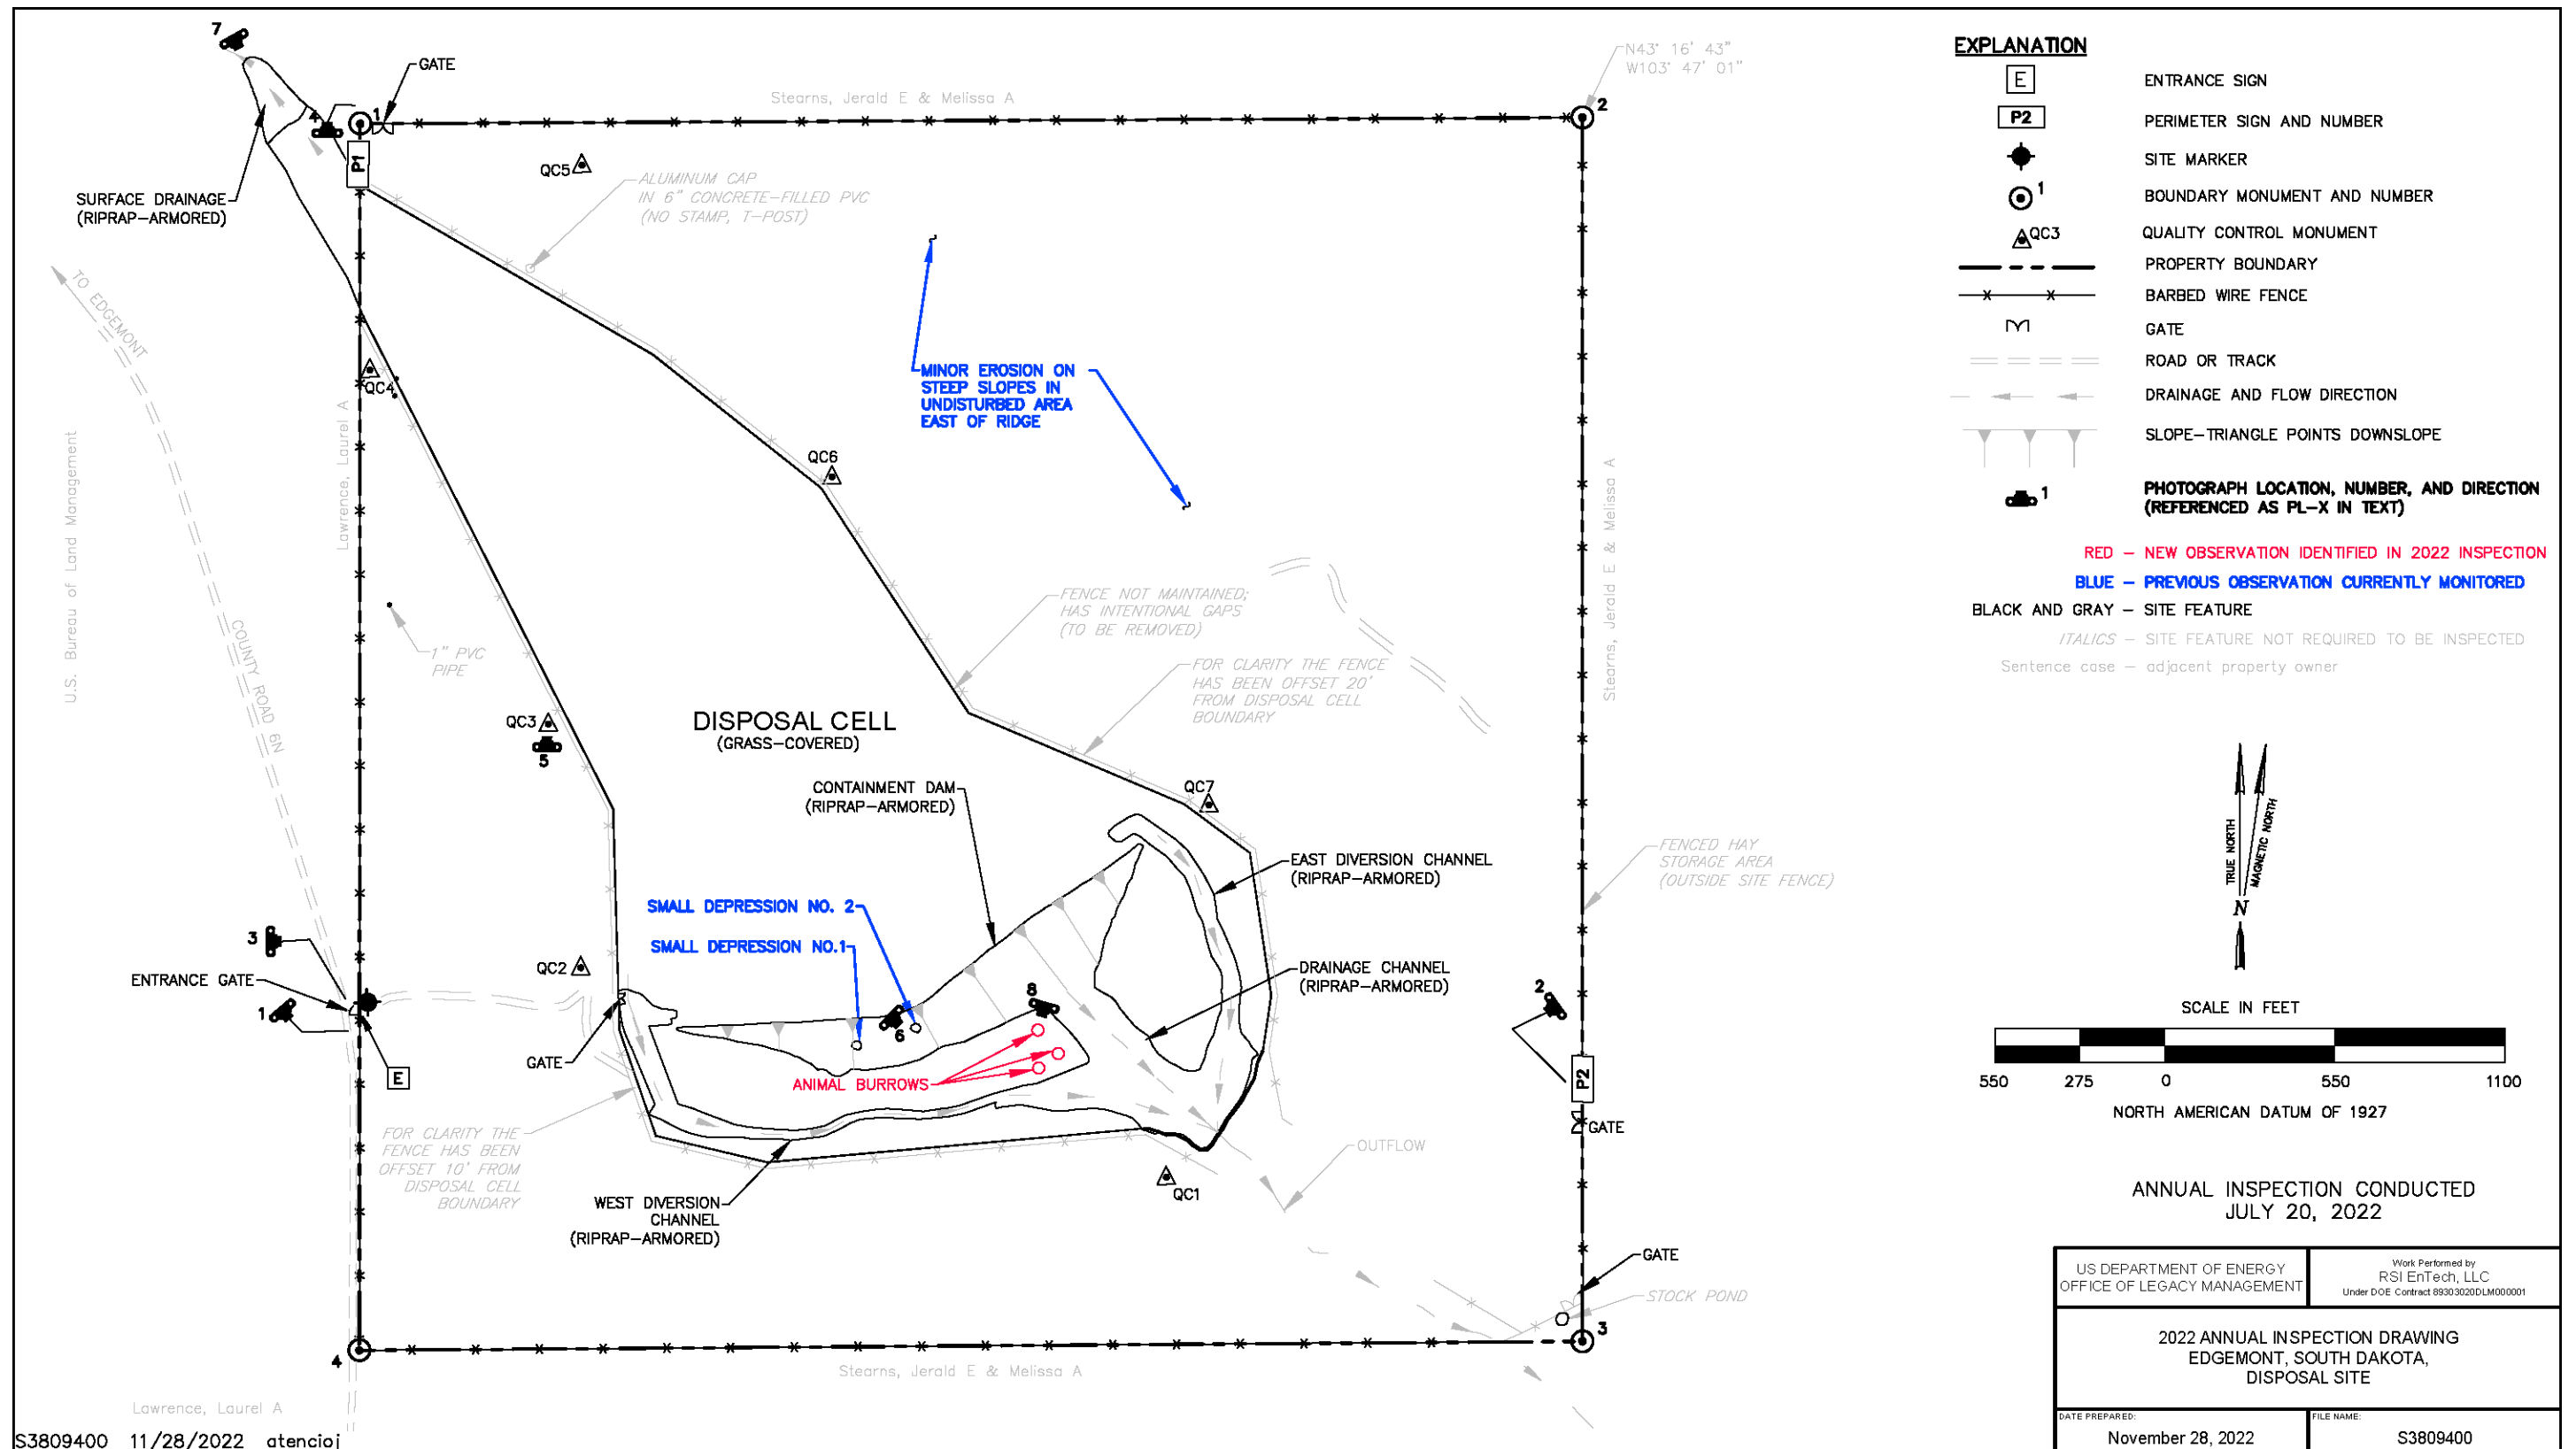
Figure 2-1. 2022 Annual Inspection Drawing for the Edgemont, South Dakota, Disposal Site

Figure 2-1 shows the locations of site features, including site surveillance features and inspection areas, in black and gray font. Some site features that are present but not required to be inspected are shown in italic font. Observations from previous inspections that are currently monitored are shown in blue, and new observations identified during the 2022 annual inspection are shown in red. Inspection results and recommended maintenance activities associated with site surveillance features are described in the following subsections. Photographs to support specific observations are noted in the text and in Figure 2-1 by photograph location (PL) numbers. The photographs and photograph log are presented in Section 2.9.
