## 4.0 Maybell West, Colorado, Disposal Site

### 4.1 Compliance Summary

Figure 4-1. 2022 Annual Inspection Drawing for the Maybell West, Colorado, Disposal Site

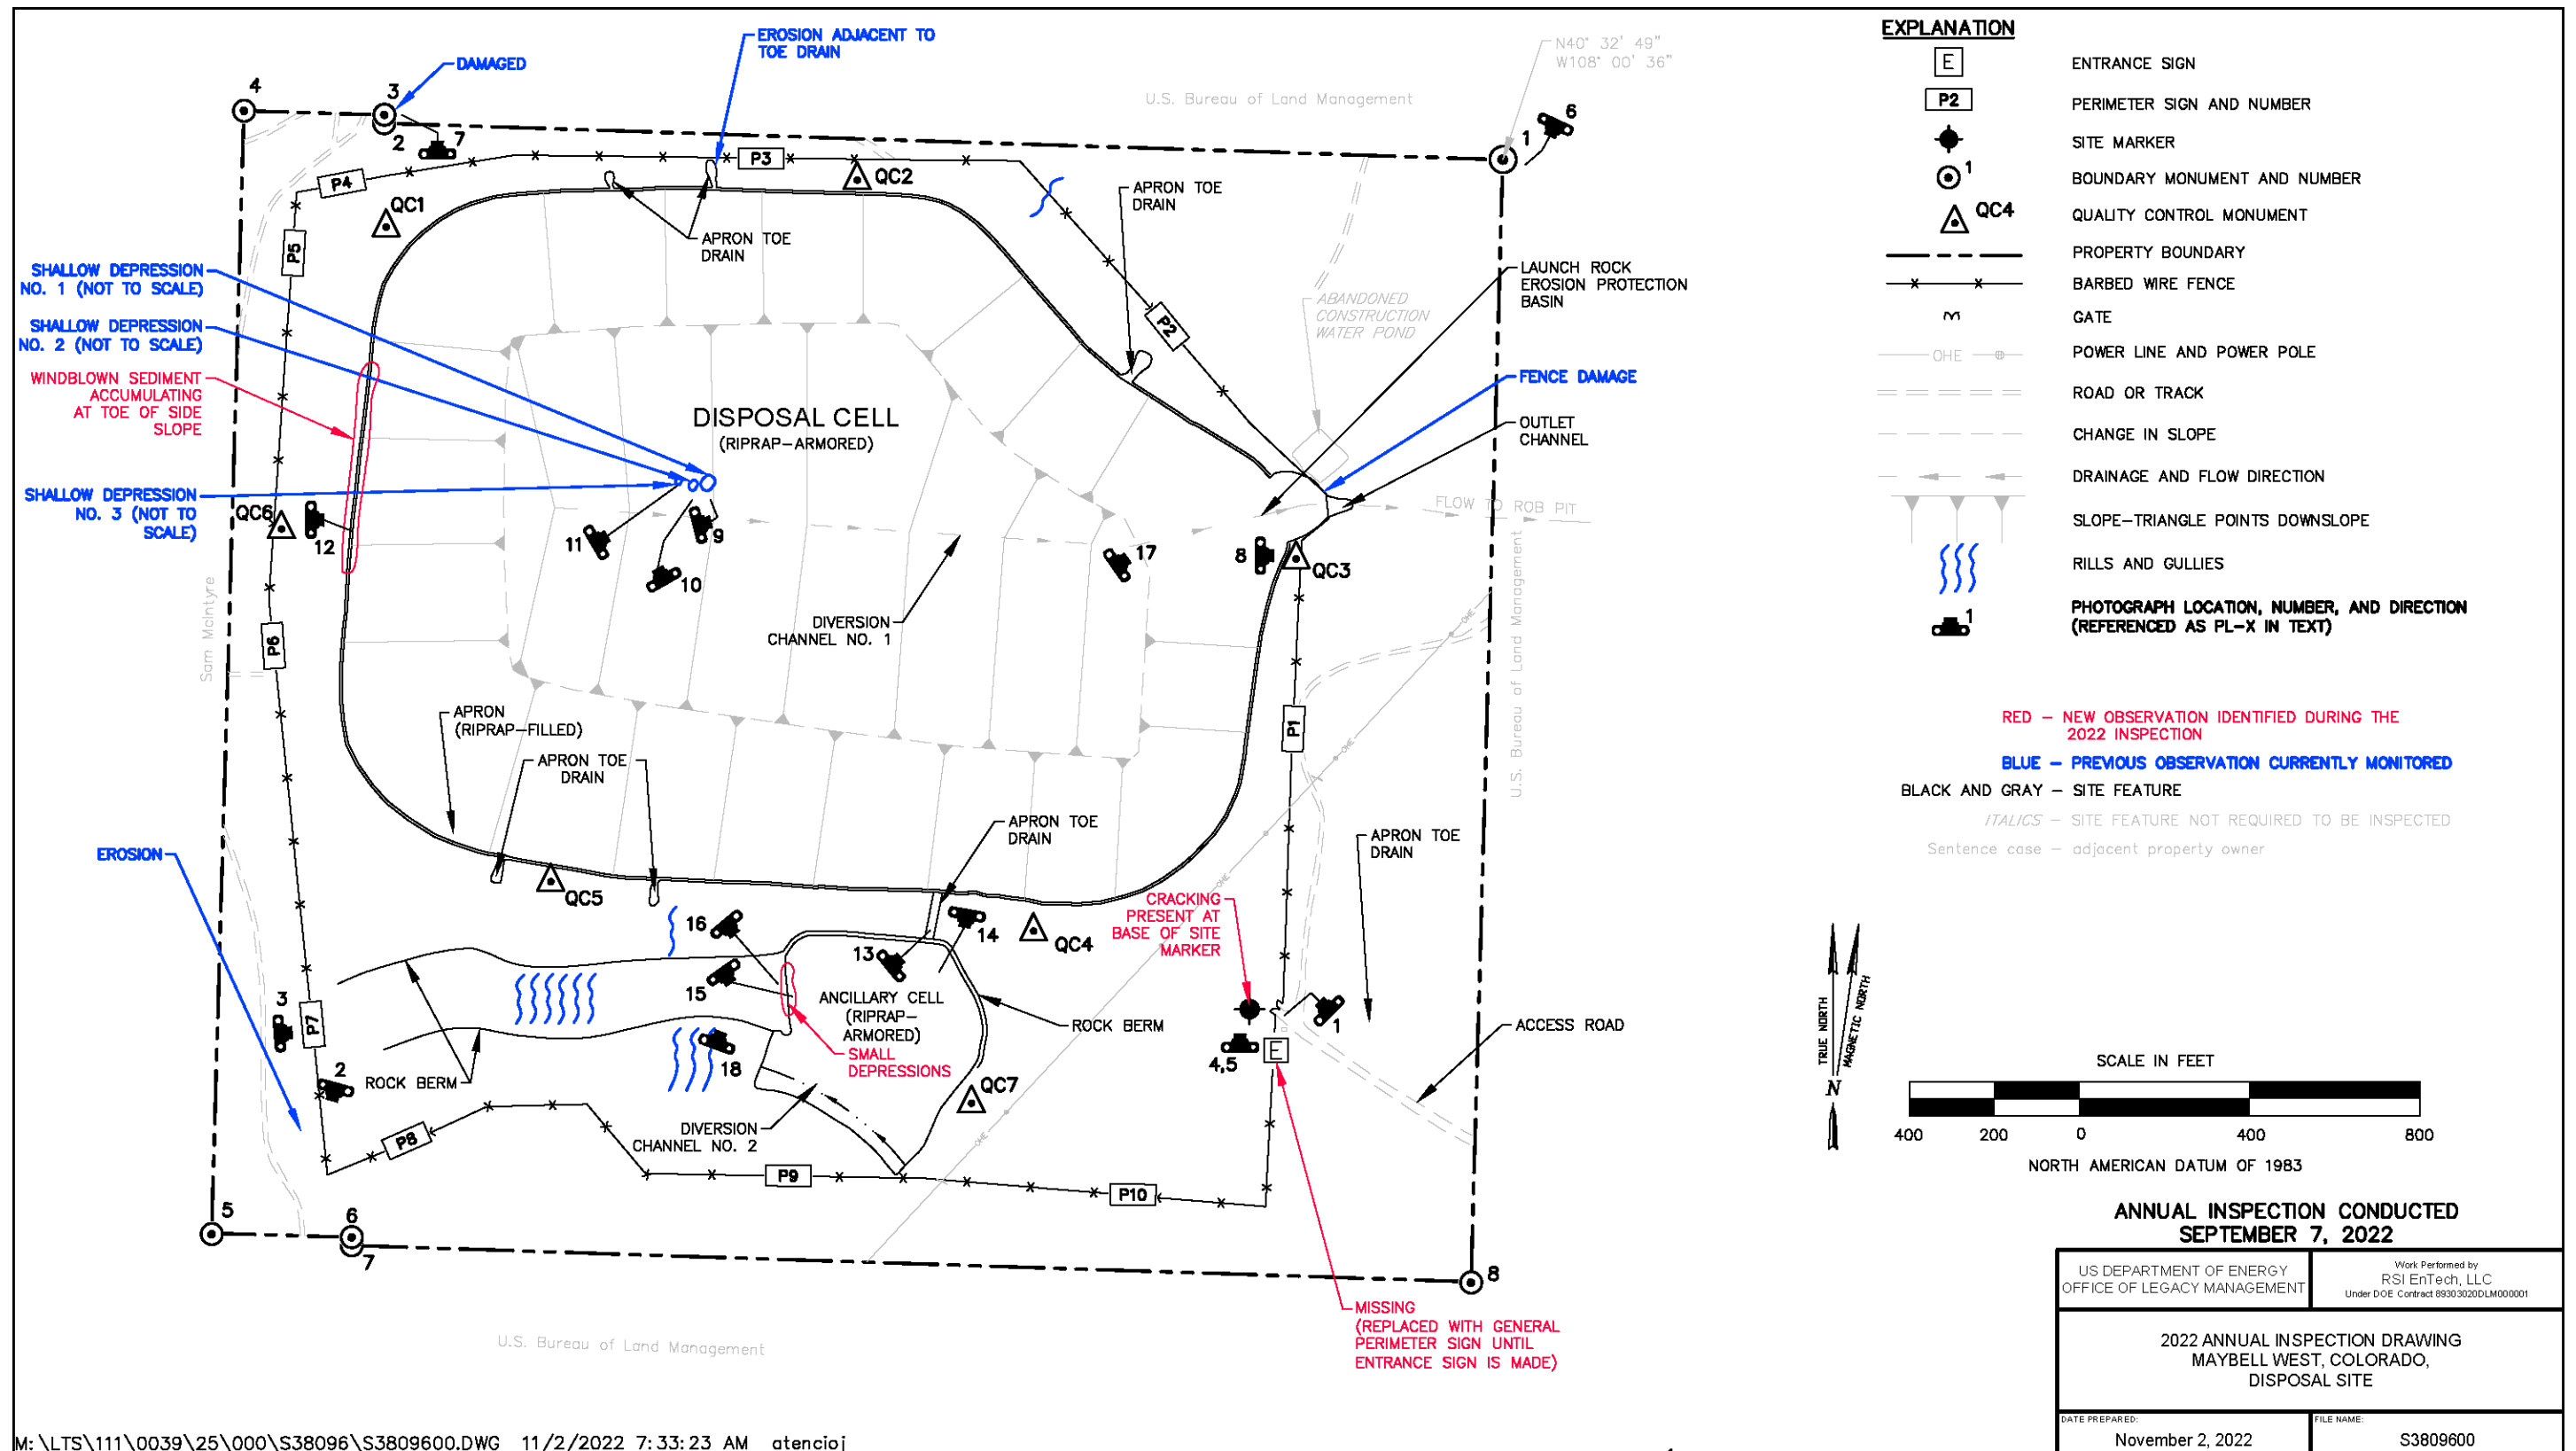
Figure 4-1 shows the locations of site features, including site surveillance features and inspection areas, in black and gray font. Some site features that are present but not required to be inspected are shown in italic font. Observations from previous inspections that are currently monitored are shown in blue, and new observations identified during the 2022 annual inspection are shown in red. Inspection results and recommended maintenance activities associated with site surveillance features are described in the following subsections. Photographs to support specific observations are noted in the text and in Figure 4-1 by photograph location (PL) numbers. The photographs and photograph log are presented in Section 4.9.
