## 3.0 L-Bar, New Mexico, Disposal Site

The L-Bar, New Mexico, Uranium Mill Tailings Radiation Control Act (UMTRCA) Title II Disposal Site was inspected on March 9, 2023. Previous inspections performed in 2021 and 2022, as required by the Long-Term Surveillance Plan (DOE 2004) (LTSP), and associated follow-up site visits, identified numerous surface degradation features on the disposal cell top slope. Two new degradation features on the top slope were identified during the March 2023 inspection. These features represent changes in cell cover characteristics, and an evaluation of the cause and need for repair is ongoing. Additionally, during an Applied Studies and Technology (AS&T) investigation in September and October of 2022, several piping features were discovered on the side slope of the disposal cell. They will continue to be monitored and do not affect the performance of the side slope at this time. Inspectors also identified several routine maintenance needs.

### **3.4 Inspection Results**

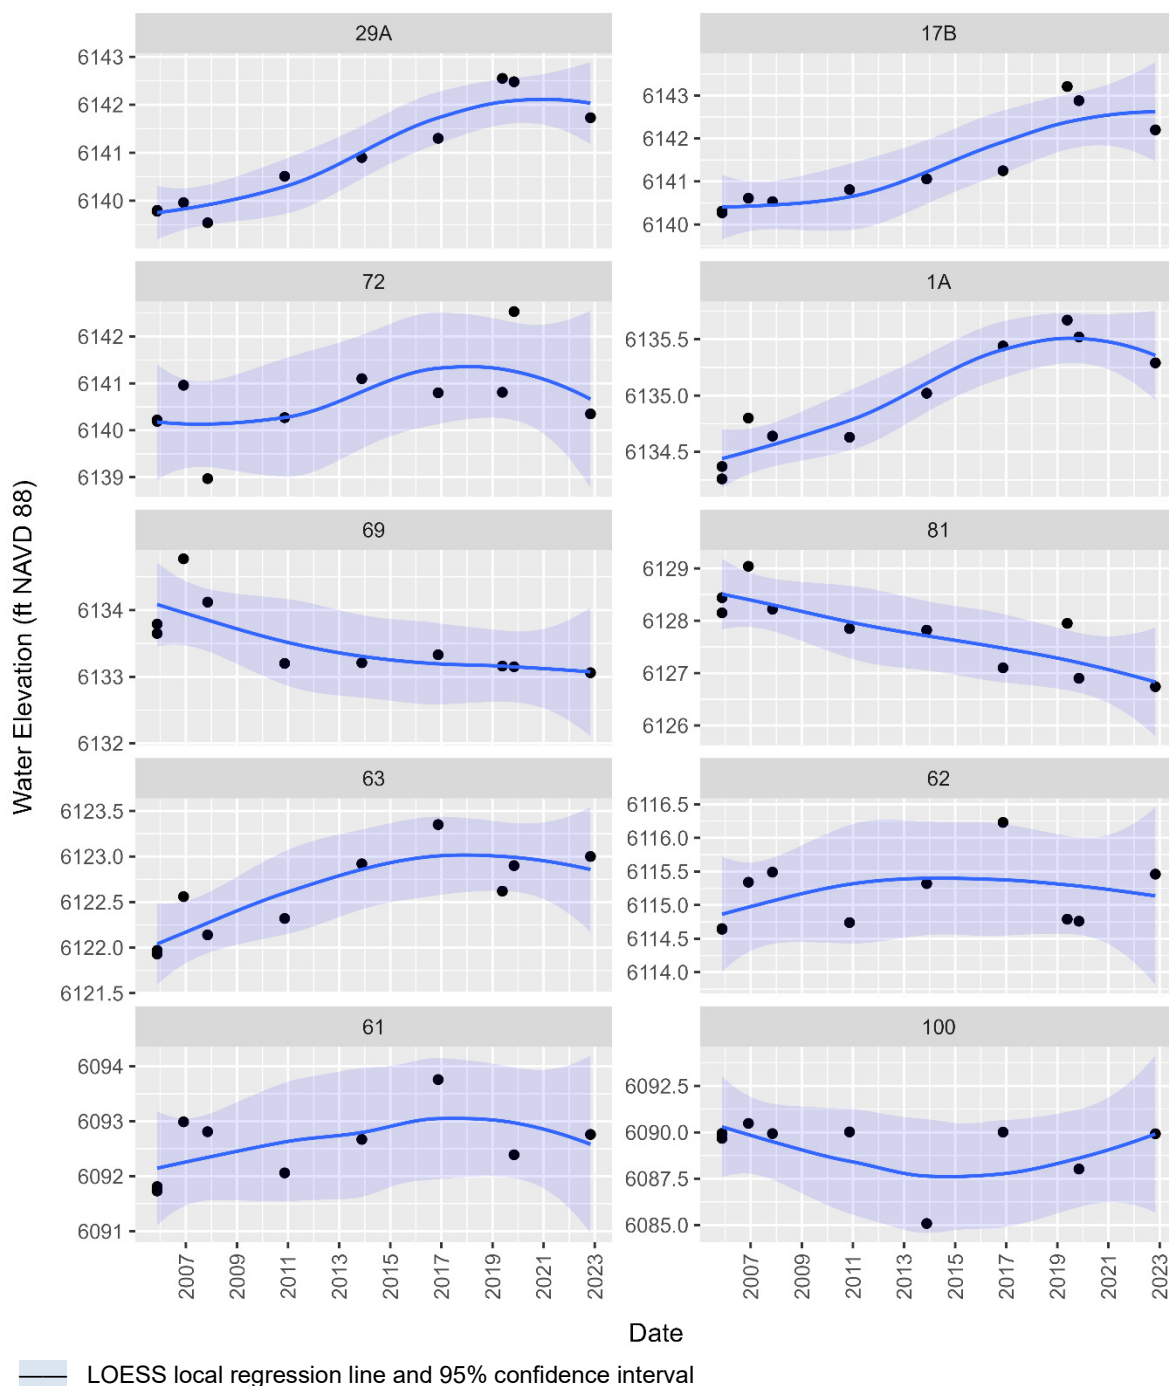
Figure 3-4. Groundwater Elevation Trends in L-Bar Monitoring Wells, 2005–2022

In general, groundwater levels have been stable or increasing in L-Bar site monitoring wells (Figure 3-4). Exceptions are wells 69 and 81, at the western edge of the disposal cell, which have declining water levels. These groundwater elevation declines likely reflect a reduction in the rate of gravity drainage of tailings fluid from the disposal cell.

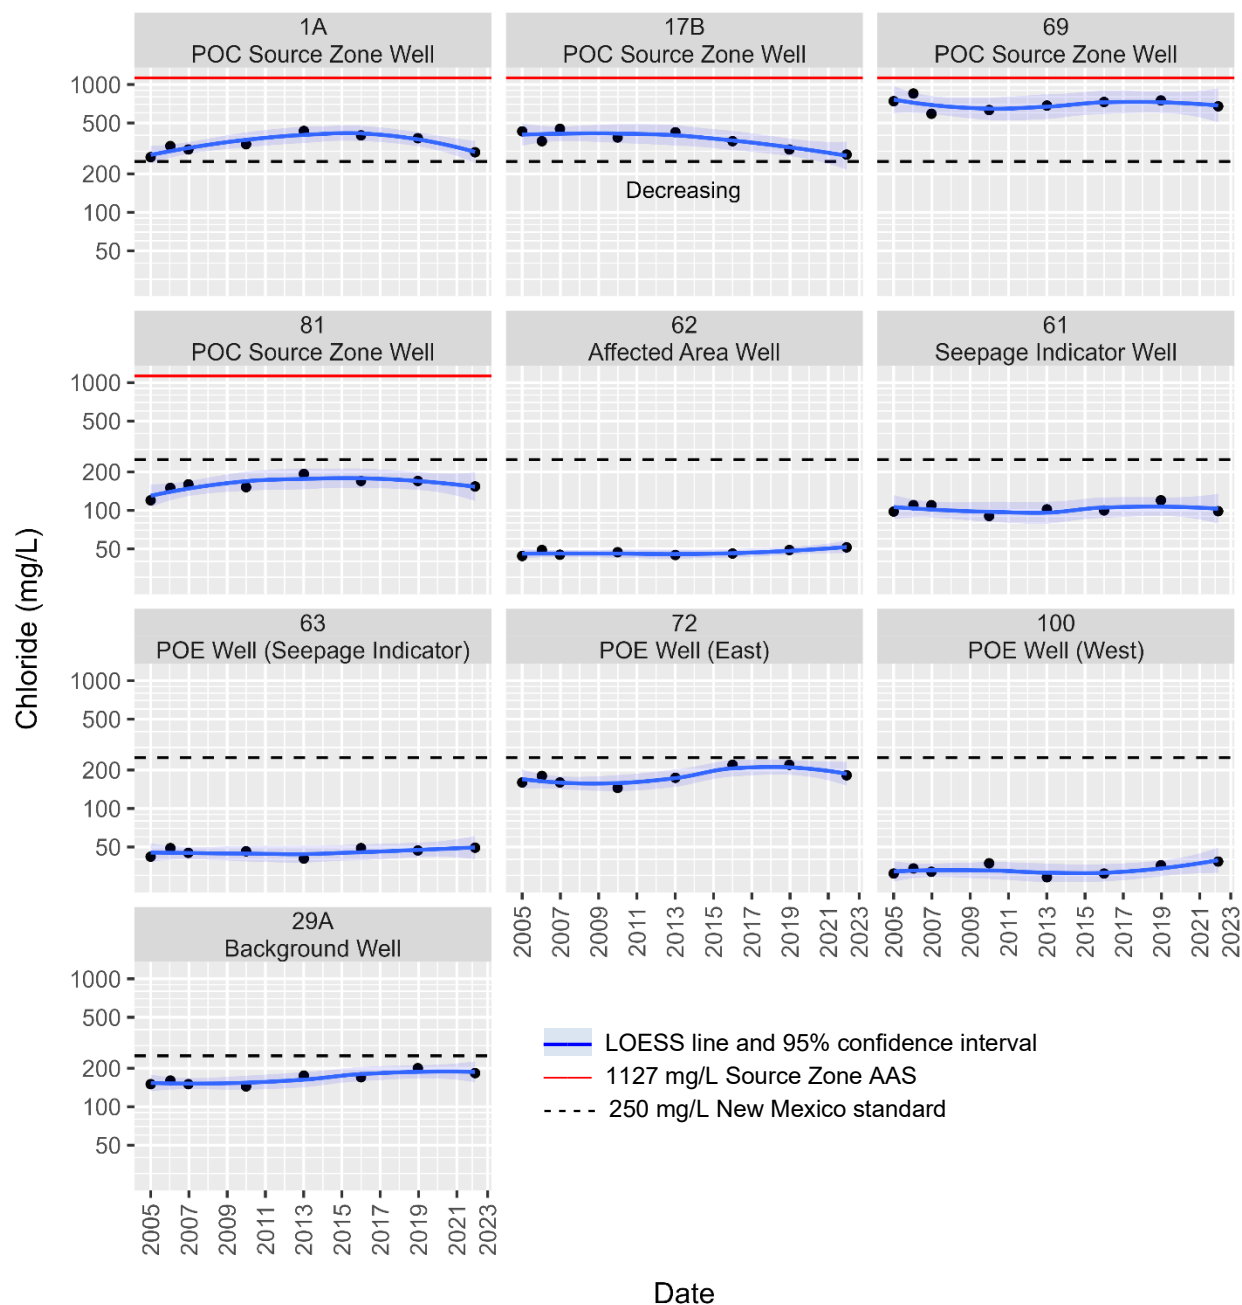
*Figure 3-5. Chloride Concentrations in Groundwater at the L-Bar Disposal Site, 2005–2022*

Chloride concentrations in POC source zone wells 1A, 17B, and 69 continue to exceed the 250 mg/L State of New Mexico standard but are below the corresponding 1127 mg/L AAS (Figure 3-5). The highest chloride concentrations have been measured in well 69 (590–850 mg/L). Chloride concentrations have decreased in well 17B (Table 3-5), from a maximum of 450 mg/L in 2007 to 283 mg/L in 2022, just slightly above the 250 mg/L standard. The remaining POC well (81) has chloride concentrations below the State of New Mexico standard (120–193 mg/L).

The three POE wells (63, 72, and 100) have chloride concentrations below the State of New Mexico standard (Figure 3-5). Temporal chloride concentrations in background well 29A mimic those in POE well 72 and have ranged from 140 to 200 mg/L.

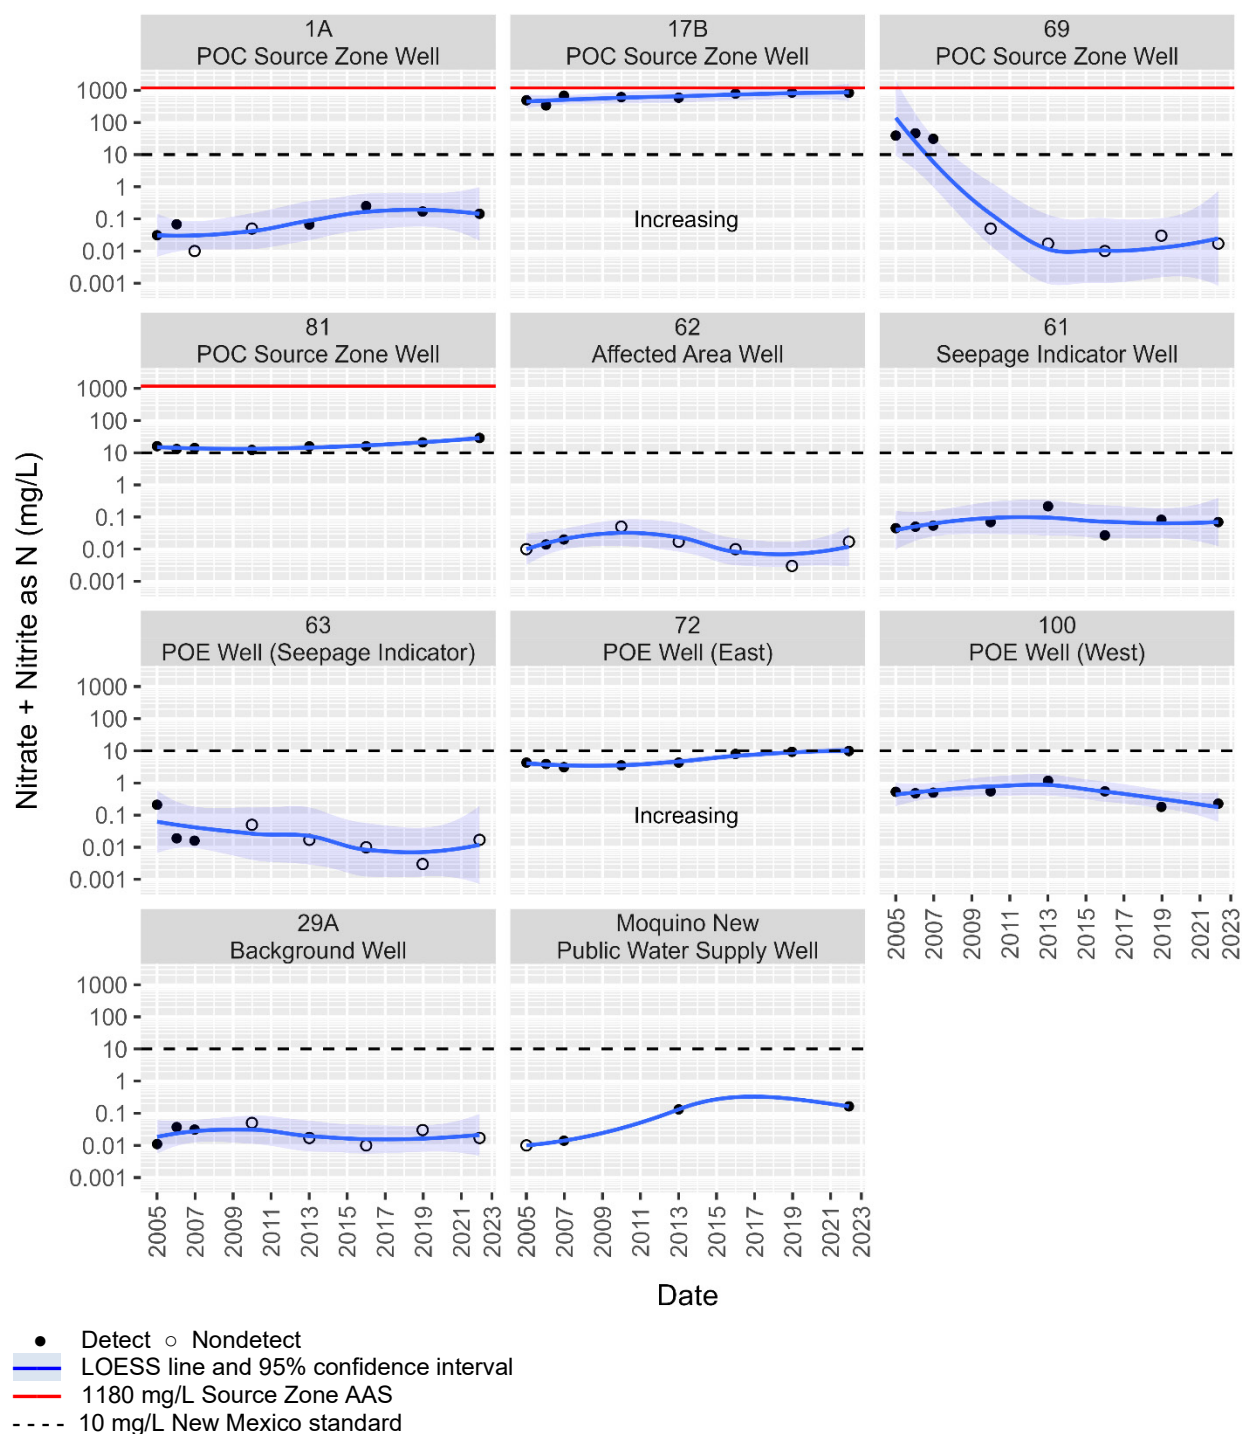
Figure 3-6. Nitrate Concentrations in Groundwater at the L-Bar Disposal Site, 2005–2022

Nitrate (+ nitrite as nitrogen [N]) concentrations in all but three site monitoring wells have been below the 10 mg/L New Mexico standard (Figure 3-6). The highest nitrate concentrations have been measured in POC source zone well 17B (340–850 mg/L); Mann-Kendall trend analysis indicates a statistically significant increasing trend (Table 3-5). The most recent (2022) result, 838 mg/L, is below the 1180 mg/L AAS, but if the increasing trend continues, the AAS could be met or potentially exceeded.

Nitrate levels in POC source zone well 69 exceeded the 10 mg/L standard between 2005 and 2007 (31–46 mg/L), then declined to nondetectable levels ( $\leq 0.05$  mg/L) (Figure 3-6). Nitrate concentrations in POC source zone well 81 have remained at levels slightly exceeding the 10 mg/L standard (12.2–28.8 mg/L) but well below the 1180 mg/L AAS. The maximum concentration was measured in November 2022.

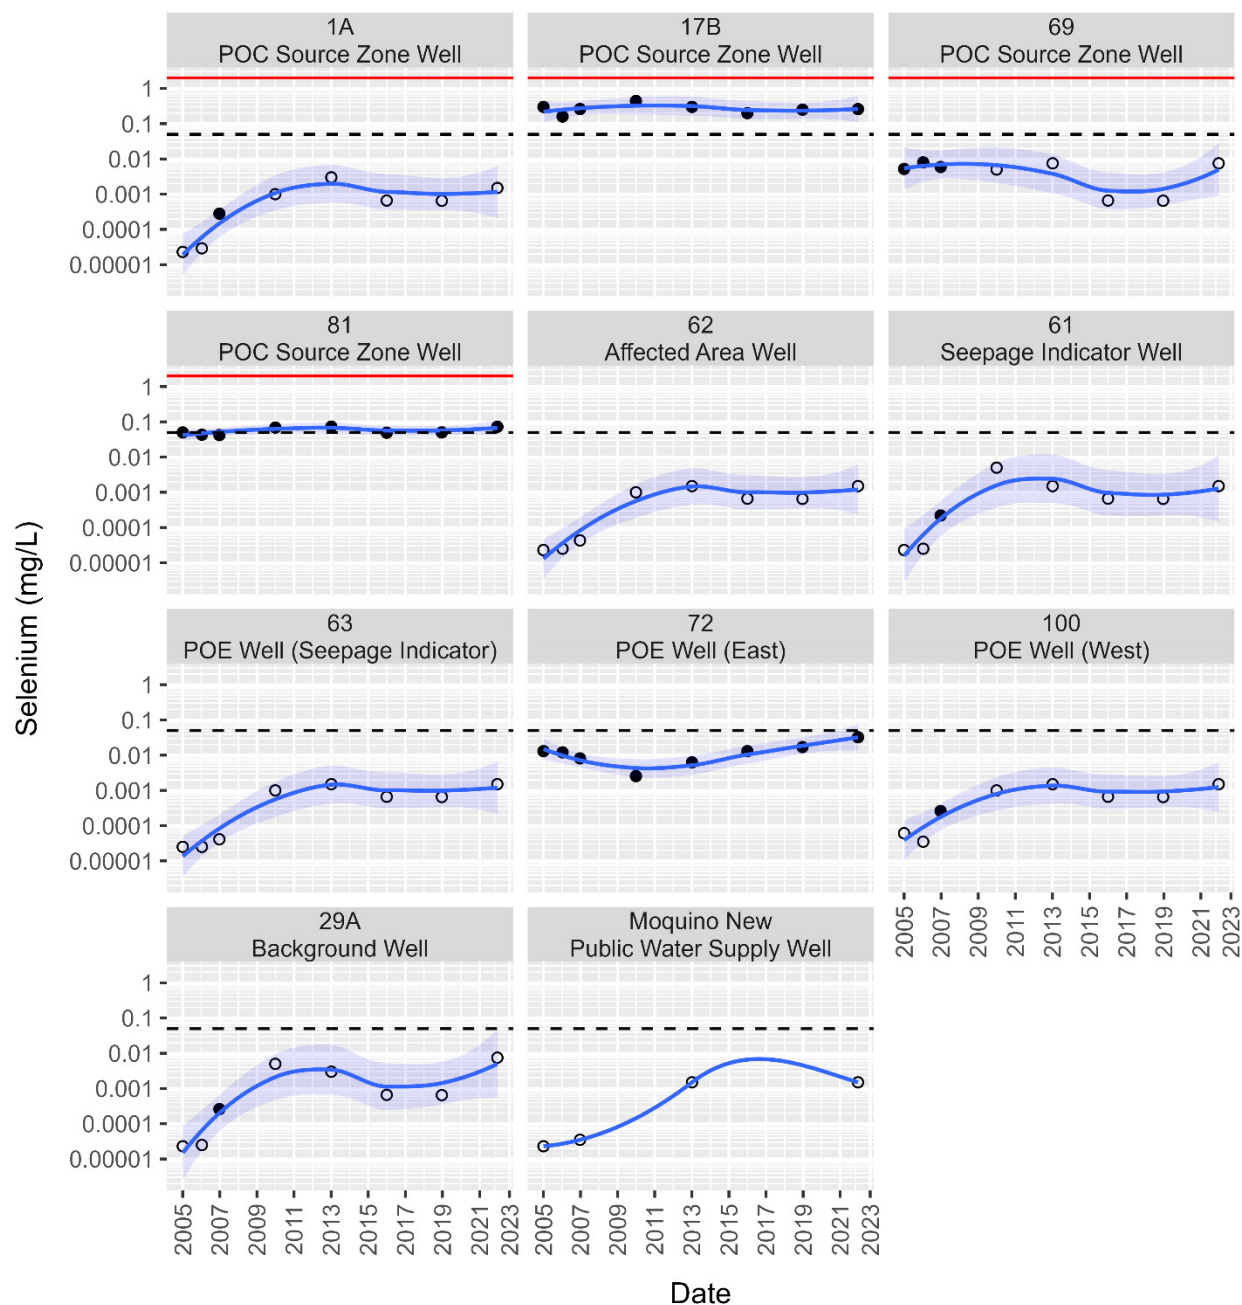
*Figure 3-7. Selenium Concentrations in Groundwater at the L-Bar Disposal Site, 2005–2022*

Consistent with previous annual reports (DOE 2021; DOE 2022), except for POC source zone wells 17B and 81 (0.16–0.44 and 0.042–0.073 mg/L, respectively), selenium concentrations in all site monitoring wells have been below the 0.05 mg/L New Mexico standard (Figure 3-7). Results for most remaining wells have been below the detection limit. An exception is POE well 72, where selenium concentrations are approaching the 0.05 mg/L standard; the most recent (2022) result was 0.032 mg/L. Although concentrations in this well are trending upward (as indicated by a positive tau value), the trend is not statistically significant (Table 3-5). However, if concentration trends continue as observed since 2013, the 0.05 mg/L State of New Mexico selenium standard will likely soon be exceeded.

Mann-Kendall trend analysis identified no statistically significant trends in selenium concentrations in any of the monitoring wells (most wells have a high proportion of nondetects). Selenium concentrations in POC source zone wells have been below the corresponding 2 mg/L ACL and AAS (Figure 3-7).

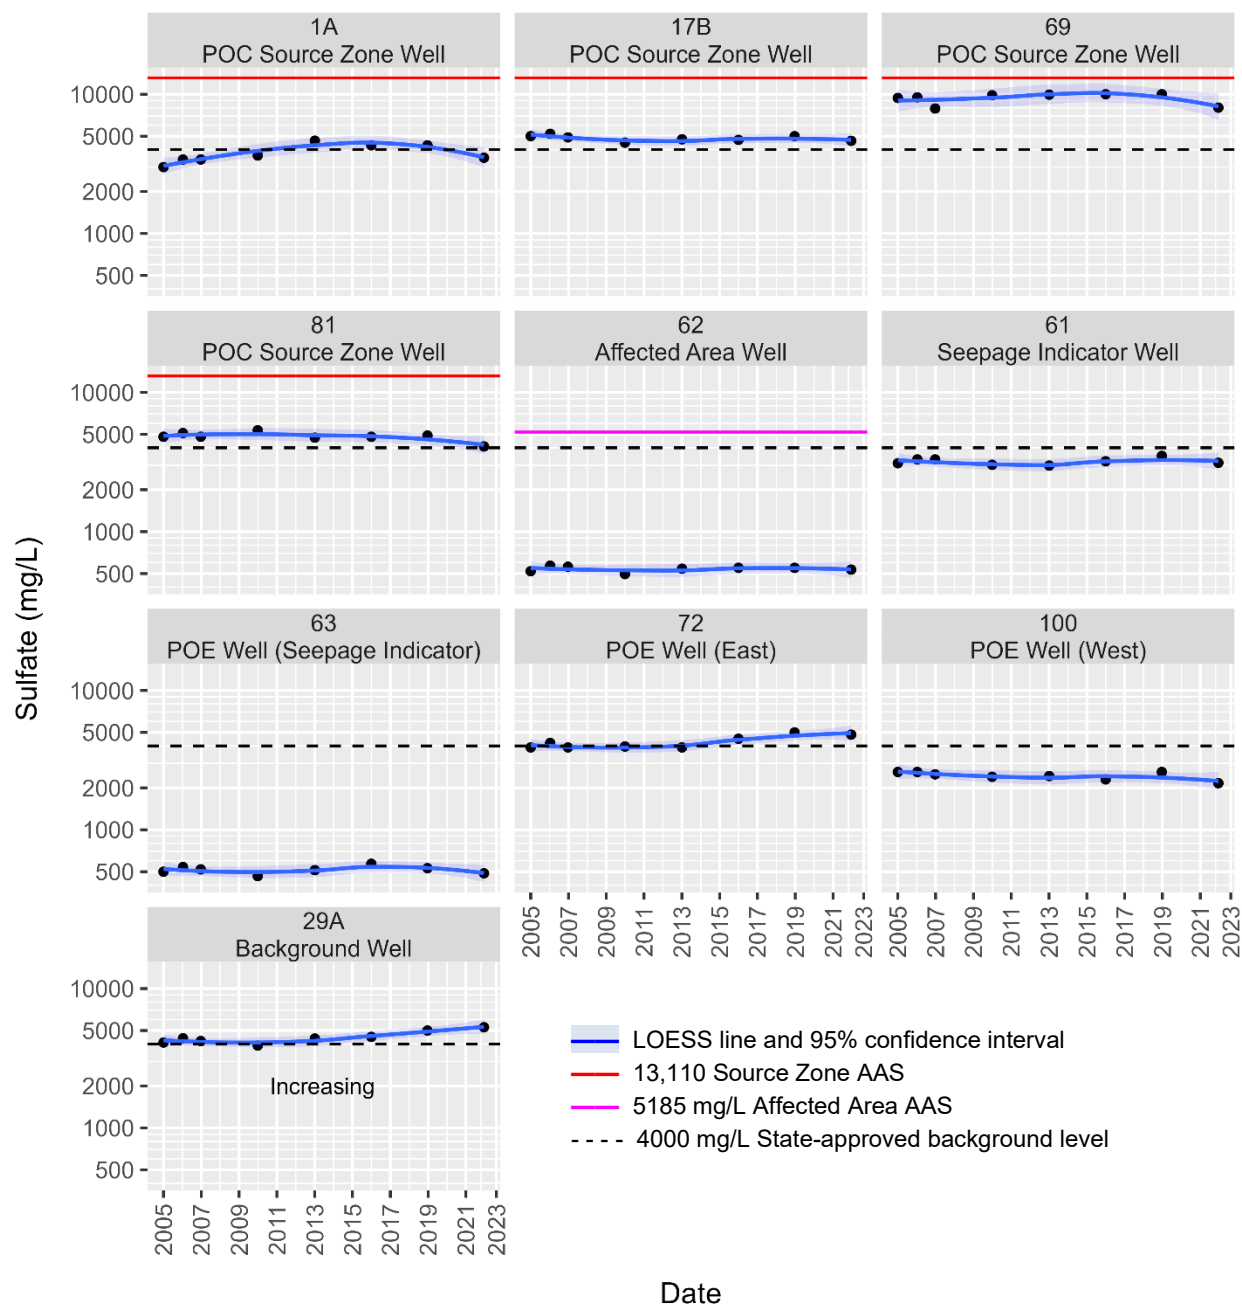
Figure 3-8. Sulfate Concentrations in Groundwater at the L-Bar Disposal Site, 2005–2022

level (Figure 3-8). Sulfate concentrations in AAS affected area well 62 (496–570 mg/L) have been well below the corresponding AAS of 5185 mg/L. Similar levels (465–570 mg/L) have been measured in POE seepage indicator well 63 (Figure 3-8), while concentrations in seepage indicator well 61 have been stable (non-trending) at levels just below the 4000 mg/L standard (2980–3500 mg/L).

Sulfate concentrations in eastern POE well 72 have exceeded this standard since 2016 (4500–5000 mg/L) and are trending upward (as indicated by a positive tau value), but the trend is not statistically significant (Table 3-5). A statistically significant increasing trend was identified for background well 29A, where sulfate concentrations have exceeded the state-approved background level in all but one sample, with the maximum (5280 mg/L) measured in November 2022. As shown in Figure 3-8, sulfate concentrations in POE well 72 are very similar to those measured in well 29A. Both wells have concentrations now exceeding those measured in upgradient POC well 17B as shown in Figure 3-11.

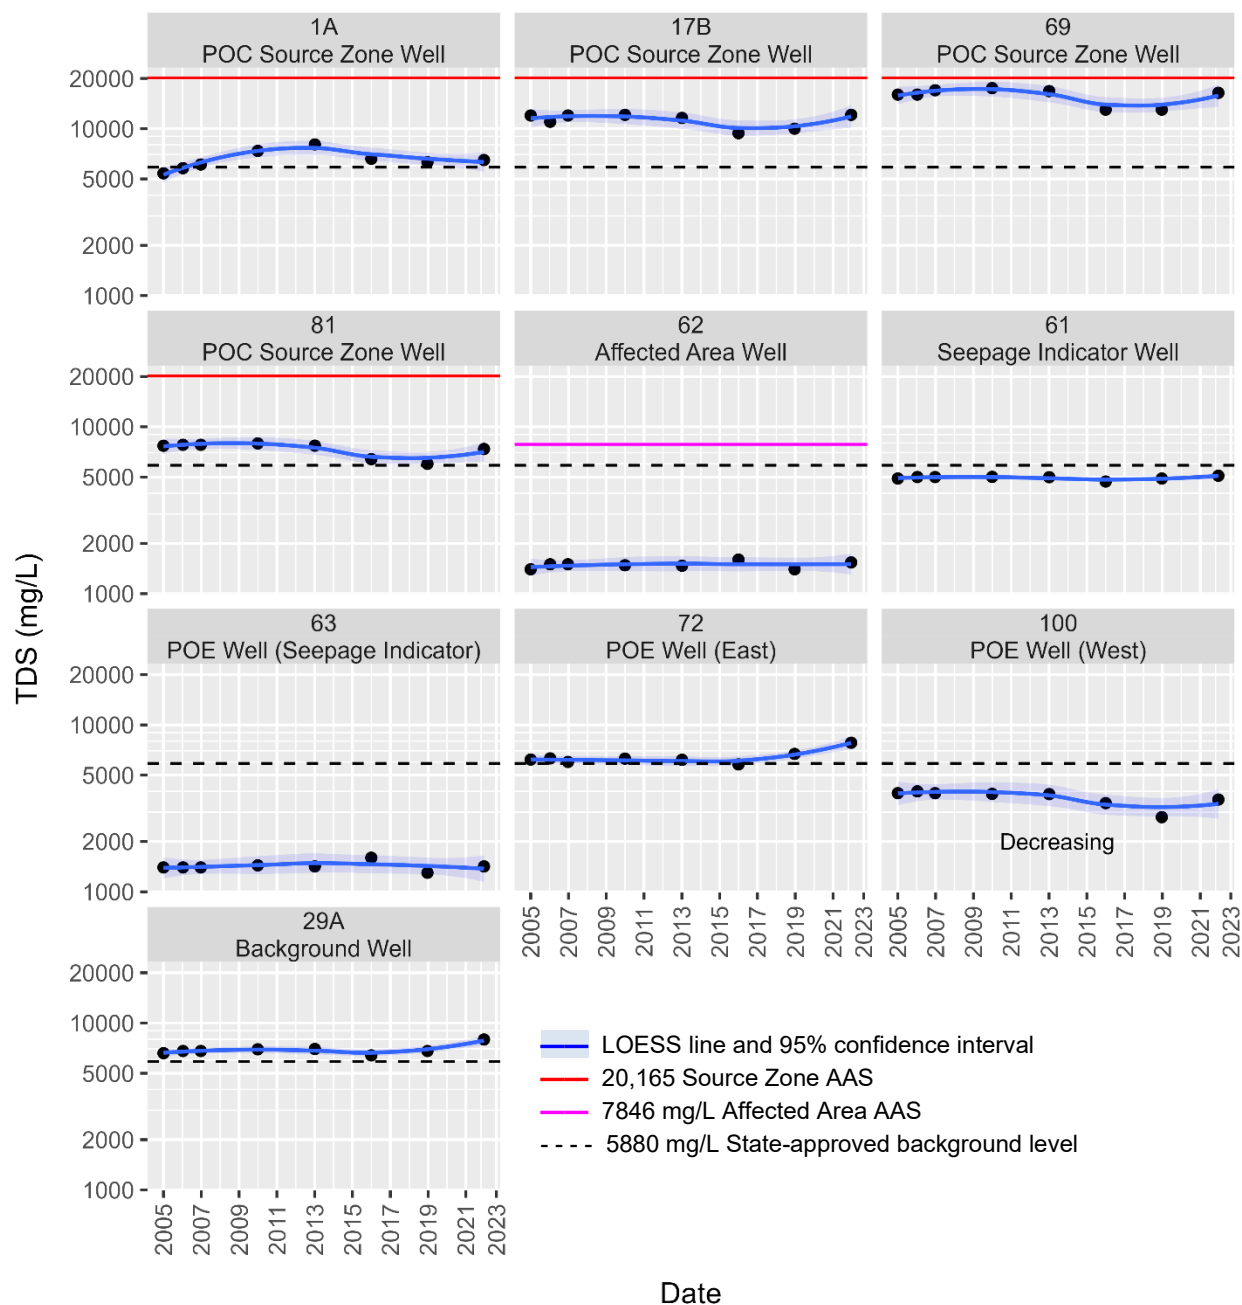
*Figure 3-9. TDS Concentrations in Groundwater at the L-Bar Disposal Site, 2005–2022*

General observations for TDS in L-Bar site wells are very similar to those discussed above for sulfate. TDS levels in POC source zone wells have exceeded the state-approved background level of 5880 mg/L but have been below the corresponding AAS of 20,165 mg/L (Figure 3-9). TDS levels have been highest in POC source zone well 69 (13,000–17,500 mg/L) and lowest in affected area well 62 (1400–1600 mg/L, well below the corresponding AAS of 7846 mg/L) and POE seepage indicator well 63 (1300–1600 mg/L).

As observed for sulfate, TDS concentrations in eastern POE well 72 are similar to those in background well 29A (>5880 mg/L for the last two sampling events), and the trend in both wells is slightly increasing but not statistically significant (Table 3-5). TDS concentrations in background well 29A have exceeded 5880 mg/L in all eight samples, with the maximum (like sulfate), 7970 mg/L, measured in November 2022. The only statistically significant trend in TDS concentrations was found for western POE well 100, with a decreasing trend (Table 3-5).

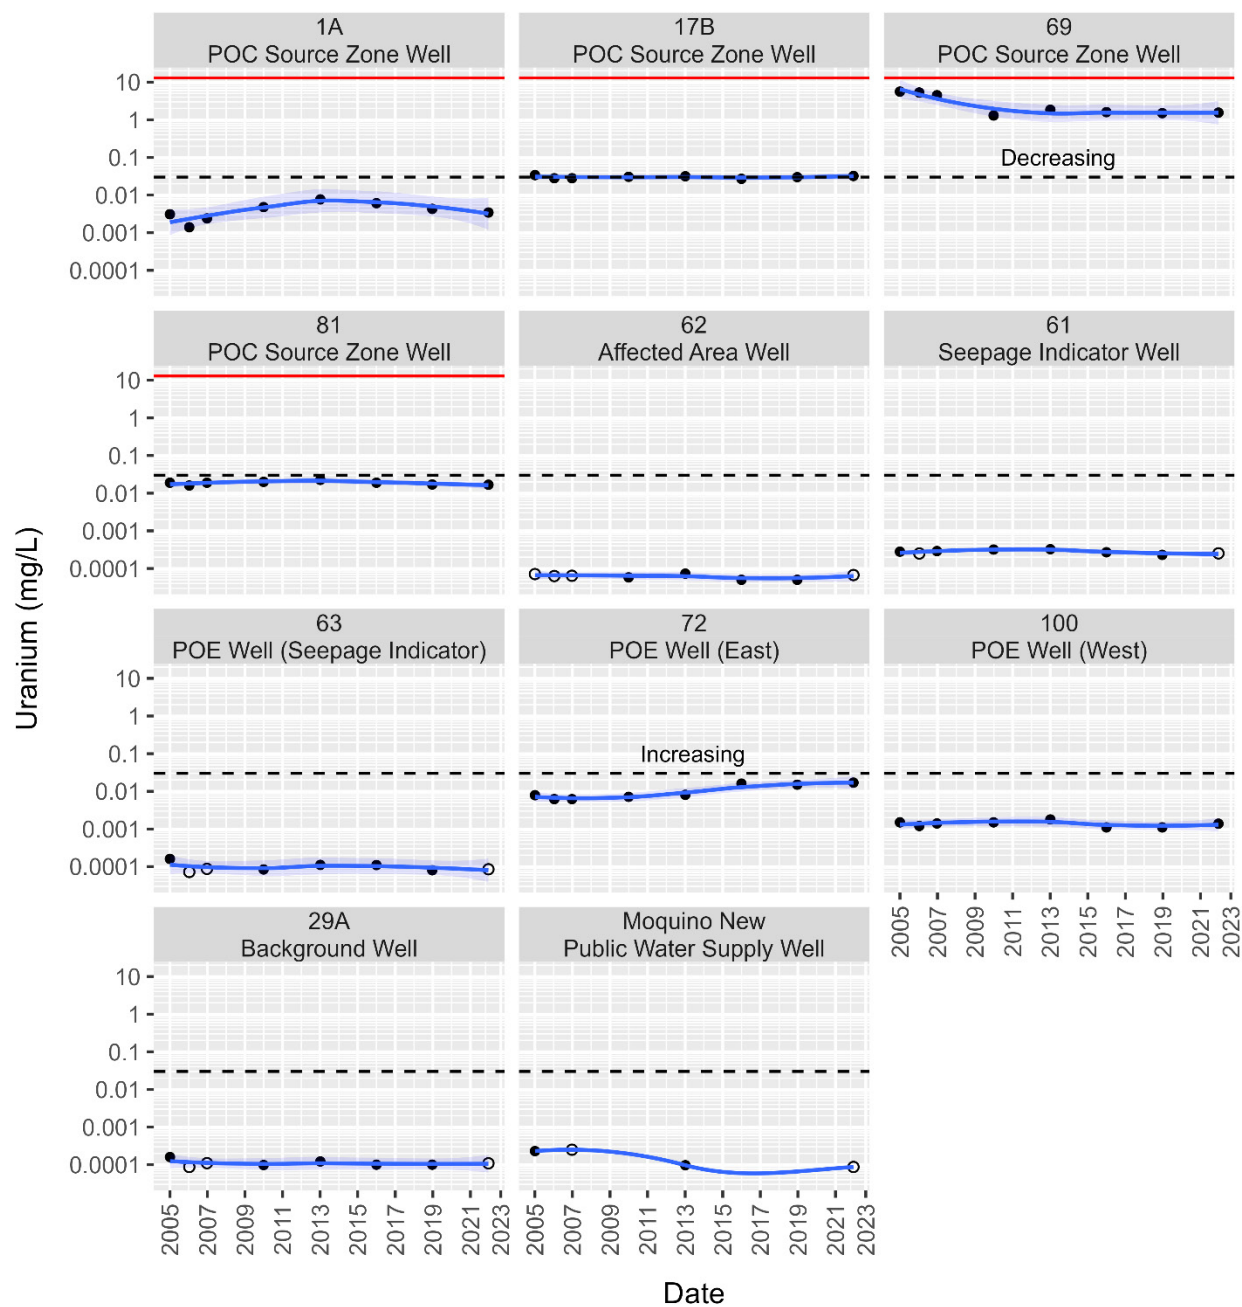
Figure 3-10. Uranium Concentrations in Groundwater at the L-Bar Disposal Site, 2005–2022

Uranium concentrations in POC wells 17B and 69 were above the 0.03 mg/L State of New Mexico standard in 2022 (Figure 3-10). Historically, uranium concentrations in POC source zone well 17B have remained stable at or slightly exceeding the standard (0.027–0.034 mg/L), while concentrations in well 69 have exceeded the standard by 1 to 2 orders of magnitude (1.3–5.6 mg/L). Although Mann-Kendall trend analysis yielded a statistically significant decreasing trend for well 69 from 2005–2022 (Table 3-5), the trend appears to have stabilized since 2010 (Figure 3-10). Uranium concentrations in all POC source zone wells continue to be below the 13 mg/L ACL and AAS.

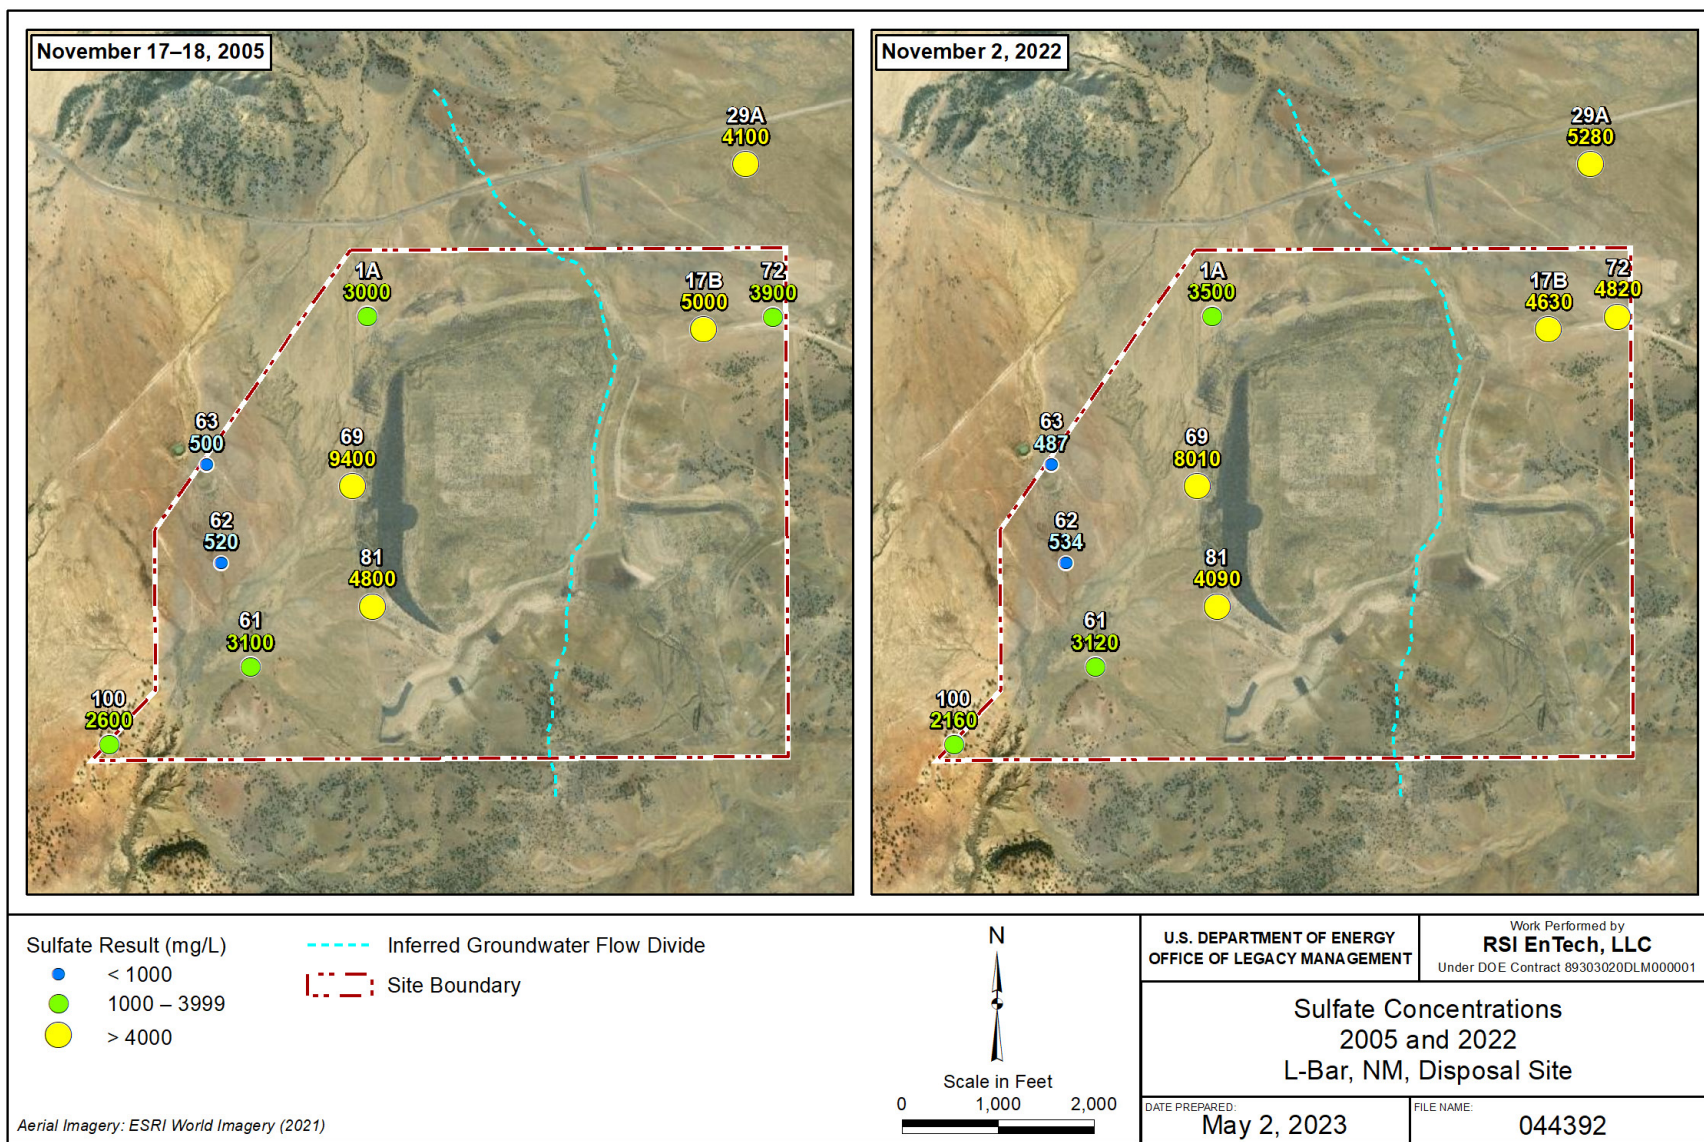
Figure 3-11. Sulfate Concentrations in 2005 and 2022, L-Bar Site Monitoring Wells

Figure 3-11 was developed to satisfy a requirement in Section 3.7.1 of the LTSP, which states that annual inspection reports are to include a groundwater level contour map (provided in Figure 3-3) and a sulfate isoconcentration map for the years that sampling has been conducted (DOE 2004). As discussed in previous annual reports (DOE 2021; DOE 2022), bubble plot maps for sulfate were generated in lieu of isoconcentration maps because of the limited number of well locations. No water quality measurements have been taken directly beneath the tailings impoundment, so interpolated isoconcentrations would likely not be representative of site conditions. All site monitoring wells are screened within the First Tres Hermanos Sandstone unit and do not represent contaminant levels in porous media above or below this stratigraphic unit. Sulfate concentrations continue to be highest in POC source zone well 69 (8080 mg/L). The state-approved background level is also currently exceeded in POC well 81 and the three easternmost wells: POC source zone well 17B, POE well 72, and background well 29A.
